Technical Service Bulletin

20 Pump nozzle cannot be inserted into fuel tank filler neck, vehicle cannot be refueled

20 14 40 2033836/2 October 6, 2014. Supersedes Technical Service Bulletin Group 20 number 13-26 dated May 15, 2013 for reasons listed below.

Model(s)	Year	VIN Range	Vehicle-Specific Equipment
A3, A6, A8, Q7	2009 - 2015	All	TDI clean diesel

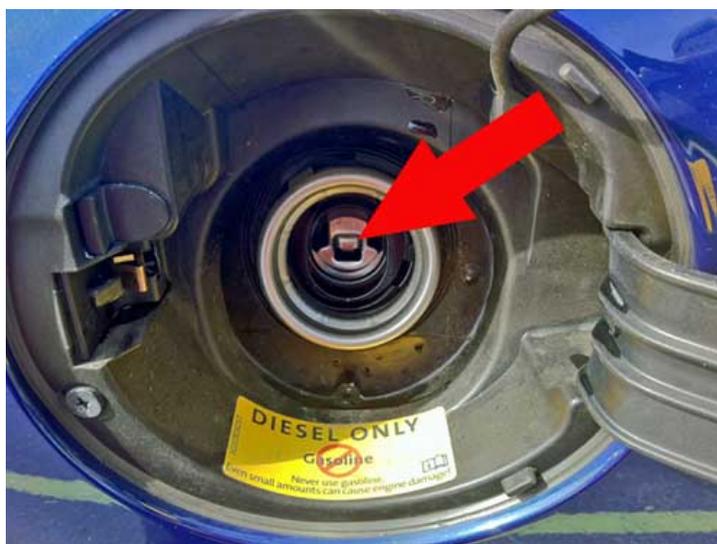
Beginning with MY2009, the filler necks of various TDI clean diesel vehicles were equipped with a misfueling guard (Figure 1). The guard minimizes the likelihood that fuel other than ultra-low sulfur diesel will be put into the vehicle.

The misfueling guard is designed to remain in a locked position when a nozzle with a diameter typically suited for non-diesel fuels (approximately 13/16", or 20.6mm) is inserted, to prevent further insertion of the nozzle into the filler neck.

A nozzle with a larger diameter typically suited for diesel fuel (approximately 15/16", or 23.8mm) will unlock the misfueling guard when inserted, allowing the nozzle to be further inserted into the filler neck.

Figure 1. Misfueling guard, indicated by red arrow. (2013 A3 TDI pictured. Other vehicles may appear slightly different.)

Explain to the customer the purpose of the misfuel guard, and how the guard is designed to function. It is normal operation for the flap inside the fuel filler neck to be in a locked position. It will only be released (free to swing open) when a nozzle of the appropriate diameter is inserted.

Also explain that some refueling stations may have damaged or worn nozzles with diameters that are out of specification, and that such nozzles may not be able to unlock the misfueling guard. Suggest that in such cases, the customer try turning the nozzle before inserting it into the fuel filler neck, try using a different fuel pump, or see an authorized Audi dealer or authorized repair facility for assistance.

Do not replace the fuel tank for this concern, as this is a normal condition. The operation of the misfuel guard can easily be checked by inserting Diesel Fueling Adapter (part number 000072709) into the filler neck. If the flap opens and allows the adapter to be inserted, the misfuel guard is operating as designed. See attached video of A6 TDI fuel tank being tested. Note that the flap *cannot* be opened by finger.
