# Technical Service Bulletin

## 21 Miscolored pipe on turbocharger

21 14 19 2034999/2 October 16, 2014. Supersedes Technical Service Bulletin Group 21 number 13-17 dated August 16, 2013 for reasons listed below.

Model(s)	Year	VIN Range	Vehicle-Specific Equipment
S6, S7, RS 7, A8, S8	2013 - 2015	All	4.0 TFSI

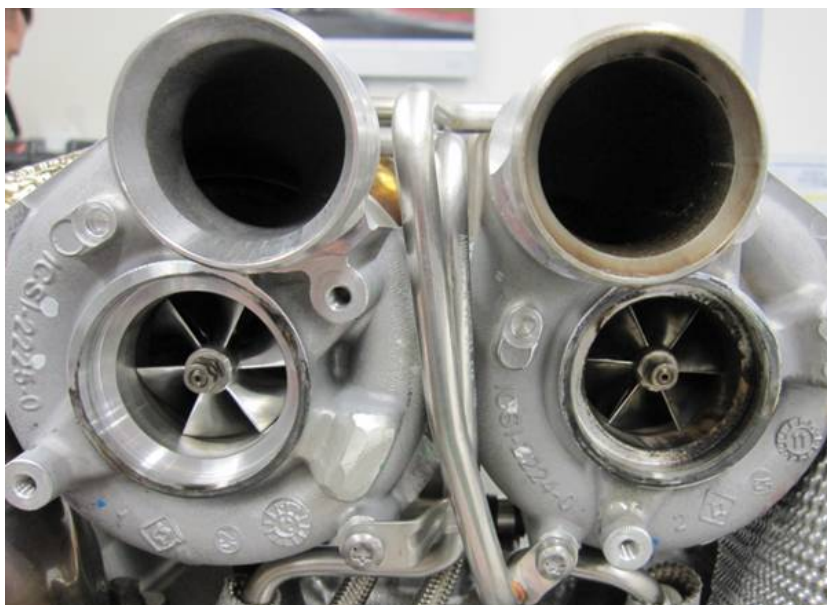
On 4.0l bi-turbo FSI engines, the pipe on the impeller side of the bank 2 turbocharger looks discolored when compared to the pipe on the bank 1 turbocharger.

The crankcase breather is only connected to the bank 2 turbocharger inlet. Blow-by gases from the crankcase breather discolor the pipe (Figure 1). This is a normal condition.

*Figure 1. The pipe on the impeller side of the bank 2 turbocharger is discolored due to blow-by gases from the crankcase breather.*

1. If necessary, explain to the customer that this is a normal condition.
2. Do not replace any parts due to this condition.
