Technical Service Bulletin

94 Headlight internal diagnosis before replacement, various concerns

94 14 54 2038597/1 October 7, 2014.

Model(s)	Year	VIN Range	Vehicle-Specific Equipment
A7	2011 - 2015	All	Not Applicable

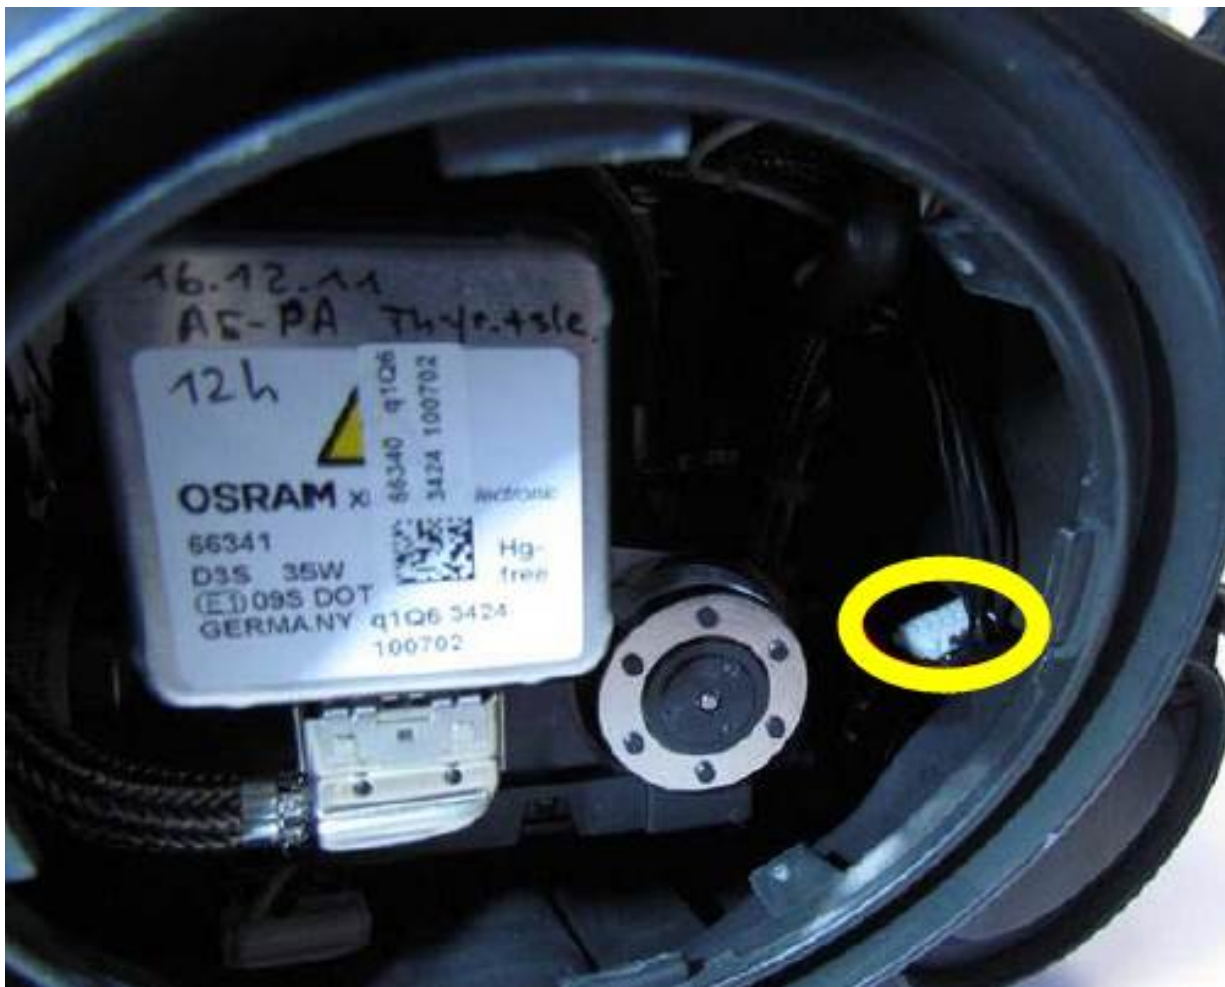
For symptom A (headlight range control inoperative):

- If the vehicle is equipped with one of the following PR codes, check the connector shown below (Figure 1):
 - **8Q3** (Automatic headlight range control, dynamic)
 - **8Q5** (Automatic headlight range control, dynamic with curve headlight circuit)
 - **8Q7** (Beam length regulator, electric)

Figure 1. Check this connector on vehicles with PR codes: 8Q3, 8Q5, and 8Q7.

3. If any connectors are not correctly plugged in, check connector for damage. If no damage is found, reconnect the connector. Do not use a screwdriver or other metal object. If all connectors were plugged in correctly, this bulletin does not apply.
4. Reconnect the headlight to the vehicle, then check the headlight operation. It is not necessary to fully install the headlight to test the headlight operation.
5. If headlight operation is fully restored, fit and adjust the headlight. Additional adaptations (radar sensor, overhead camera, night vision) may be necessary, depending on vehicle equipment.

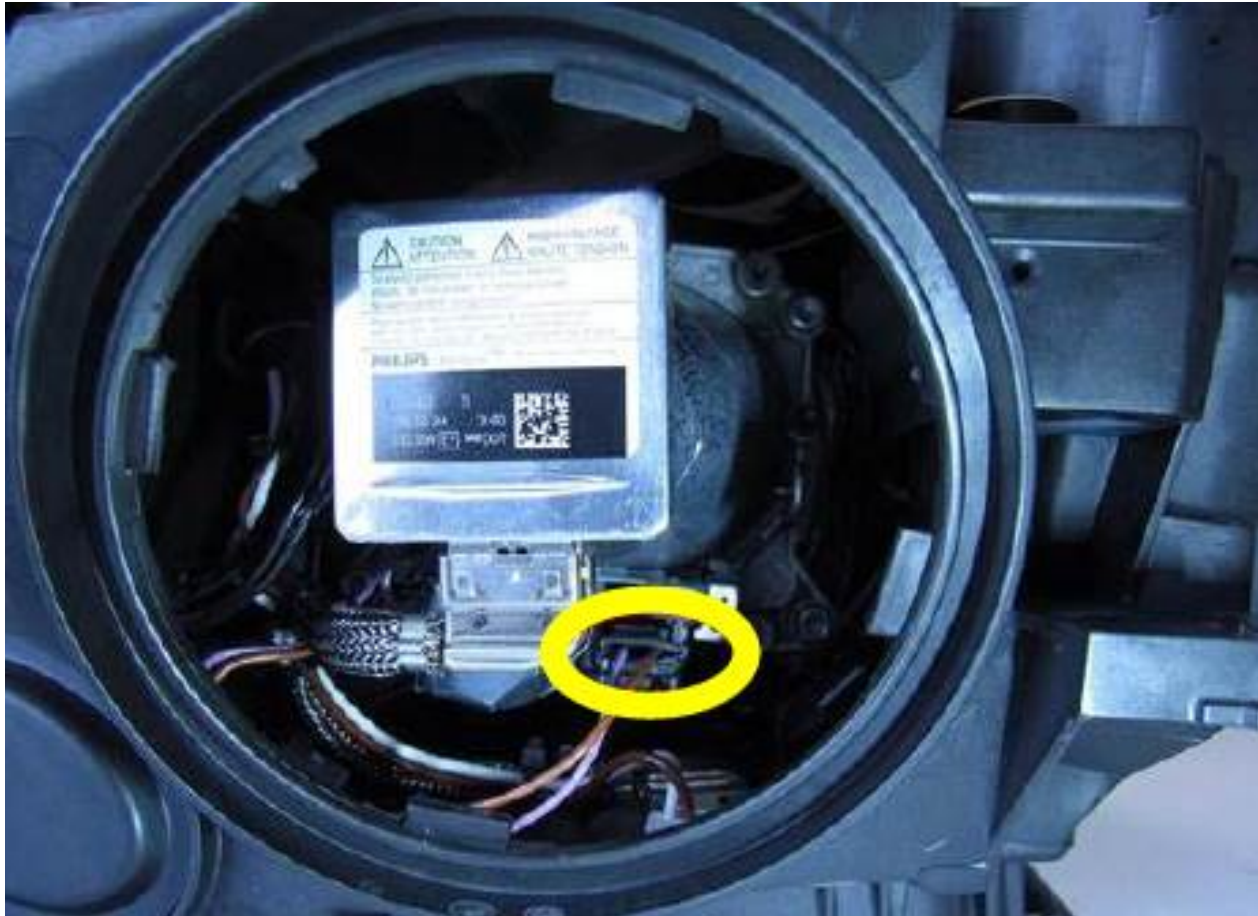
For symptom B (Xenon high beam shutter inoperative on one side (low beam functioning)):

- If the vehicle is equipped with the following PR code, check the connector shown below (Figure 2):
 - **8Q3** (Automatic headlight range control, dynamic)

Figure 2. Check this connector on vehicles with PR code 8Q3.

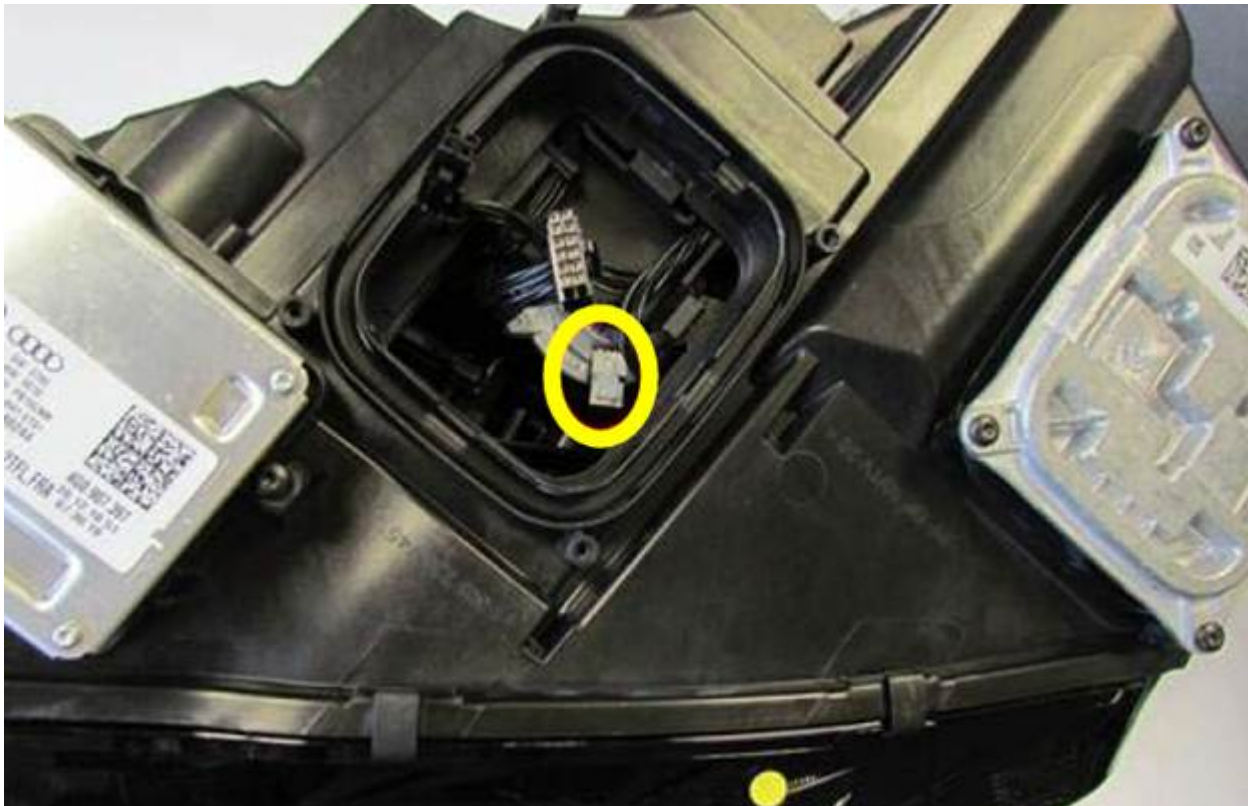
For symptom C (Internal fan inoperative):

- If the vehicle is equipped with one of the following PR codes, check the connector shown below (Figure 3):
 - **8EX** (LED main headlights)
 - **8EY** (LED main headlights)

Figure 3. Check this connector on vehicles with PR codes 8EX and 8EY.
