Technical Service Bulletin

94 Headlight internal diagnosis before replacement, various concerns

94 14 53 2038601/1 October 7, 2014.

Model(s)	Year	VIN Range	Vehicle-Specific Equipment
A4	2013 - 2014	All	Not Applicable

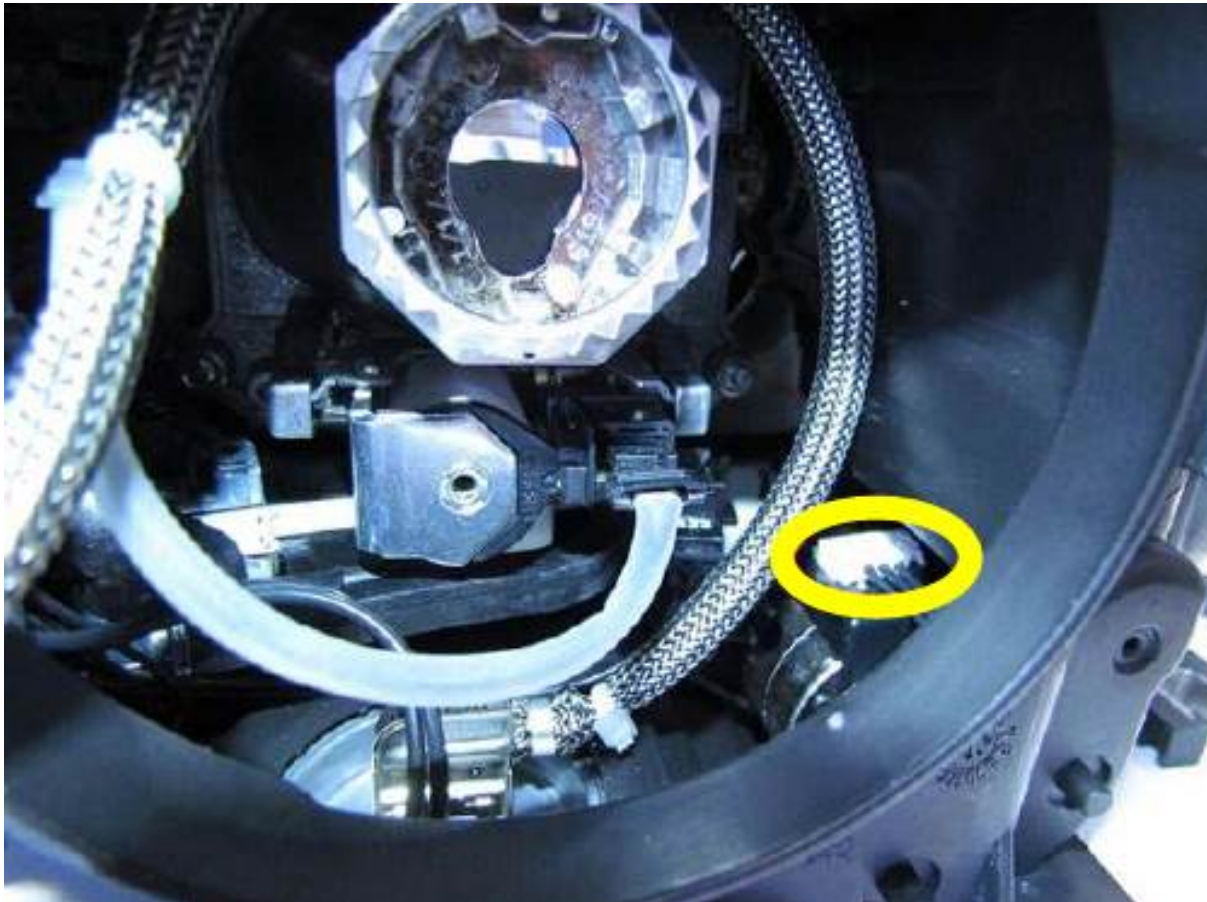
Connector in the headlight is not properly seated.

For symptom A (headlight range control inoperative):

Figure 1. Check this connector on vehicles with PR codes 8Q3 or 8Q5.

3. If any connectors are not correctly plugged in, check connector for damage. If no damage is found, reconnect the connector. Do not use a screwdriver or other metal object. If all connectors were plugged in correctly, this bulletin does not apply.
4. Reconnect the headlight to the vehicle, then check the headlight operation. It is not necessary to fully install the headlight to test the headlight operation.
5. If headlight operation is fully restored, fit and adjust the headlight. Additional adaptations (radar sensor, overhead camera, night vision) may be necessary, depending on vehicle equipment.
