# Technical Service Bulletin

## 91 iPod or USB unit not recognized or does not charge - MMI 3G/concert radio

91 14 67 2021037/8 October 16, 2014. Supersedes Technical Service Bulletin Group 91 number 13-85 dated May 29, 2013 for reasons listed below.

Model(s)	Year	VIN Range	Vehicle-Specific Equipment
All	2010 - 2016	All	MMI3G/concert radio

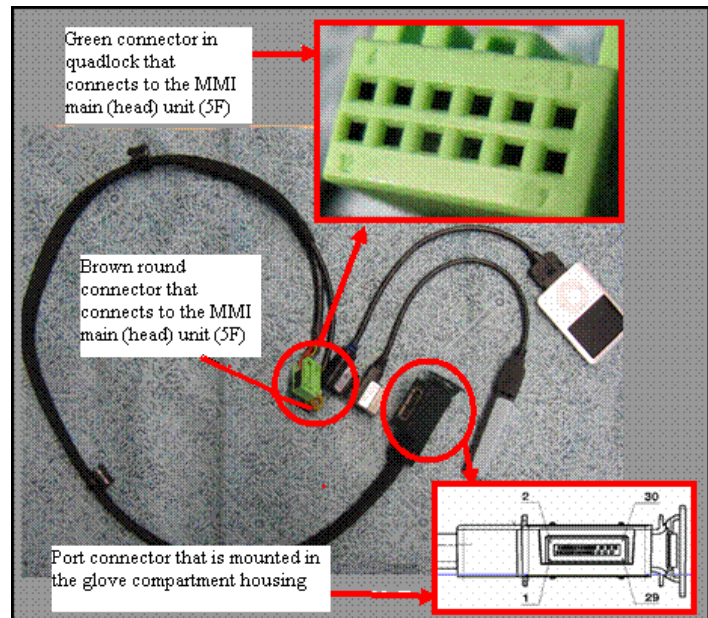
The wiring harness for AMI between the MMI control unit and the port connection for the adapter cable is damaged.

**Figure 1.** MMI3G+ AMI wire harness, iPod and adapter cable, USB memory stick and adapter cable.

4. If the complaint is not resolved with steps 1 – 3, check the AMI wiring harness for continuity and shorts. Replace the harness for MMI3G+ (Figure 1) if necessary.

The original wiring harness may remain in the vehicle, but it must be protected from rattling against other components.

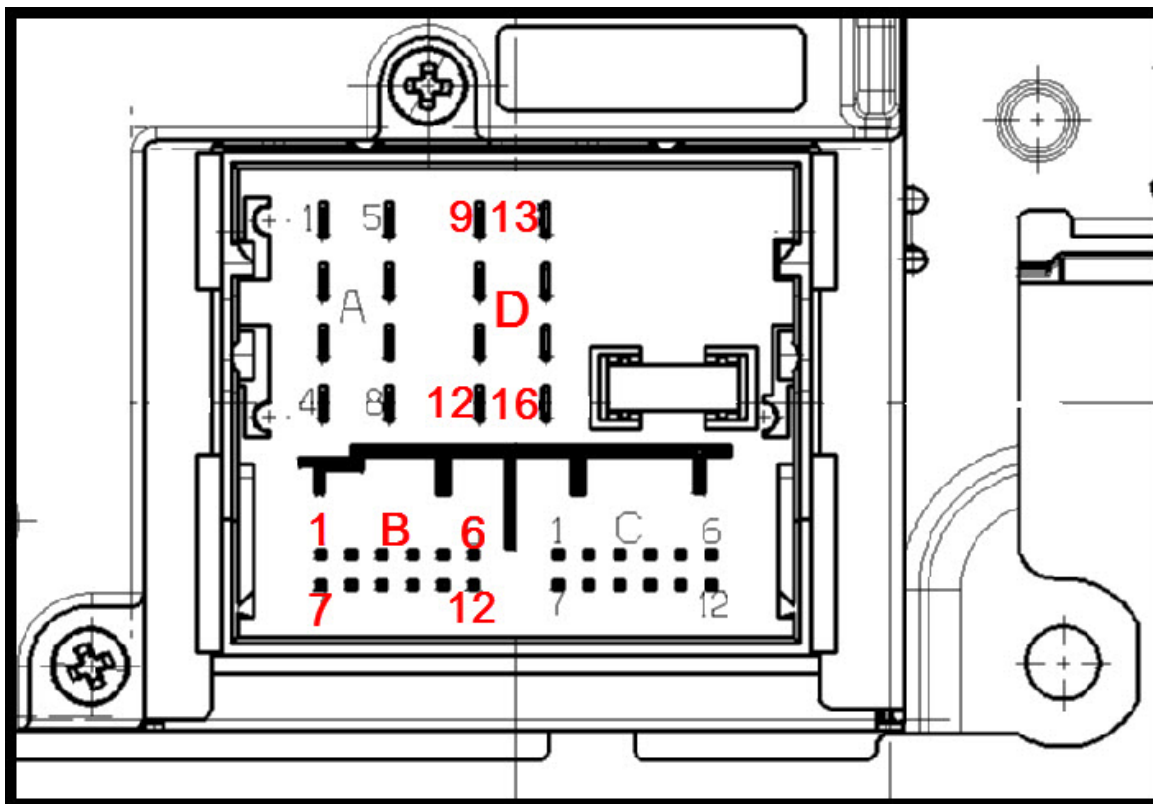
Figure 2. CAN Radio Quad-lock connector diagram with sections "B" and "D".
