# Technical Service Bulletin

## 92 Washer solvent level warning on

92 14 09 2038151/2 September 12, 2014. Supersedes Technical Service Bulletin Group 92 number 14-08 dated August 19, 2014 for reasons listed below.

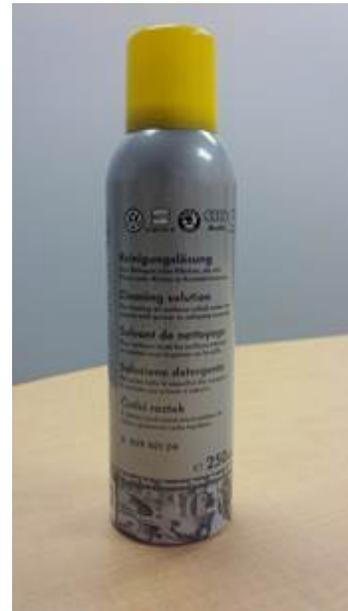
*Figure 1: D 009 401 04 all-purpose cleaner*

1. Empty the reservoir and remove the level sensor. Clean the sensor probes using all-purpose cleaner **D 009 401 04** (Figure 1), then reinstall the level sensor.

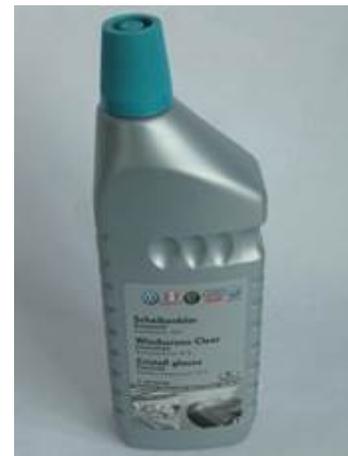
*Figure 2: G 052 164 M2 windshield cleaner concentrate with anti-freeze*

2. Refill the reservoir with the correct type and concentration of solvent. Windshield cleaner concentrate with anti-freeze **G 052 164 M2** works best (Figure 2). This solvent can be adjusted for freeze protection to  $-70^{\circ}\text{C}$  ( $-94^{\circ}\text{F}$ ), prevents washer jet contamination particularly on the “fan” type of washer jet, and is highly effective in removing residues and insects from the windshield.

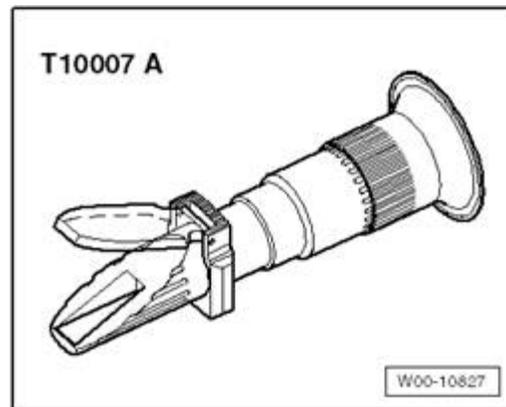
**Figure 3:** T10007A refractometer

3. The concentration and freeze point can be checked using the T10007A refractometer (Figure 3).

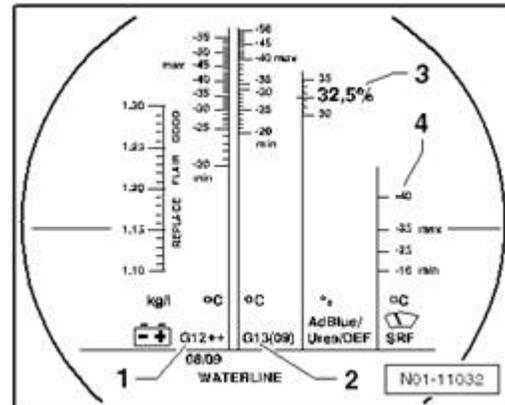
**Figure 4:** Scale in the view of the T10007A refractometer.

4. Put a drop of washer fluid with the pipette on the glass of the refractometer. When viewing the refractometer, a light-dark border can be clearly recognized. Using the scale to the right (Figure 4), adjust the concentration of the solvent to accommodate the current weather conditions.
