# Technical Service Bulletin

## 91 Voice recognition is not available or not enabled

91 14 60 2038136/1 September 9, 2014.

Model(s)	Year	VIN Range	Vehicle-Specific Equipment
A3 cabriolet	2015 - 2016	All	MIB MMI
A5 cabriolet	2010 - 2016	All	MMI3G or 3G+

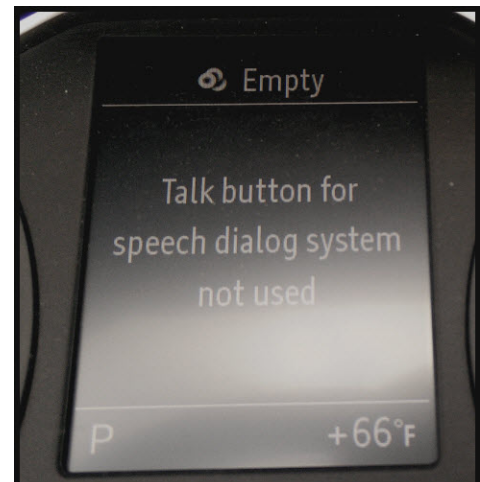
- The message “Talk button for speech dialog system not used” appears in the DIS for A3 cabriolet vehicles (Figure 1).
- The message “Not available” appears in the DIS for A5 cabriolet vehicles (Figure 2).

Figure 1. Message for A3 cabriolet

If the customer requests to have the VR feature enabled, it can be done through a change to the coding of the information control unit 1, J794 (address word 5F). The labor to perform this change is not covered by warranty.

**Coding change A3 cabriolet with MIB High:** Byte 24 of the information control unit 1, J794 (address word 5F) long coding controls the activation of the VR/SDS system.

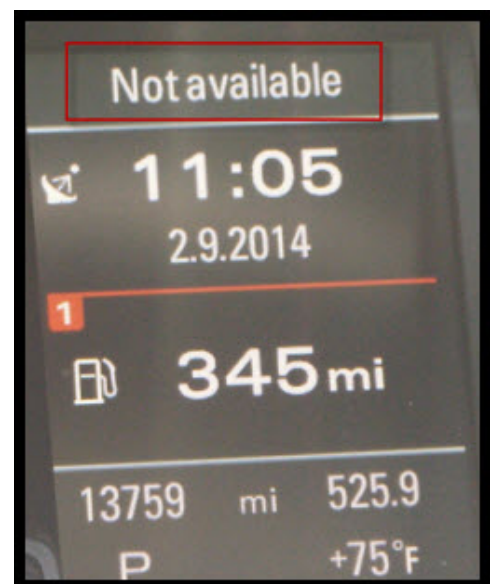
Figure 2. Message for A5 cabriolet

**Coding change for A5 cabriolet vehicles with MMI3G/MMI3G+:** Byte 16 of the information control unit 1, J794 (address word 5F) long coding controls the activation of the VR/SDS system. Note that this is byte 16 when counting in decimal, i.e., 1, 2, 3,...9, 10, 11, 12, 13, 14, 15, 16. Some aftermarket diagnostic tools number the coding bytes using HEX, i.e., 1, 2, 3,...9, A, B, C, D, E, F, 10, 11.

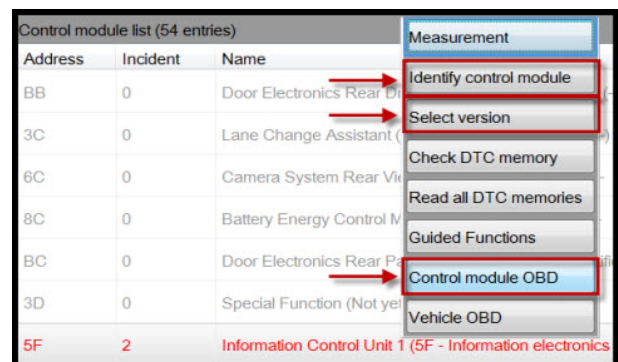
Figure 3. ODIS Options for 5F

1. Start diagnosis with ODIS. Uncheck "Guided Fault Finding" to speed up the process, or use OBD (self-diagnosis) from the ODIS start screen. The instructions in this TSB will be from GFF.
2. Right-click 5F\*. Choose "Identify Control Module". Next, right-click 5F again and choose "Select version". Then, right-click 5F again and choose "Control module OBD", then select "Code" (Figure 3).

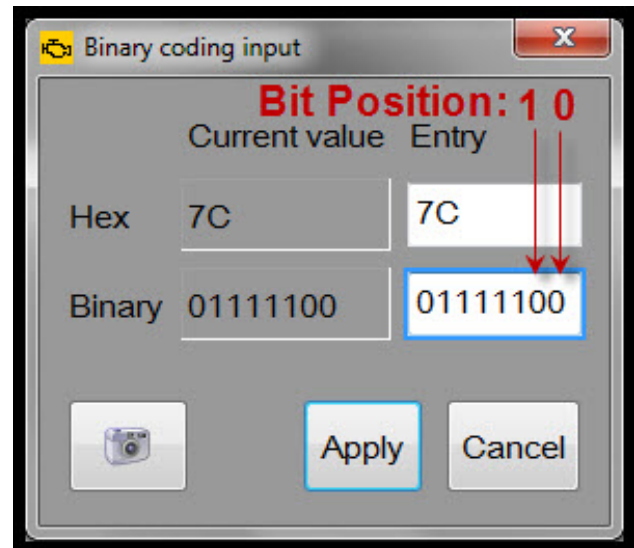
**Figure 4.** ODIS binary input for coding with indicated bit positions.

4. At the bottom of the screen, choose “Binary Coding”.  
The Binary coding input window will appear (Figure 4).

5. **For MMI3G/MMI3G+:** Change bit 0 from “1” to “0”. Bit position 0 is indicated in Figure 4.  
**For MIB High:** Change bit 1 from “0” to “1”. Bit position 1 is indicated in Figure 4.

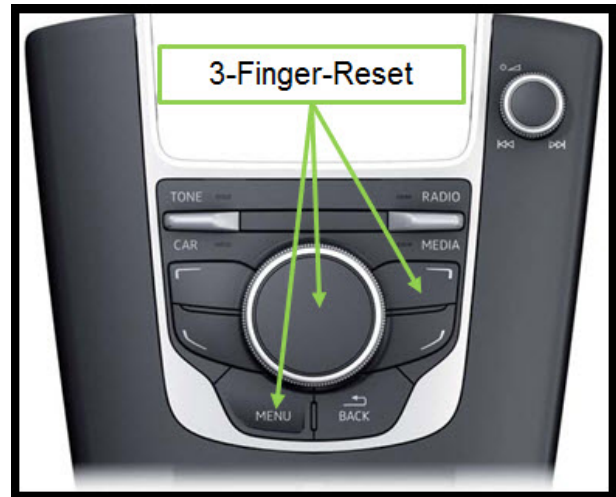
**Figure 6.** Three-finger reset for MIB

6. Hit “Apply” in the pop-up window, then hit “Apply” at the bottom of the main window.
7. Perform a three-finger reset of the main unit using the MMI control panel (Figure 6, Figure 7, Figure 8).

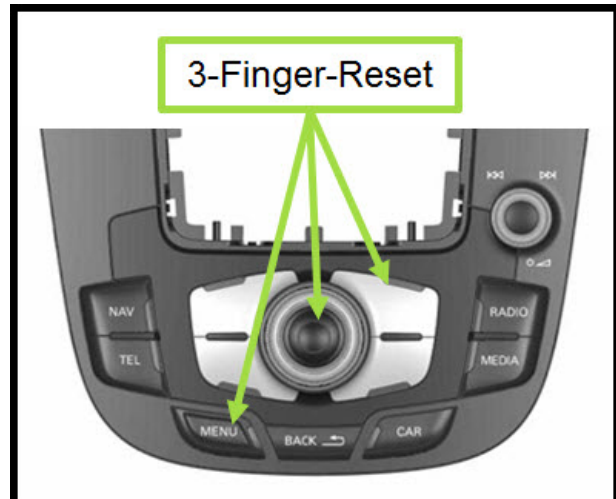
**Figure 7.** Three-finger reset for MMI3G+

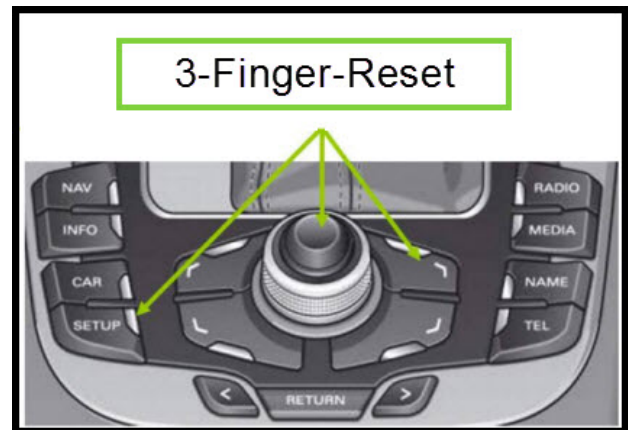
**Figure 8.** Three-finger reset for MMI3G

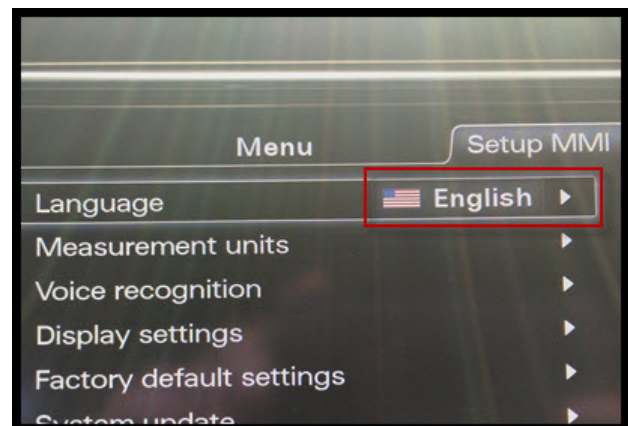
**Figure 8.** System language setting

- 8 Test the system to verify all functionality. If the VR/SDS system does not fully function, or if it is in a different language, go to *Menu >> Setup MMI >> Language* (Figure 8) and change the language to any language other than English (either Spanish or French). Perform a three-finger reset, then set the language back to English and test the system again.
