# Technical Service Bulletin

## 91 MMI3G+ Navigation GPS location is inaccurate (MY13 only)

91 14 59 2036607/2 September 5, 2014. Supersedes Technical Service Bulletin Group 91 number 14-42 dated April 30, 2014 for reasons listed below.

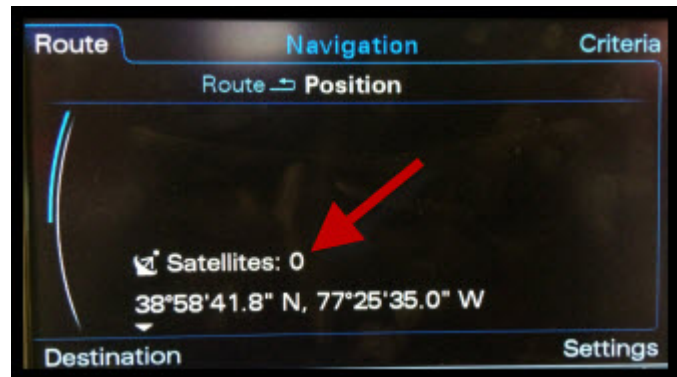
1. Turn the HVAC system blower off.
2. Verify that the MMI navigation system consistently shows 0 satellites (Figure 1) with the car outside in clear view of the sky.

Figure 1. Zero satellite reception in MMI.

3. MMI main unit GPS hardware reset:
  - **If the system shows 0 satellites:** Reset the GPS hardware in the MMI main unit before proceeding to step 4. To reset the hardware, turn the ignition off and disconnect the quad lock connector from the back of the main unit for one minute.
  - **If the system shows one or more satellites and the Navigation map shows the correct location:** proceed to step 4.
4. Perform the ZUG K0715 software update as outlined in TSB 2030465, *91 MMI 3G+ Sound system "popping" and various other technical Issues (K0715 Update)*.
5. After the update is complete, verify that all systems show "OK". If "NOK" is displayed, the update was not completed successfully and it should be performed again (starting with step 3) until it is successful.

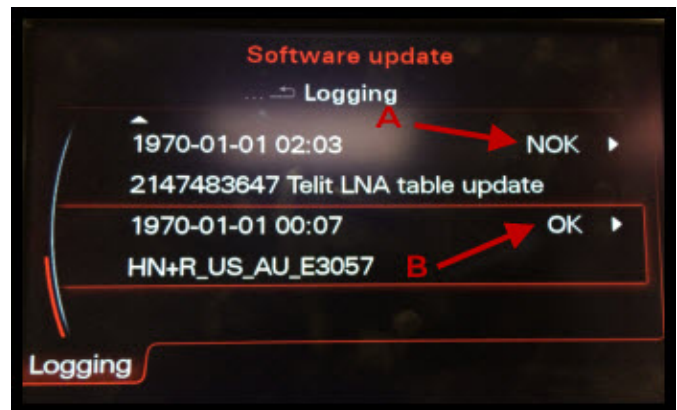
Figure 2. Update not completed successfully (A); Update completed successfully (B).

6. After the update is completed successfully, leave the vehicle in the shop for at least five minutes with 0 satellite reception and the HVAC system or blower off. (It may be necessary to cover the antenna with a stainless steel object -- first cover the antenna with a blanket or other non-scratching material, then place the stainless steel object over it.) Keep the satellite reception screen (Figure 1) displayed in the MMI.
