Technical Service Bulletin

PSS 91 MMI 3G+ GPS location is inaccurate (MY13, MY14, & MY15)

91 14 58 2035919/4 September 5, 2014. Supersedes Technical Service Bulletin Group 91 number 14-53 dated July 24, 2014 for reasons listed below.

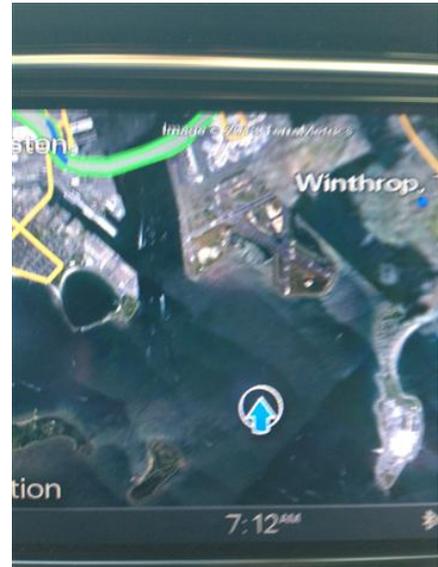
The vehicle is a model year 2013 vehicle and TSB 2036607, *91 MMI3G+ Navigation GPS Location is inaccurate*, has been completed. The GPS location or vehicle direction indicated on the navigation map does not match the vehicle's actual location or direction of travel (Figure 1).

Figure 1. GPS location incorrect.

- If TSB 2036607, *91 MMI3G+ Navigation GPS Location is inaccurate*, has not been completed, stop now and complete it for all model year 2013 vehicles.
- If TSB 2036607, *91 MMI3G+ Navigation GPS Location is inaccurate*, has been completed and the 0 satellite condition only occurs with the HVAC blower on while in panel vent mode, proceed to the *Service* section of this bulletin.

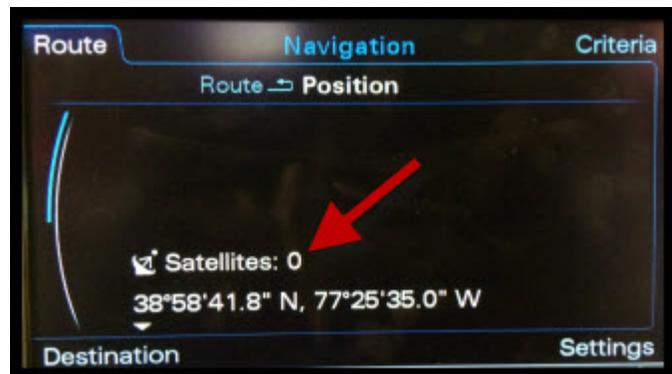
To view the number of satellites being received, go to *Nav >> Route >> Current Position (first item in list) >> Scroll up* (Figure 2). If the system does *not* receive any satellites during this timeframe, submit a Technical Assistance Center ticket.

Figure 2. Number of satellites received.
