## Technical Service Bulletin

#### 35 Gearbox warning light on (DTCs P179E00, P179F00, P0700, P060A)

35 14 17 2032211/2 September 25, 2014. Supersedes Technical Service Bulletin Group 35 number 12-08 dated December 21, 2012 for reasons listed below.

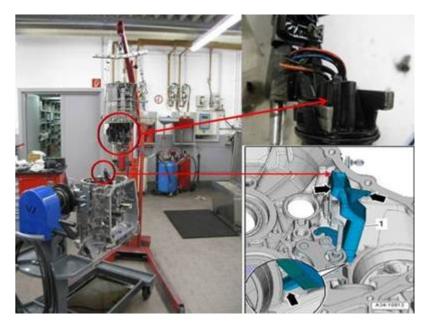
**Tip:** Use caution when lifting or lowering intermediate housing to avoid damage to components (Figure 2).

Figure 2. Caution points: drip tray and sensor module connector.

1. If the Condition matches exactly, replace the G676 sensor module with circuit board by following instructions in Elsa >> Repair manual >> Transmission >> S Tronic Transmission Internal Components >> 35 Gears, Shafts >> Removal and Installation >> Sensor Module with Transmission Input Speed Sensor -G612-,-G632-, -G676-and Circuit Board 3.

When replacing the sensor module, its wiring loom must also be replaced.
