Technical Service Bulletin

26 Refill AdBlue warning comes on prematurely with no faults stored

26 14 24 2038295/1 September 16, 2014.

Model(s)	Year	VIN Range	Vehicle-Specific Equipment
Q7	2009 - 2012	All	TDI clean diesel

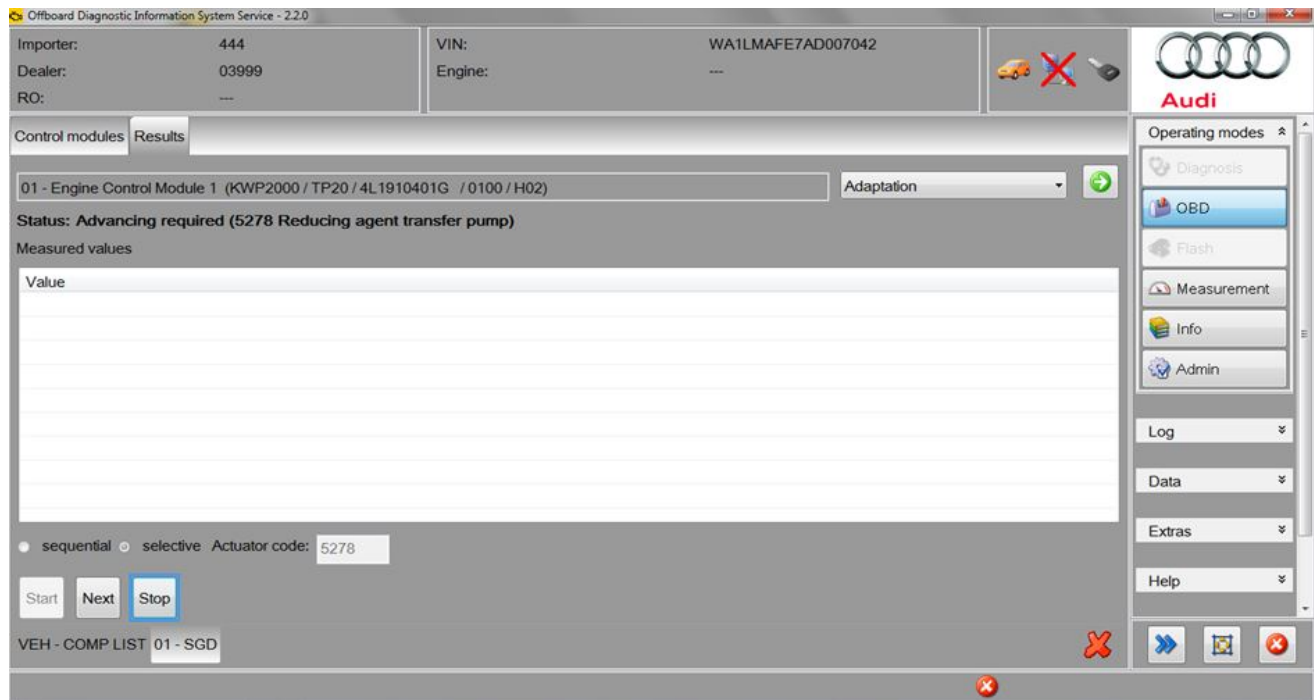
Figure 1. Output test of SCR transfer pump in ODIS for KWP2000 vehicles.

1. Locate the output test in ODIS under *OBD >> 01 Engine Control Module 1>> Output Diagnostic Test Mode*.
2. Click the dot next to *selective*, then enter actuator code 5278.
3. Click Start to begin the output sequence (Figure 1).
4. If the transfer pump fails to function (see attached video for typical clicking noise made during normal operation) or fails to transfer fluid (which can be verified by disconnecting transfer pump line), see *Repair Manual >> Engine >> Engine Mechanical >> 26 Exhaust System, Emission Controls >> Reducing Agent Metering System>> Reducing Agent Transfer Pump V436, Removing and Installing*.

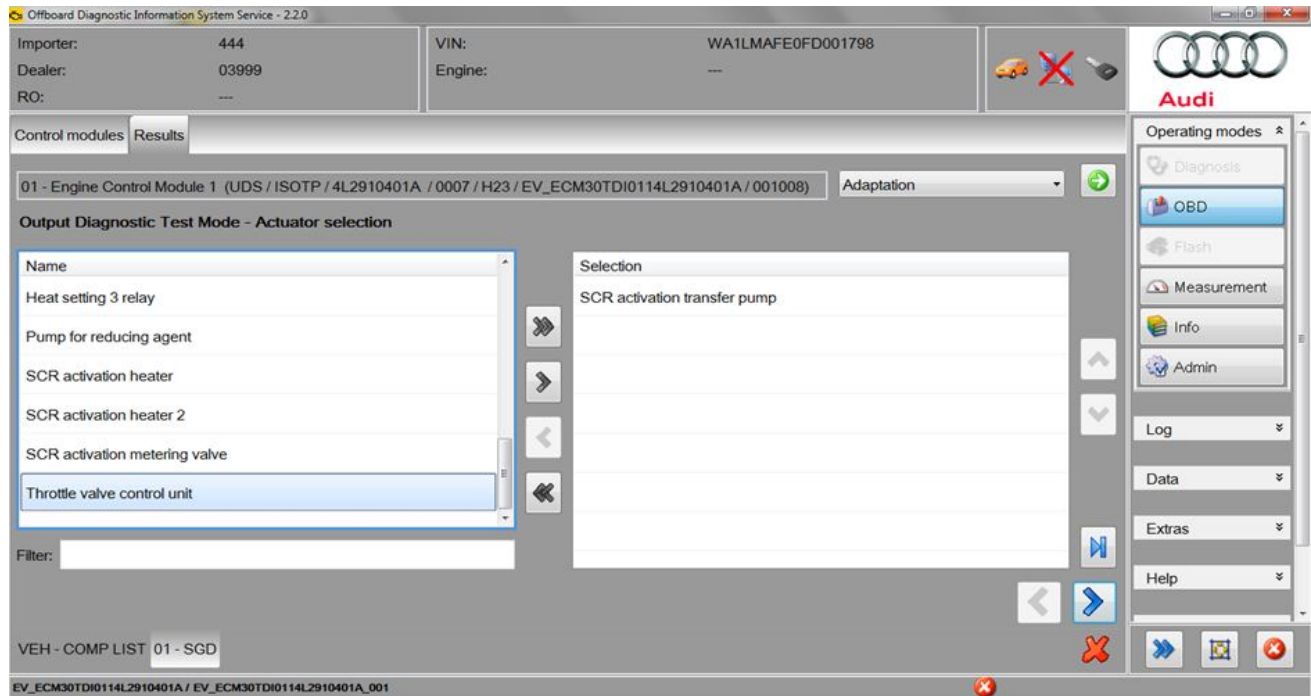
Figure 2. Output test of SCR transfer pump in ODIS for UDS vehicles

1. Locate the output test in ODIS under *OBD >> 01 Engine Control Module 1 >> Output Diagnostic Test Mode >> Actuator selection >> SCR activation transfer pump* (Figure 2).
2. If the transfer pump fails to function (see attached video for typical clicking noise made during normal operation) or fails to transfer fluid (which can be verified by disconnecting transfer pump line), see *Repair Manual >> Engine >> Engine Mechanical >> 26 Exhaust System, Emission Controls >> Reducing Agent Metering System >> Reducing Agent Transfer Pump V436, Removing and Installing*.
