Technical Service Bulletin

70 Noises in instrument panel

70 14 40 2039016/1 November 18, 2014.

Model(s)	Year	VIN Range	Vehicle-Specific Equipment
R8	2008 - 2016	All	Not Applicable

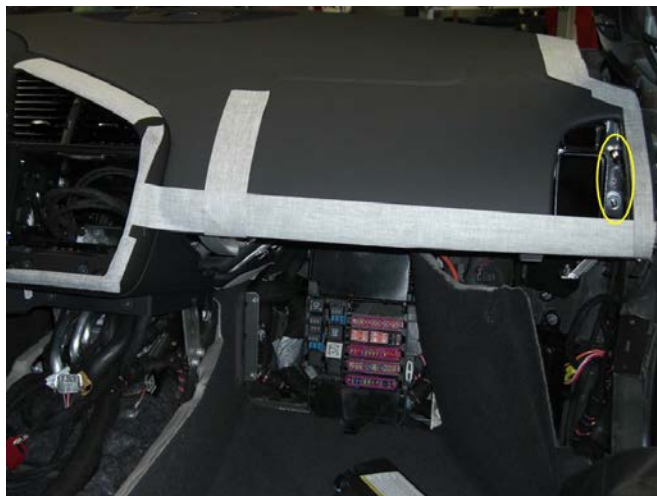
Figure 1. Right instrument panel vent removed.

1. Remove the right instrument panel vent (Figure 1).

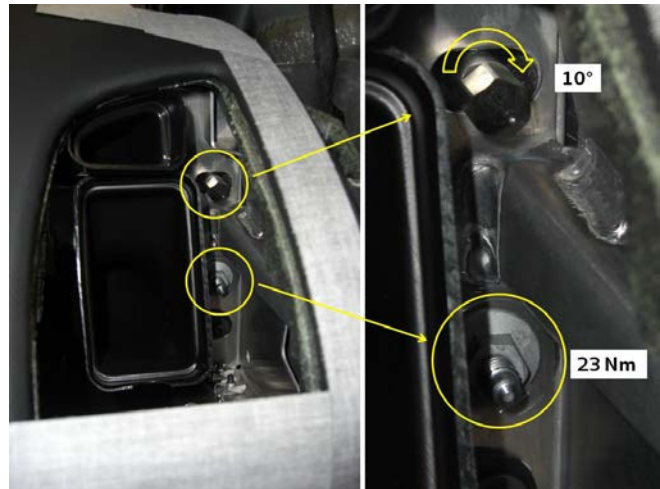
These noises may be caused by contact between the instrument panel carrier and an adjustment cam used in the assembly process in production.

Figure 2. Location of adjustment cam and instrument panel carrier nut.

2. Check the torque of the instrument panel carrier nut to ensure that it is not loose. It should be torqued to 23 Nm. Check the adjustment cam. If it is making contact with the carrier, it can be turned $\sim 10^\circ$ to the right so that there is clearance around the eccentric (Figure 2).

The eccentric pin is a production aid used to precisely align the instrument panel in the production process. It has no fastening function, therefore it can be turned 10° to create clearance from the instrument panel carrier.

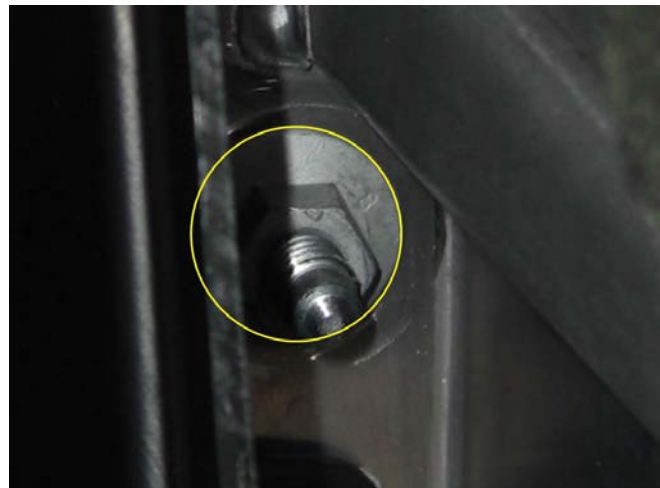
Figure 3. Instrument panel carrier nut to be marked.

3. Because the adjustment cam eccentric will be moved out of the original position, mark the outside of the instrument panel carrier nut with a marker (Figure 3). This will aid in repositioning the instrument panel should it need to be removed in the future.
