Technical Service Bulletin

20 Noises from fuel tank area

20 14 42 2035591/2 December 19, 2014. Supersedes Technical Service Bulletin Group 20 number 14-30 dated December 13, 2013 for reasons listed below.

Model(s)	Year	VIN Range	Vehicle-Specific Equipment
Q7	2011 - 2014	All	3.0 TFSI

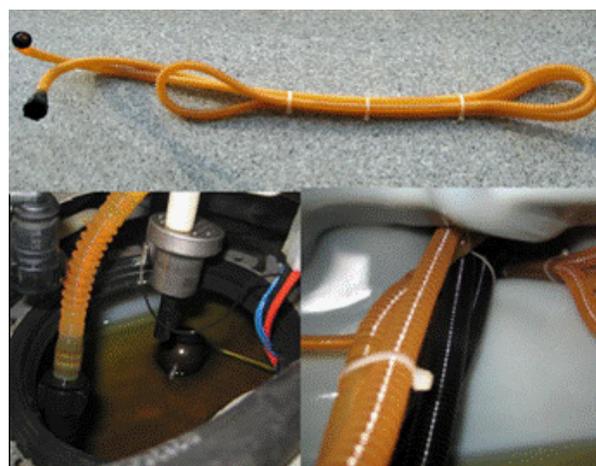
Normal fuel system pulsation can cause slight vibrations in the pressure regulator on the flange located on the right side of the fuel tank. This pulsation also causes the long, curved fuel lines (Figure 1) to vibrate and make a jarring noise in the tank.

Figure 1. The long, curved fuel lines that run across the fuel tank from right to left.

Long, curved fuel lines fastened with a tie wrap.

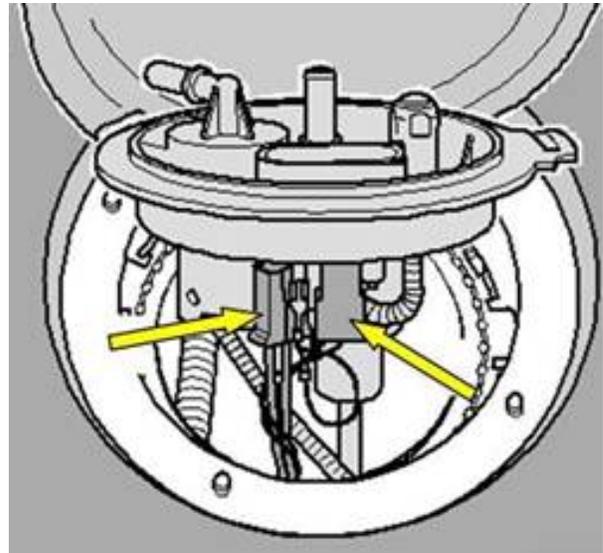
Figure 2. Two electrical connectors on the right locking flange to be disconnected.

1. Open the flange lock on the right side of the fuel tank according to the instructions in *Repair Manual >> Engine >> Fuel Supply System >> 20 Fuel Supply >> Removal and Installation*.
2. Slightly pull the right locking flange with seal out of the fuel tank.
3. Disconnect two electrical connectors on the underside of the right locking flange (Figure 2).

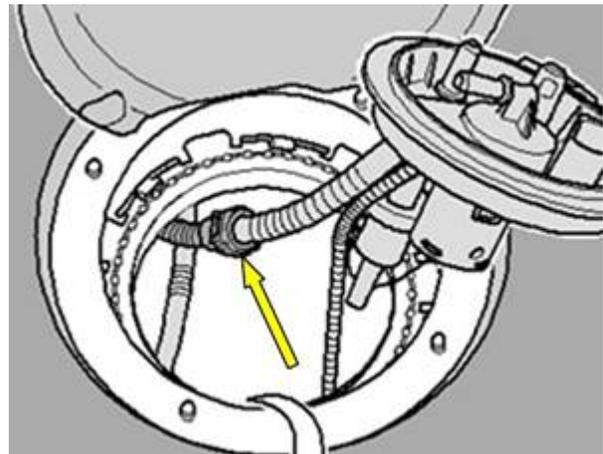
Figure 3. Fuel line connected to the locking flange.

4. Disconnect fuel line (Figure 3) by pressing release button.

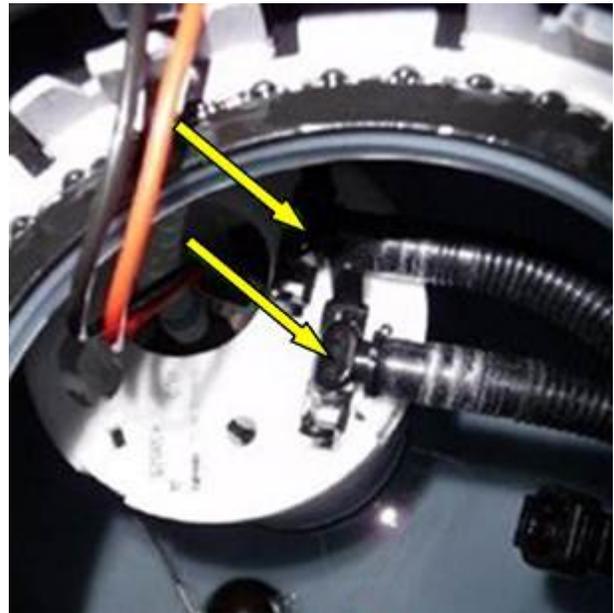
Figure 4. Black corrugated lines leading from the suction jets to be moved.

5. Disconnect the two black corrugated lines leading from the suction jets and move them to the left in order to create space for working on other fuel lines (Figure 4).

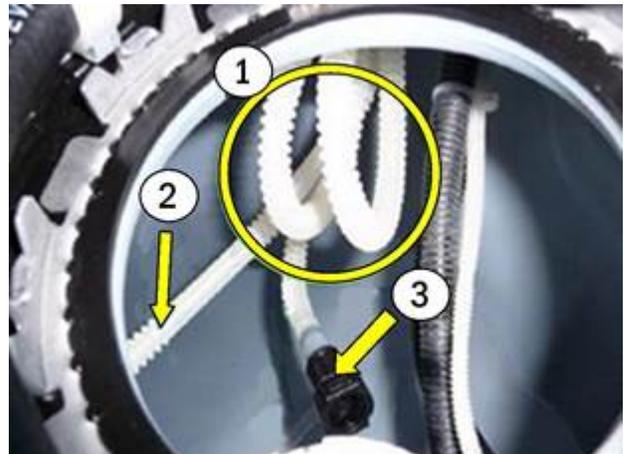
Figure 5. Curved fuel lines (1), fuel supply pipe (2), and fuel line.

6. Pull the curved fuel lines (Figure 5) as far to the right of the vehicle as possible without using force.

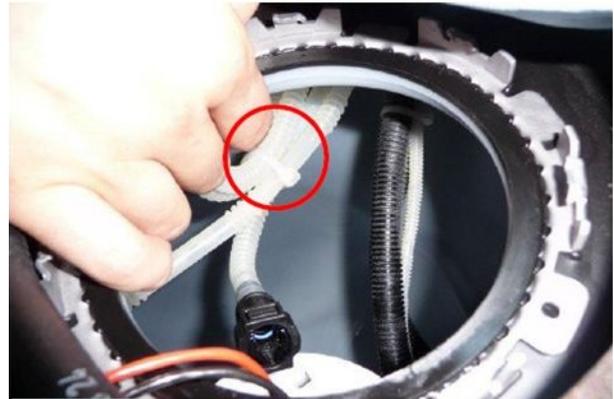
Figure 6. Curved fuel lines, fuels supply pipe, and fuel line tied together with tie wrap.

7. Tie the curved fuel lines, fuels supply pipe, and fuel line together with a tie wrap (Figure 6).

The tie wrap must be close to the lower section of the curve of the curved fuel lines to prevent any contact with the suction jet pipes.

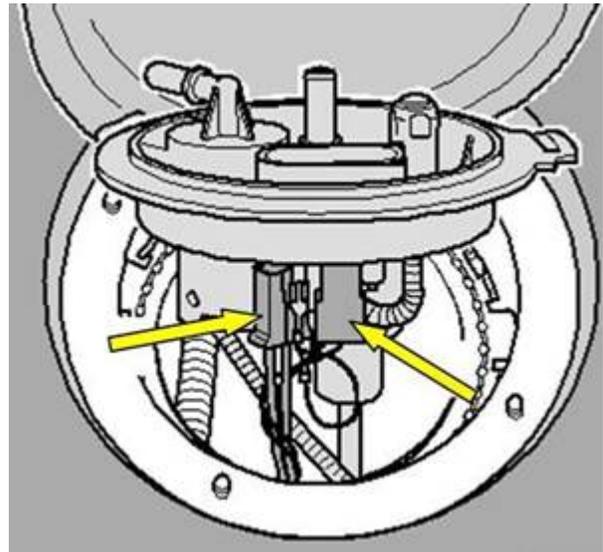
Figure 7. Two electrical connectors on the right locking flange to be reconnected.

8. Refit the two black corrugated lines leading from the suction jets. Reconnect the rest of the lines and reconnect the two electric connectors to the flange.

Reinstall the flange according to the instructions in Elsa, and ensure that the flange seal is positioned correctly.
