## Red Linked Belt Install Tool Modification

Please use the following job codes when submitting a claim (and reference TSB-533) through the IMPCO Warranty Portal

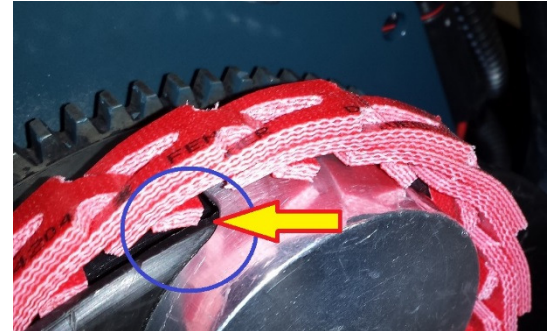
Potential risk for damage / premature failure of linked v-belt for APU generator. During belt installation, there is potential for the linked belt underside tab to be trapped under the tongue of install tool (see picture on right) and may cause the belt tab to overstretch or even crack.
