Service Bulletin

PRELIMINARY INFORMATION

Subject: Rattle Noise From the Exhaust

Models: 2010 - 2014 Chevrolet Camaro

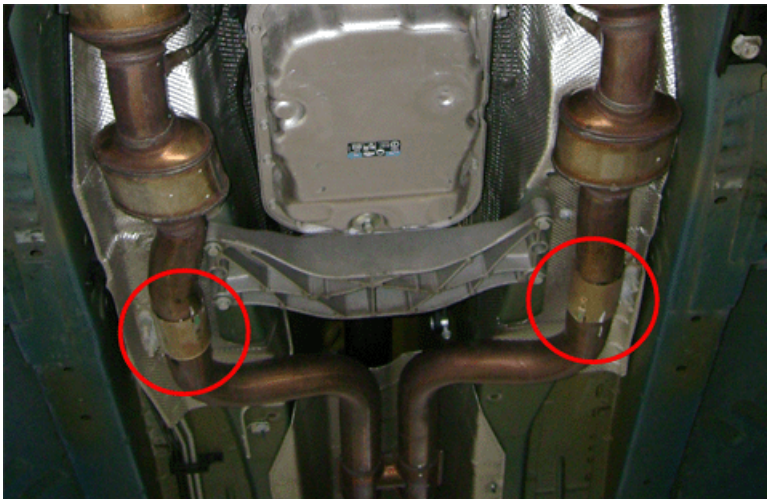
Customers may comment on a rattle noise coming from their vehicle. Upon inspection, dealership technicians may have difficulty in determining where the source of this noise may be coming from. It may even sound like it originates from the transmission area, when in fact, it may be coming from the exhaust system. If a noise concern is being addressed from underneath the vehicle, dealership technicians are to first strike the exhaust system with a rubber mallet or a deadblow hammer and listen for the noise to occur. If a noise is heard, inspect the area of the exhaust where the two front exhaust band clamps join the front catalytic converter assembly to the rest of the exhaust system. See the photo below for the area of these clamps. These clamps have been circled for each bank.

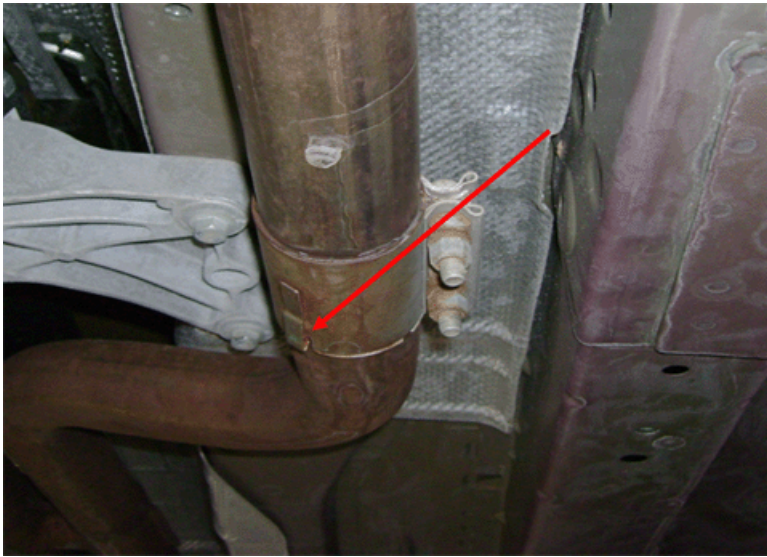
This joint is called a Torca coupling. In this coupling, a small alignment tab is welded onto the exhaust pipe. Then, a band clamp is positioned around the joint and slid towards the rear of the vehicle until a notch in the band clamp slides around this alignment tab. This assures that the clamp is properly positioned on the exhaust before it is tightened down. As this clamp is slid into position, another "J-shaped" piece of metal, referred to as a clip, slides up and over this alignment tab to "lock" this clamp into position on the pipe. The photo below shows what a normal coupling looks like. The red arrow points to the clip that hooks over the top of this alignment tab.

In certain instances, a rattle noise may be heard coming from this coupling and there are 2 likely possibilities for this noise concern.

Concern 1) This J-shaped clip may rattle against the exhaust pipe causing the noise

Concern 2) The alignment tab that was originally welded on the exhaust pipe may have separated from the exhaust pipe and is now causing a rattle noise.

If a noise has been confirmed from this coupling, carefully inspect this area of the exhaust for any obvious damage or looseness in the related components. If nothing is found, bend the J-shaped clip away from the exhaust pipe. If the small alignment tab is found to be loose, completely remove it from the exhaust pipe. In most cases this can be accomplished with the use of a regular screwdriver. Make sure the J-shaped clip will no longer contact anything which may cause another rattle noise in the future.

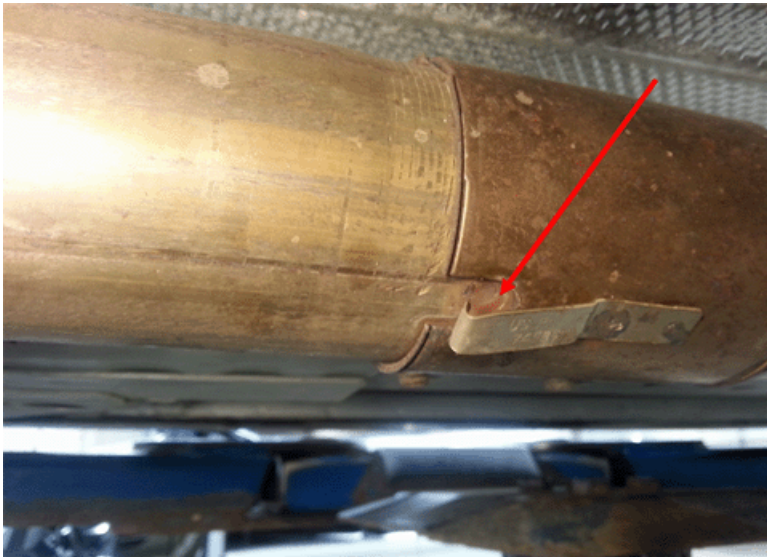
See the photo below for an example of a repaired coupling.
