Service Bulletin

Subject: Instrument Panel Cluster (IPC) Warning Lamps And/Or MIL Are Illuminated Diesel Exhaust Fluid (DEF) Message Displayed Various DTCs Set (Inspect Wiring Harnesses for Chafing)

Models: 2015 Chevrolet Silverado
2015 GMC Sierra
Equipped with 6.6L Duramax™ Diesel Engine RPO LML

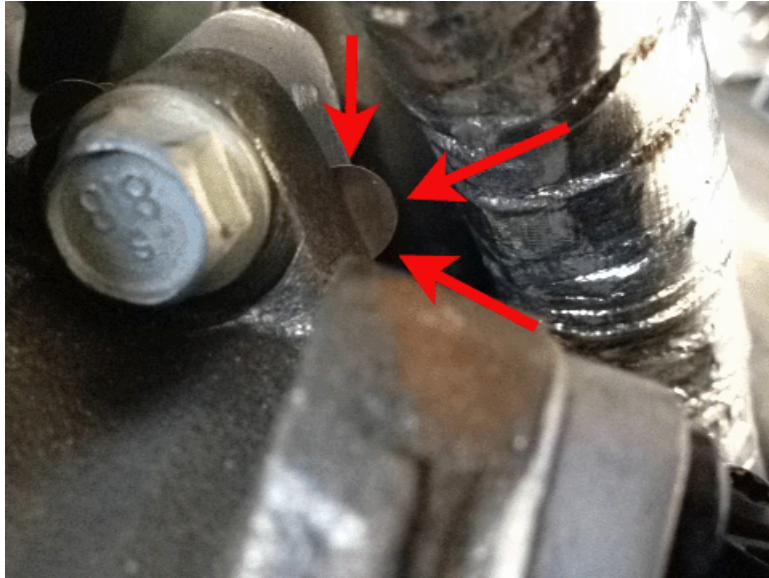
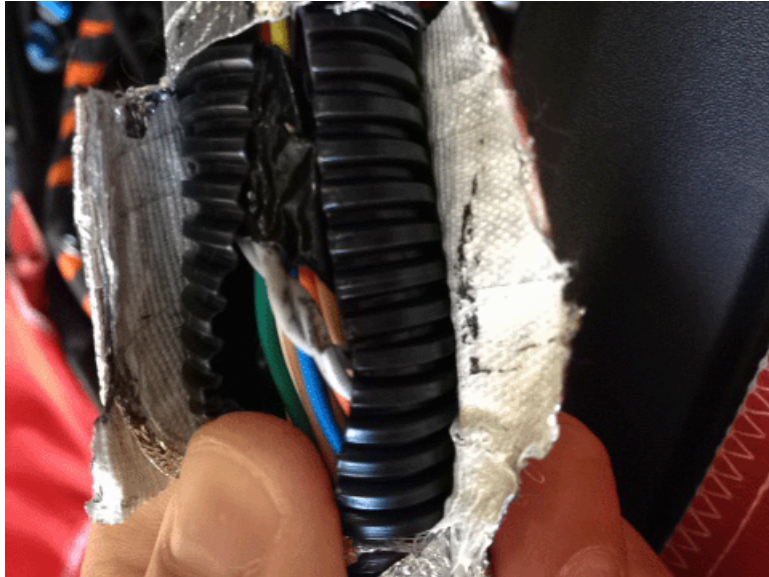
If the diagnosis does not lead to a resolution or if the symptoms or DTCs are intermittent and cannot be duplicated, check for chafing of the engine wiring harness that is routed near the EGR Valve. The wiring harness has been found chafed on a tab of the EGR Valve metal gasket.

Repair or replace the wiring harness if it is found chafed on the tab of the EGR Valve metal gasket.

Bend the tab of the EGR gasket over to prevent a re-occurrence.

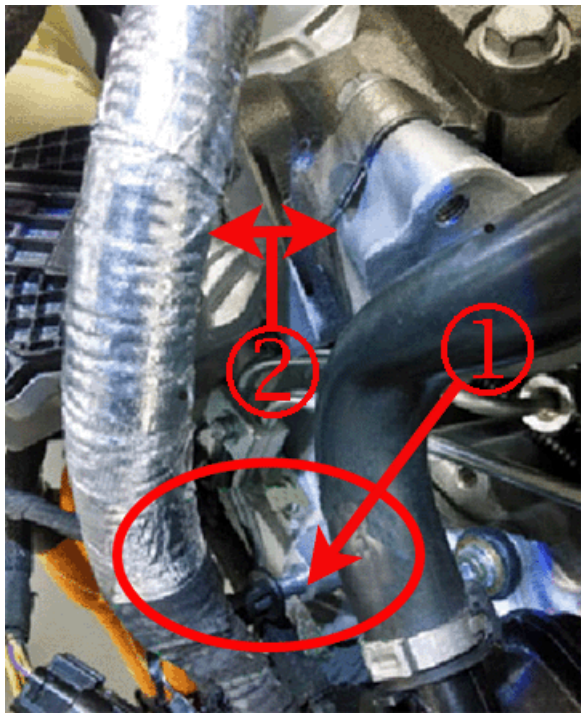
1. Wiring harness retainer fully seated onto the stud on the driver's side rocker cover.
2. Proper clearance between the harness and the EGR valve

It is critical that the wiring harness retainer is fully seated onto the stud on the driver's side rocker cover. This retainer is tied to the harness and is located underneath the charged air cooler (CAC) inlet pipe near the #4 fuel injector. Proper routing and securing of the harness ensures there is clearance between the harness and the EGR valve.

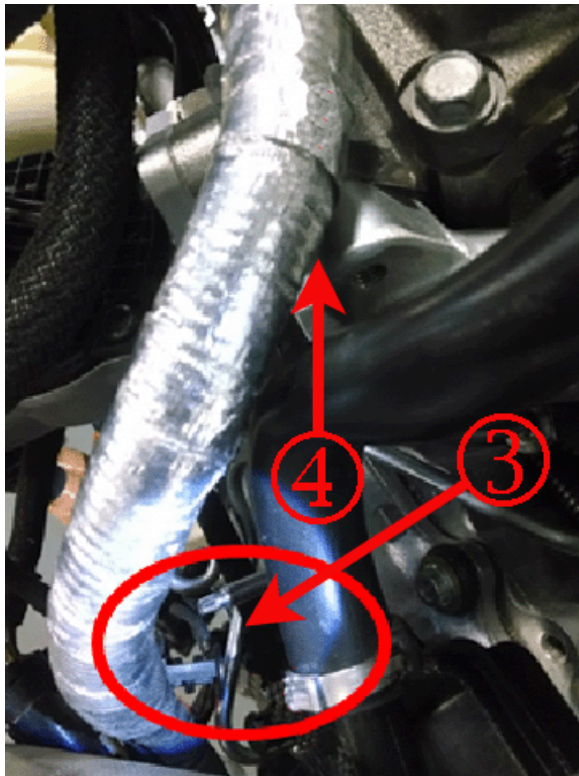
3. Wiring harness retainer NOT fully seated onto the stud on the driver's side rocker cover.
4. IMPROPER clearance between the harness and the EGR valve.
