# Service Bulletin

Bulletin No.: PI1120B

**Subject:** Creak or Pop Type Noise Coming from Windshield Area During Cold Ambient Temperatures

**Models:** 2011-2015 Chevrolet Equinox  
2011-2015 GMC Terrain

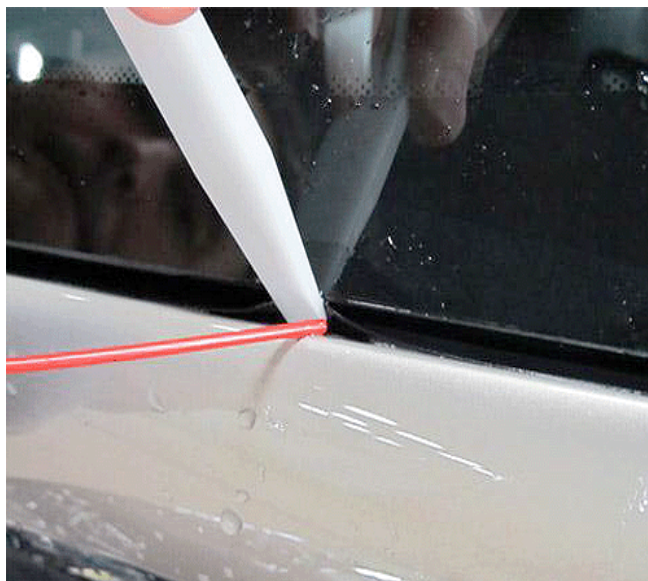
3653600

If the noise is coming from the upper windshield area, the condition may be caused by the windshield exterior molding binding with the windshield glass and/or the windshield opening. If the noise is coming from the base of the windshield, there may be a bind condition between the inside of the windshield glass and the foam seal at the front of the instrument panel upper trim panel.

If the noise is heard in the area surrounding the upper windshield area, spray GM Super Lube up and under the lip of the outside windshield molding.
