Service Bulletin

Bulletin No.: PI1126E

Subject: Blank Screen After Startup and Reverse, Rearview Camera Message On, Touch Screen Inoperable, Bluetooth® and Navigation Concerns

Models: 2014 Buick LaCrosse, Regal
2013-2014 Cadillac ATS, SRX, XTS
2014 Cadillac CTS Sedan (VIN A), ELR
2015 Cadillac Escalade Models
2014 Chevrolet Corvette, Impala (VIN 1), Silverado 1500
2015 Chevrolet Silverado, Suburban, Tahoe
2014 GMC Sierra 1500
2015 GMC Sierra, Yukon Models
Equipped with RPOs IO4, IO5, IO6

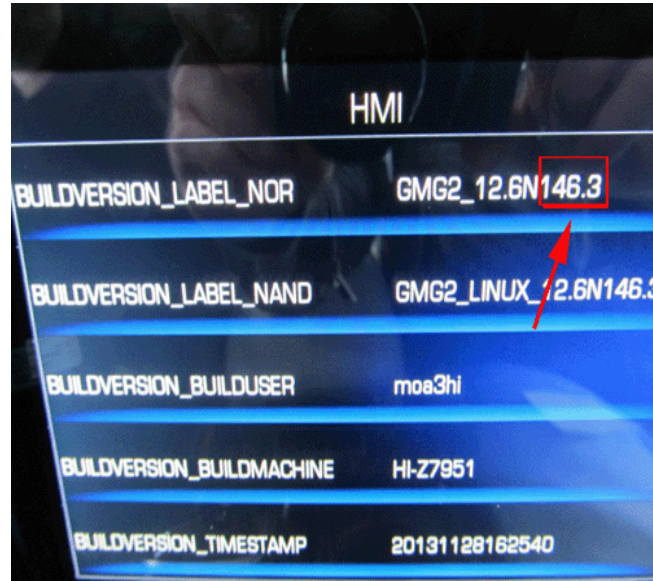
4033005

Before updating software, check the HMI build version. The HMI build version label should be GMG2.12.6N146.3 or earlier.

Note: The last 3.1 numbers as shown above will increase as the software gets updated. Those are the numbers to check when verifying software version.

Caution: If the software version is GMG2.12.6N146.3 or lower proceed with this PI. If the version is higher, damage to the HMI module may occur. DO NOT PROCEED WITH THIS PI if the version is higher.
