# Service Bulletin

Bulletin No.: PI0345D

**Subject:** Inspect XM/Cellular Mobile Phone/OnStar® Antenna for Looseness or Damage, XM/Cellular/OnStar® Reception Performance Degraded, Rattle/Flutter/Squeak Noise, Wind Noise/Whistle at Highway Speeds, Water Leak on Headliner at Sunvisor

**Models:** 2010-2015 Cadillac Escalade Models  
2010-2013 Chevrolet Avalanche, Silverado LD Models  
2010-2015 Chevrolet Silverado HD, Suburban, Tahoe  
2010-2013 GMC Sierra LD Models  
2010-2015 GMC Sierra HD Models, Yukon Models

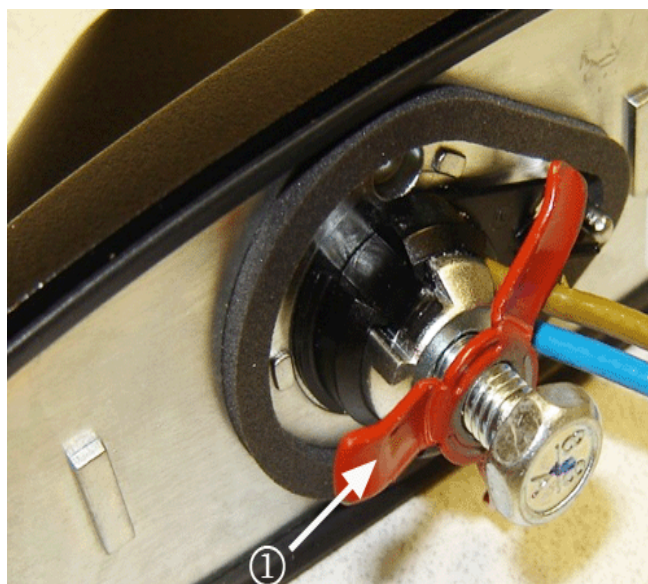
The cause of this condition may be looseness and/or damage of the XM/cellular mobile phone/OnStar® antenna, which may affect the grounding of the antenna and may allow a rattle/wind noise at highway speeds and/or a water leak.

Though difficult to detect evidence of impact damage, upon inspection of the antennas returned in warranty, there is a likelihood this damage occurred during vehicle transportation to dealerships. The result of impact damage is most often to the underside retainer (1), which is found to be bent backward or otherwise damaged and no longer provides proper retention.

Inspect new vehicles right after receipt from the vehicle carrier. Process transportation claims as appropriate.

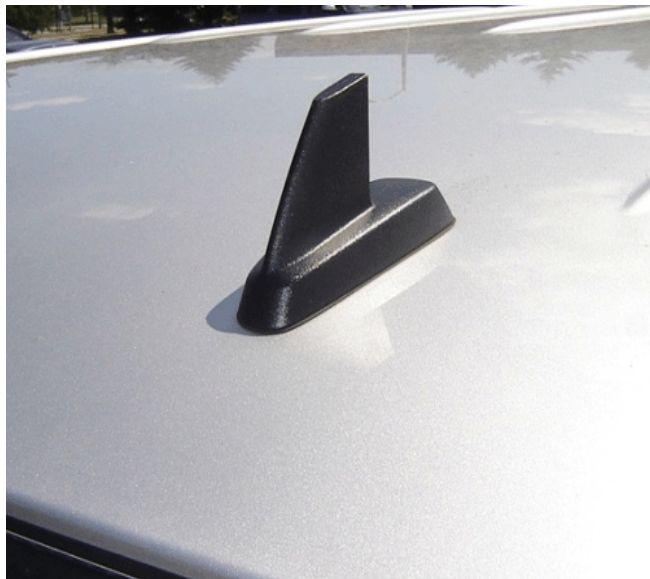
2555891

Grasp and physically inspect the XM, cellular mobile phone, and/or OnStar® antenna for looseness and/or damage. If the antenna is mounted securely and exhibits no signs of physical damage, follow regular diagnostic information in SI to address any customer concern.

If the antenna is loose or damaged, it must be replaced. Refer to Cellular Communications/Digital Radio Antenna Replacement in SI.
