Service Bulletin

Bulletin No.: PI1382

Subject: Intermittent Unable to Charge from DC Fast Charge

Models: 2014-2015 Spark EV
Equipped with PROVISIONS-FAST CHARGING ACCOMMODATIONS (RPO CBT)

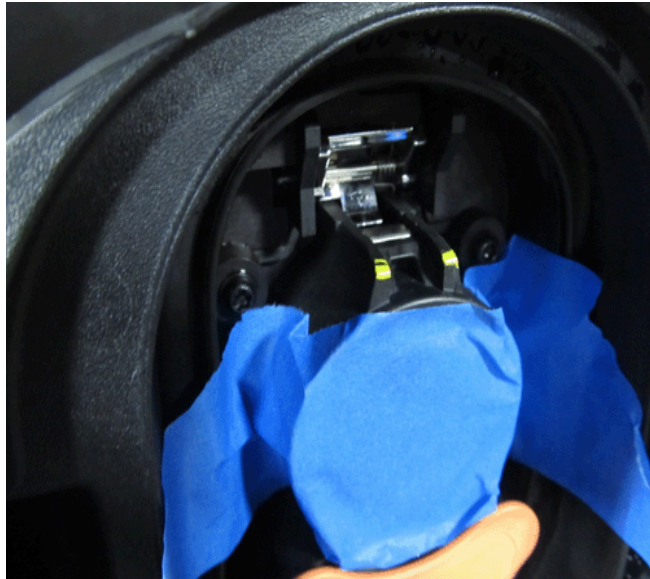
4003481

Note: Upper receptacle guides are marked in yellow for illustration purposes only.

2. Mask off the charge port so that no debris can enter the plug area, leaving exposed upper guides.

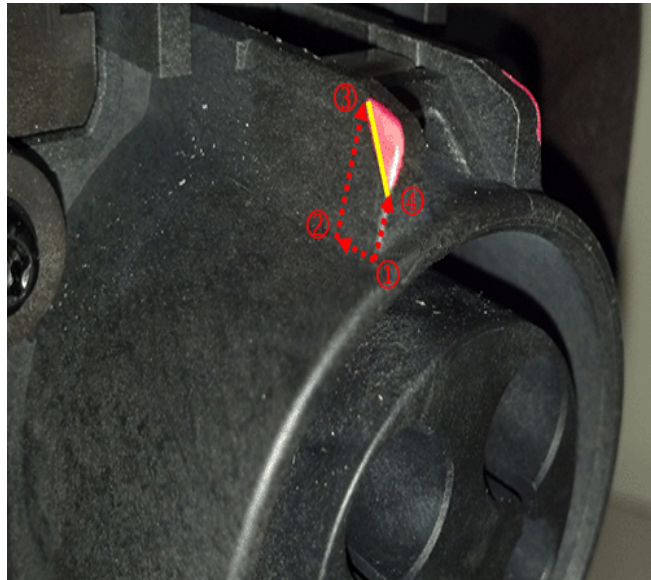
4037063

This condition may be caused by interference between the DC fast charge coupler and the vehicle charge port receptacle. The presence and severity of the concern can vary between DC fast charge stations.

3. Starting at point "1" as shown above, measure 6 mm to point "2" and 3 mm to point "4." The material above that mark (shown in red above) will be the material removed. Repeat on second receptacle guide.

Important: It is important to follow the dimensions as given above to ensure the interference concern is addressed.
