Service Bulletin

Bulletin No.: PI1257

Subject: Revised Upper Intake Manifold with Relocated MAP Sensor for DTC P0106

Models: 2007–2009 Chevrolet Silverado
2007–2009 GMC Sierra
Equipped with 6.6L Duramax Diesel Engine (RPO LMM)

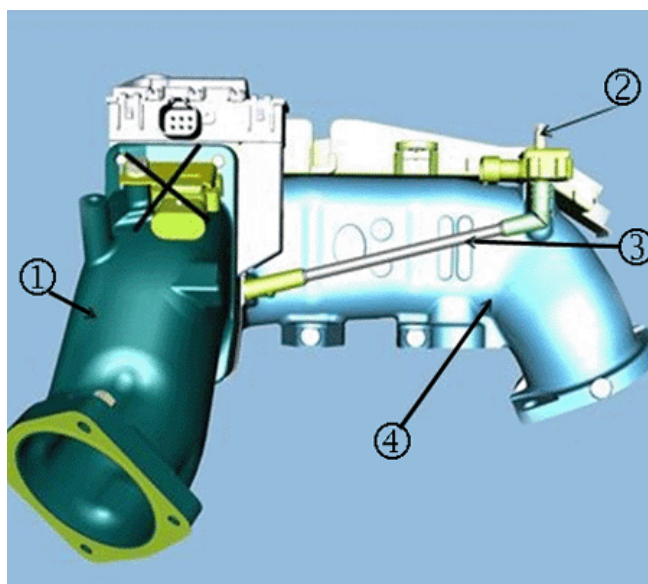
3714283

During 2009 production the MAP sensor was relocated from the intake pipe to the upper intake manifold to prevent ice from building up in the MAP sensor and setting DTC's. The MAP sensor on this new design was located on the top of the upper intake manifold and connected through a hose which connects to a pressed in hose barb. The old design upper intake manifold without the hose barb is no longer available.

If an upper intake manifold is ordered, it will be of the new design. This hose barb can be plugged with a second MAP sensor and the MAP sensor tube if there have been no icing issues, or the harness can be extended from the old sensor to the new sensor location to reduce chances of icing.
