Service Bulletin

Bulletin No.: PI0962C

Date: June, 2014

Subject: Radio Resets, Navigation Inoperative, Map Not Displayed, DVD Will Not Play or Resume, Bluetooth® Inoperable, Radio Lockup, Voice Recognition Cuts Off, USB Source not Returning to Last Song, OnStar® Default Volume Low

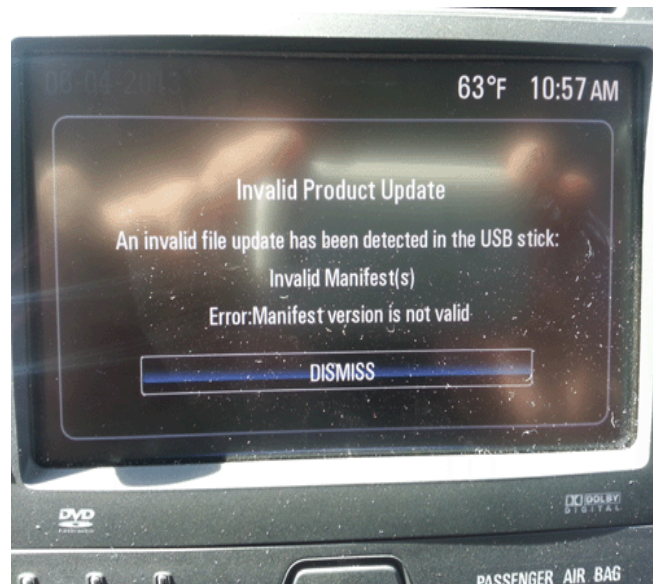
3462549

Note: If the following screen above is shown on the screen, the radio already has the latest calibration installed and no further action is required.
