## Auxiliary A/C Inverter Case Ground VN Models

### SP396-001, Auxiliary A/C Inverter Case Ground

(February 2014)

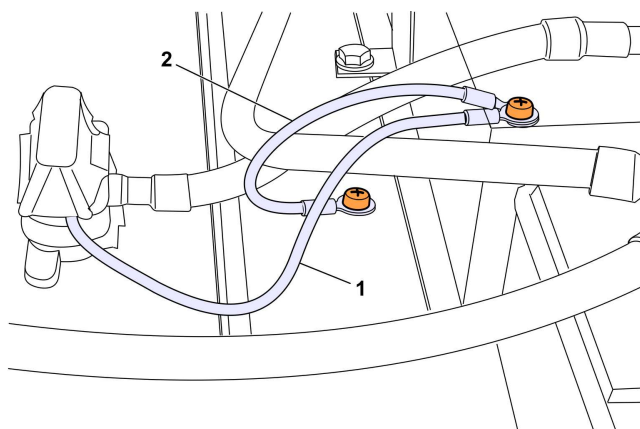
W3086000

Certain VN Product vehicles built between January 1, 2012 and May 31, 2013 with the Dometic 7 battery auxiliary AC system option requires the removal of an inverter case ground wire. Follow the procedure below to correct the issue.

- 1 Secure the vehicle for service by parking it on a flat level surface, applying the parking brake, chocking the rear wheels, and placing the transmission in neutral.
- 2 Remove battery cover.
- 3 Disconnect all cables from the negative (ground) battery terminal to prevent personal injury from electrical shock and prevent damage to electrical components.
- 4 Remove the redundant (green) wire **(2)** from the inverter case and battery box.

**Note:** Discard the wire after removal.

**Note:** Discard the ground screw on battery box.

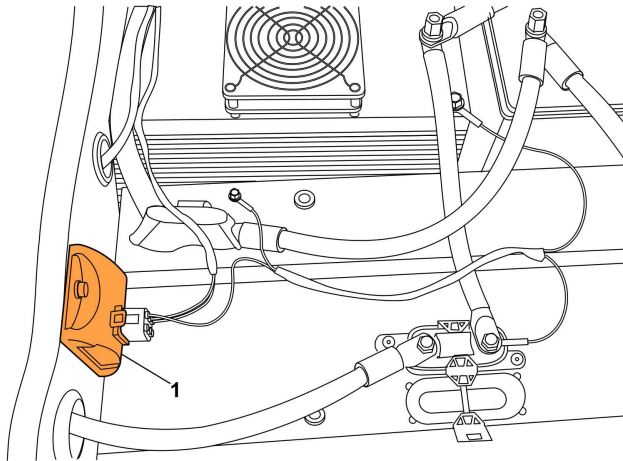
W3087316

- 6 If unit is equipped with a Low Voltage Disconnect (1), the redundant wire will be grey in color going to battery box floor.

1. Low Voltage Disconnect

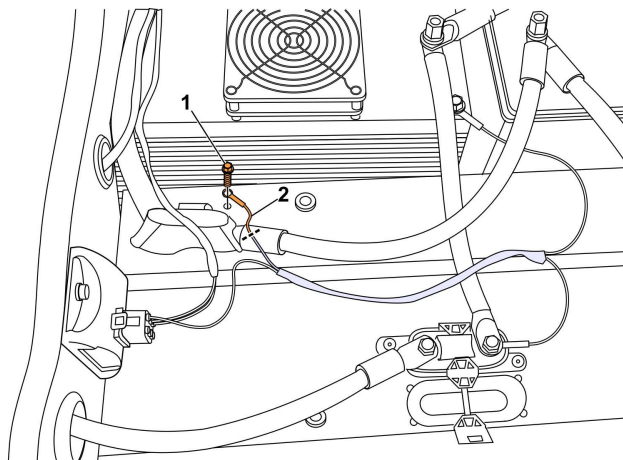
W3087631

1. Screw  
2. Grey Wire

- 7 Remove the screw (1) and cut the ring terminal from the gray wire (2).

**Note:** Do not allow the wire to touch the battery box.

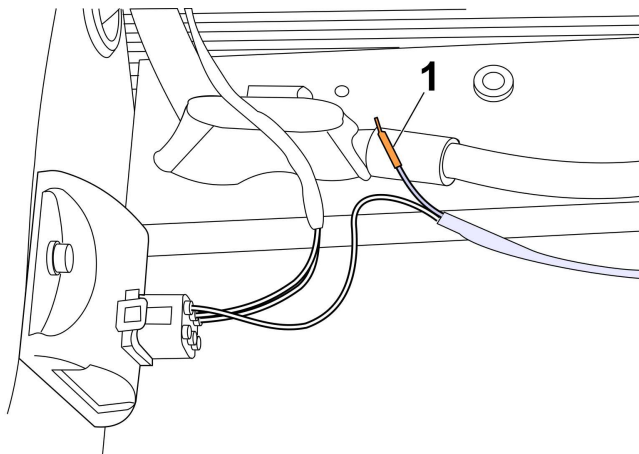
W3087632

1. Heat shrink tubing

- 8 Apply heat shrink tubing to the end of wire and secure.
