City Horn  
VHD, VAH

## FSB 362-001, City Horn

(February 2014)

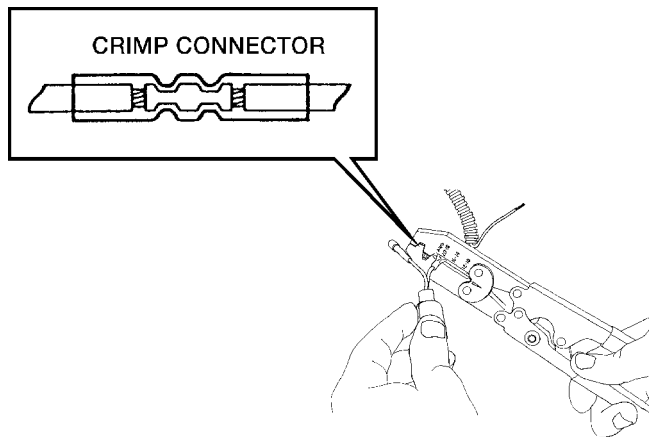
W3002876

- 7 Crimp the splice leads from the new pigtail harness (22285544) to the chassis wires.

**Note:** Match the new connector wires to the harness in the same position as before.

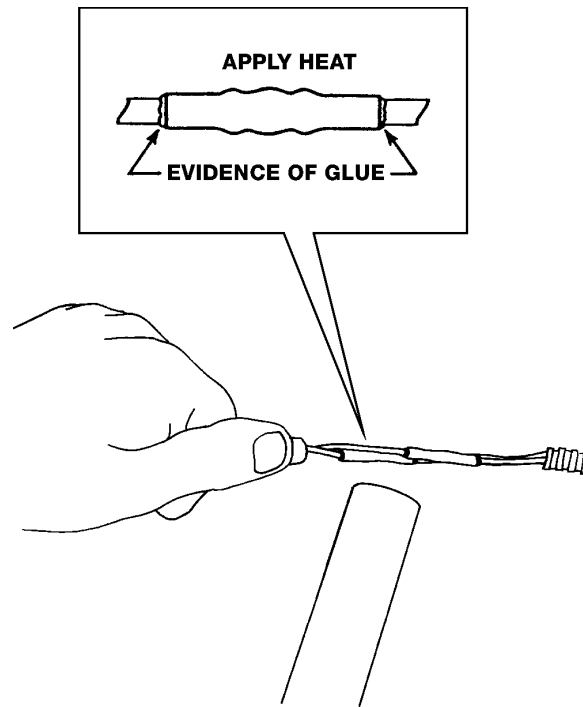
W3002877

- 8 Heat shrink the wire splices properly using a heat gun.

**Note:** Heat shrink the splices until the glue appears from the end of splice.

**Note:** Make certain the factory crimped ends of the splice are also heat shrunk properly.

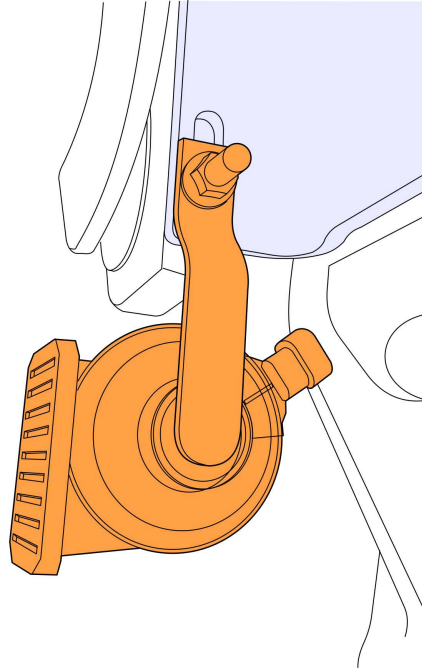
W3085662

- 9 Install and secure replacement horn and bracket assembly. Torque the bracket to chassis to  $48 \text{ Nm} \pm 8 \text{ Nm}$  ( $35 \pm 6 \text{ ft lb}$ ).
