**Dual Pin Lift Gate Receptacle**  
**VN****SP 379-001, Dual Pin Lift Gate Receptacle****(October 2014)**

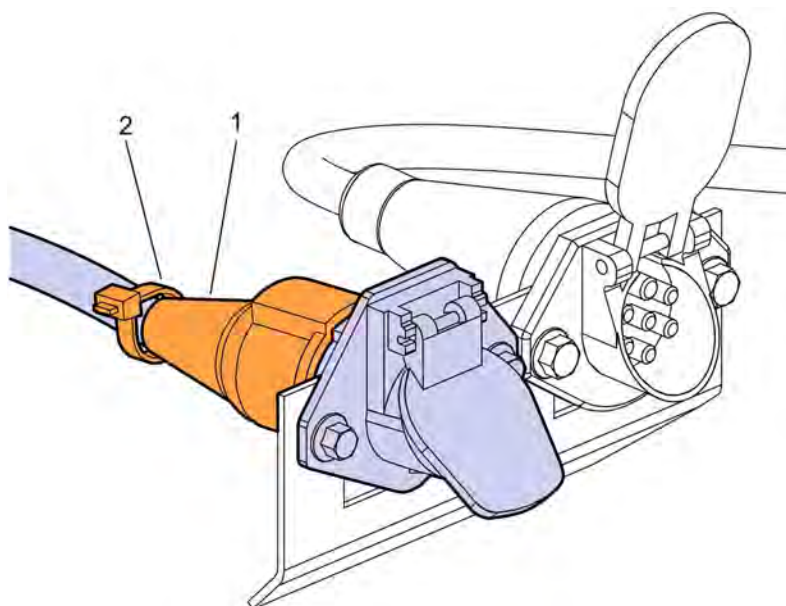
W3092534

Certain VOLVO trucks built between 07/05/2010 and 06/30/2014, equipped with a lift gate receptacle option can experience intermittent or erratic operation of lift gate equipment. Normal exposure to the elements caused corrosion build up at the dual pin lift gate receptacle. To ensure proper operation of all lift gate equipment, the terminals and studs of the dual pin lift gate receptacle will require cleaning along with an application of a corrosion inhibitor. Additionally, a boot and cable tie will be installed at the lift gate receptacle to protect the terminals from corrosion build up.

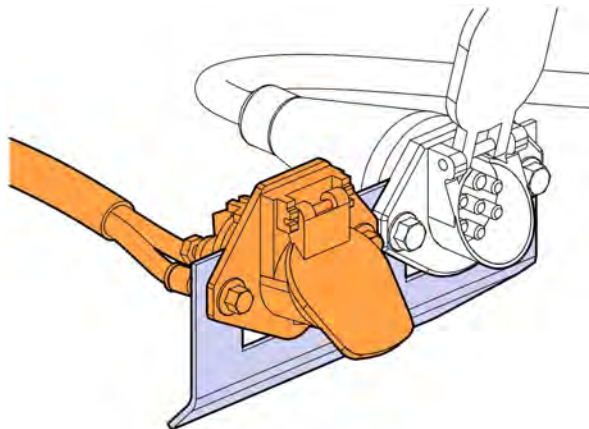
W3092537

- 8 Locate the dual pin lift gate receptacle at the back of the cab.
