Software Updates  
D11J, D13J, D16J  
VAH, VHD, VN

## SP 284-054, Control Module Software Updates

(October 2014)

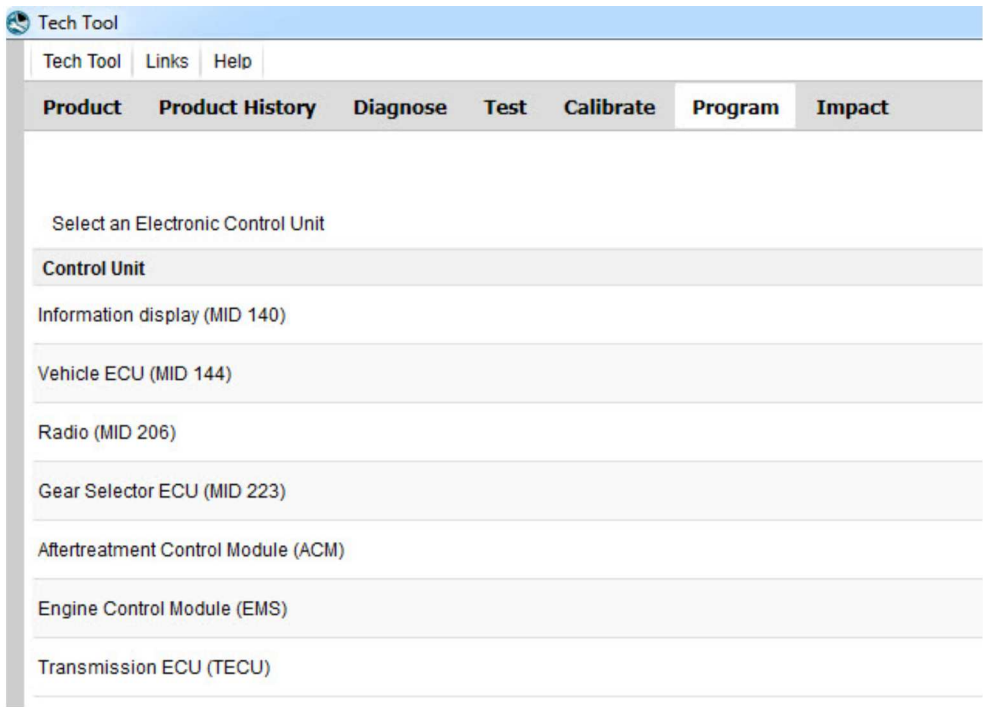
W2079943

9 Select Program to update the ACM with the latest software.

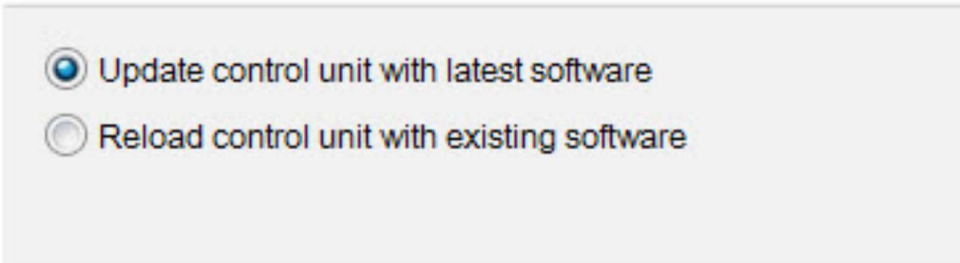
W2085461

- 10 Certain conditions must be met to continue with programming: battery voltage above 10v, parking brake applied, and ignition key in ON position with engine not running. When all conditions have been met, click Continue to proceed with programming.

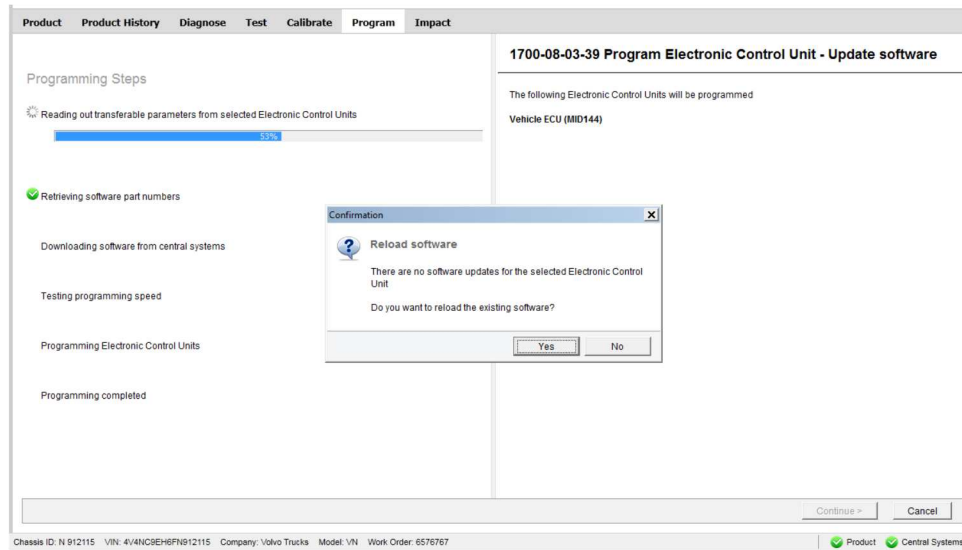
W2094387

- 12 If the software is already updated, this screen opens. Select Yes to reload existing software.
