> 122SD and Coronado  
Business Class M2  
Cascadia  
108SD/114SD

**Freightliner  
Service Bulletin**

## Modifying the Lift Channel Bracket

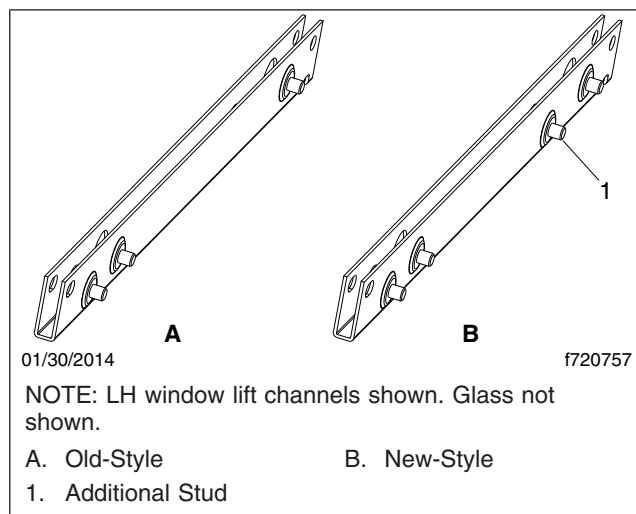
**Fig. 1, Window Lift Channel Comparison**

The design of the lift channel on the Coronado door window glass assembly has changed. The new lift channel has four studs, and older channels have three; see [Fig. 1](#). The design of the lift channel bracket on the regulator assembly has likewise changed to accommodate the extra stud.

If both the window glass assembly and the regulator assembly are replaced, no modifications are needed. If a new window glass assembly is to be used with an old-style regulator, the forward lift channel bracket of the regulator must be modified as described in this bulletin.
