## **Subject: Airliner 69K Axle Stops**

**Models Affected: Specific Freightliner 108SD, 114SD, Business Class M2, Cascadia, and Coronado vehicles; and Western Star 4700 vehicles manufactured October 1, 2012, through July 15, 2013, equipped with 69K Airliner suspension.**

# Field Service Campaign

February 2014  
SF488A

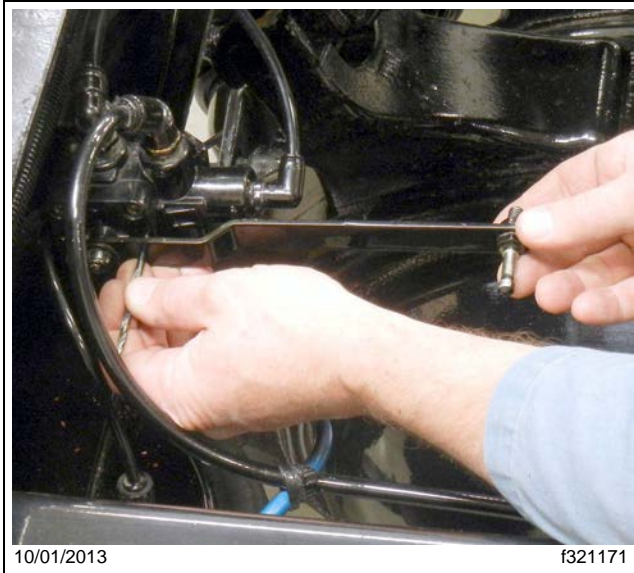
**Fig. 1, Inserting a 5/32-inch diameter drill bit or nylon rod to lock the arm in neutral position.**

9. Pin the arm in neutral position with a 5/32-inch drill bit or nylon rod. See **Figure 1**. (For dual valves, pin both arms.)
10. Install the height gauge block. (For dual valves, install a block on both sides.)

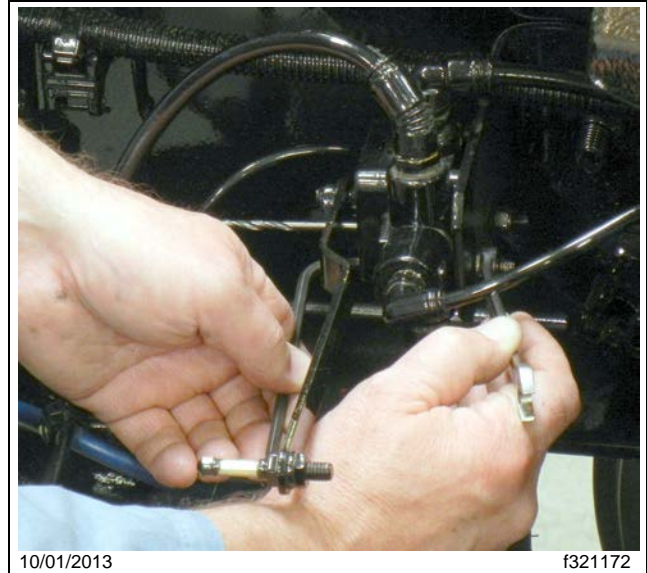
**Fig. 2, Holding the height-control valve mounting stud in place with an Allen wrench when loosening the nut.**

13. While holding the height-control valve mounting studs in place with an Allen wrench, loosen the nuts that attach the valve to the mounting bracket. See **Figure 2**. (For dual valves, loosen both valves.)
