BTB 21394-51940 (1407) REV-1

MIL Comes On With DTC P1441

Supersedes 00-003 dated June 5, 2000; see revision summary

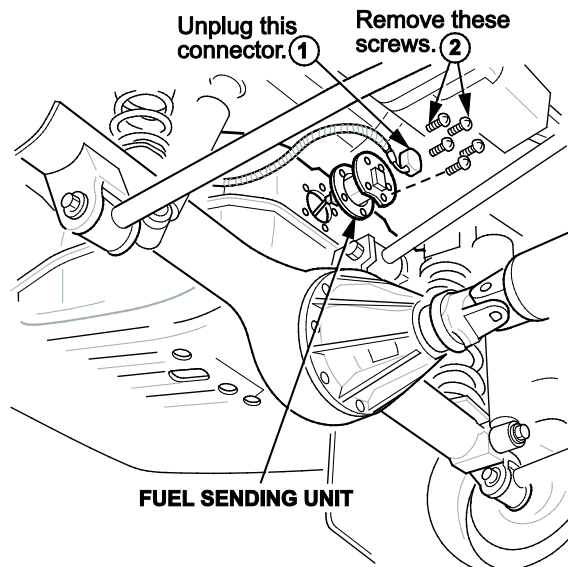
The PCM software does not compensate for signal variation in the fuel tank pressure sensor when fuel sloshes in a nearly full fuel tank.

4. If the fuel tank is more than 1/2 full, drain or siphon the fuel into a suitable container, then tighten the drain plug to 20 N·m (14 lb-ft).
5. Raise the vehicle on a lift.
6. Use brake cleaner and compressed air to thoroughly clean the area around the fuel sending unit.
7. Remove the sending unit from the tank. Make sure you cover the tank opening to prevent any dust or dirt from getting inside. Discard the sending unit.

8. Install the new sending unit.
9. Lower the vehicle.
10. Refill the tank with the fuel you drained, and reinstall the fuel fill cap.
