July 2014  
FL655  
NHTSA #13V-605  
Transport Canada #13-423  
INTERIM RECALL BULLETIN  
REVISED NOTICE

## Subject: Sterling Bullet Left Tie Rod Ends

**Models Affected: Specific Sterling Bullet vehicles manufactured October 15, 2007, through November 10, 2008.**

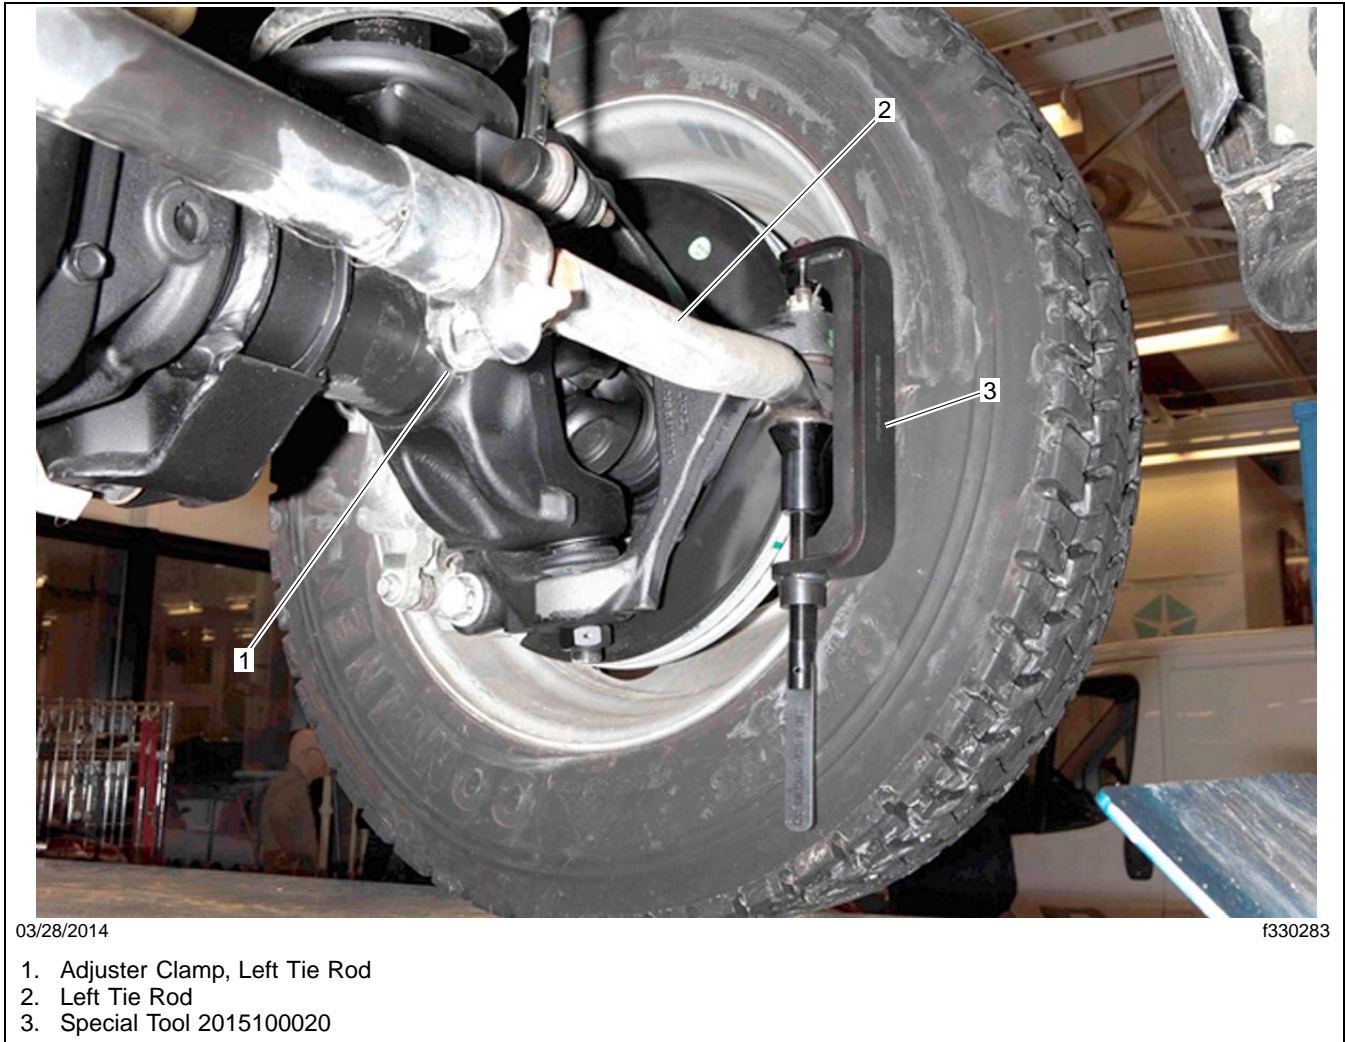
**Fig. 1, Left Tie-Rod Alignment**

1. Park the vehicle on a drive-on type hoist with the front wheels in the straight ahead position, shut down the engine, and set the parking brake. Chock the tires.
2. Install special tool 2015100020 hand-tight onto the left tie rod as shown in **Fig. 1**.

If the bottom face of the tie rod is flush against the tool, the tie rod is properly aligned—remove the special tool and go to step 5 on page 6 of this bulletin.

If the bottom face of the tie rod is not flush against the tool, go to the "Tie Rod Alignment" section of these instructions.

1. Ensure the vehicle meets the following criteria before measuring the tie-rod end angles.
  - vehicle is parked on a level surface
  - full vehicle weight is on the front tires
  - bottom sides of both tie-rod ends are clean
  - bottom sides of both tie-rod ends are free of burrs
2. Set the toe and center the steering wheel following the alignment rack manufacturer's instructions.
3. Install special tool 2015100020 onto the left tie rod as shown in **Fig. 1** and hand-tighten it until the bottom face of the tie rod is flush against the tool.
4. Tighten the left tie rod adjuster clamp nut and bolt to 66 lbf·ft (90 N·m).

5. Remove the special alignment tool from the left tie rod.  
**Do NOT** install a completion sticker. The completion sticker will be installed during the final repair.
6. Remove the chocks from the tires.
