Service Information Bulletin

SUBJECT	DATE
SPN 3556 (ACM) (EPA10)	July 2014

2 SPN 3556/FMI 1 - EPA10

Regeneration Temperature - Out Of Range Low - EPA10

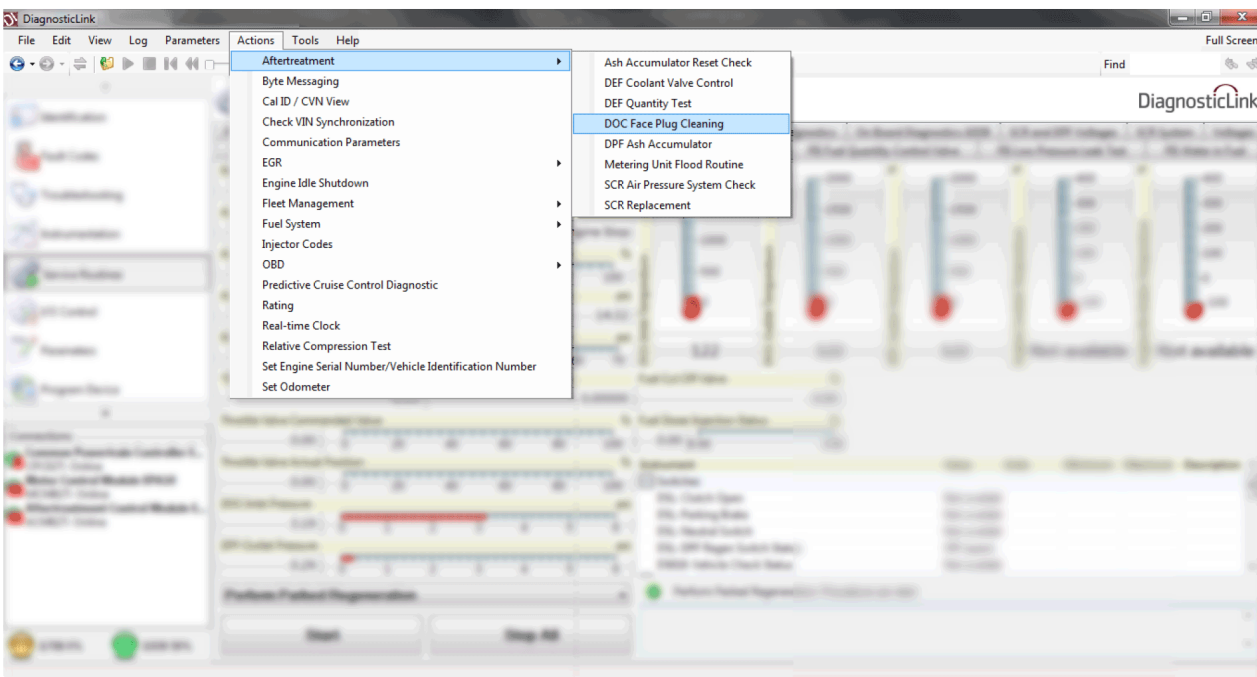
d500222

9. Perform a parked regeneration. Go to step 10.
10. Review the log file and monitor the DOC inlet pressure sensor reading. Does the DOC inlet pressure sensor reading start off high and stay high (1.5 or greater for a one box and 1.8 or greater for a 2 box)?
 - a. Yes; the constant high pressure indicates that the DOC is plugged. Go to step 11.
 - b. No; replace the HC doser block. Refer to section "Removal of the Hydrocarbon Doser Block ". Verify repair.
11. Check the Aftertreatment Control Module (ACM) software level. Is the ACM software level at least 8.7.0.105?
 - a. Yes; Go to step 12.
 - b. No; update the ACM software. Go to step 12.

12. Use DiagnosticLink and perform the DOC Face Plug Cleaning routine.
