February 18, 2014

BTB 50992 (1402)

MIL Comes On With DTC P0455 and/or P0456

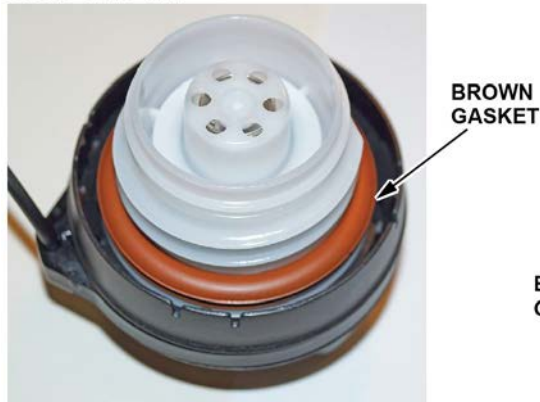
GOOD GAS CAP

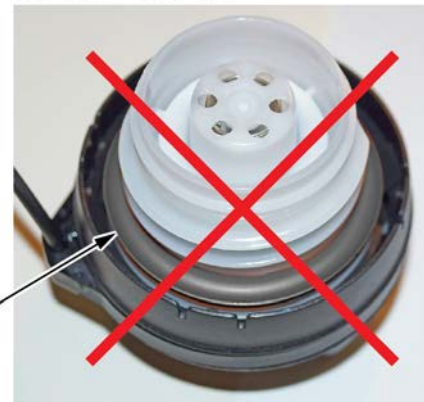
The fuel fill cap gasket creates too much friction, preventing the cap from sealing properly.

NO GOOD GAS CAP

Replace the fuel fill cap with a new one that has a brown gasket.
