Technical Service Bulletin

68 Rear power outlet compartment detached from center console

68 14 15 2038904/1 November 5, 2014.

Model(s)	Year	VIN Range	Vehicle-Specific Equipment
A6, A7, A8	2011 - 2016	All	Not Applicable

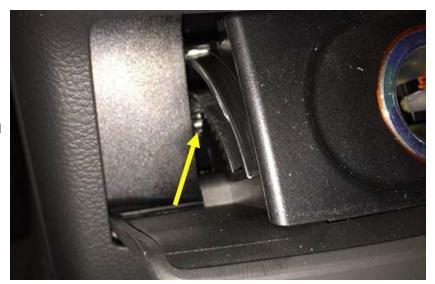
Ensure that the slow release brake wheel (Figure 1) is not damaged or missing. The slow release brake wheel prevents the compartment from opening too quickly.

Figure 1. Slow release brake wheel.

1. Before reinstalling the compartment, inspect it for damage.

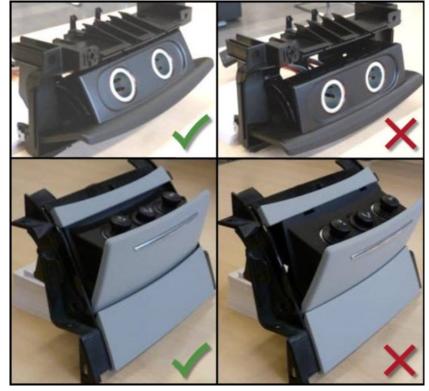
Figure 2. Correctly engaged compartments (A6, A7 in top left and A8 in bottom left) and incorrectly engaged compartments (A6, A7 in top right and A8 in bottom right).

Reinstall the compartment by positioning it on both hinge guides, then using a forceful push (toward the front of the vehicle) to engage it (Figure 2). The attached video shows this process.
