Countries:	CANADA, UNITED STATES, PUERTO RICO	Document ID:	IK0800336
Availability:	ISIS, Bus ISIS, Fleet ISIS, Body Builder	Revision:	9
Major System:	ELECTRICAL SYSTEM	Created:	2/14/2012
Current Language:	English	Last Modified:	2/11/2014
Other Languages:	NONE	Author:	Ken Fogelstrom
Viewed:	3305

Title: Horn Sounds On Its Own While Vehicle Parked - OR - Horn Inoperative

Applies To: Trucks and busses using one of these horn pad assemblies: 3616382C1 or 3586911C1 or 3862892C1. Affected vehicles have a build date: Between March 3, 2010 - December 10, 2013

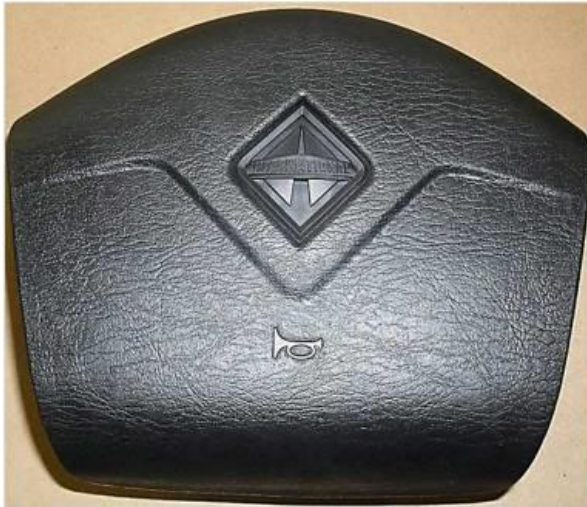
Top View

Horn pad assembly, No certification mark on part

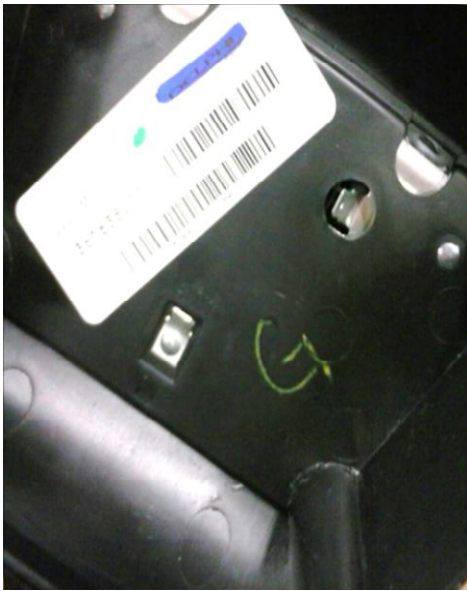
Bottom View, "G" Mark

Horn pad assembly, With certification mark

Replace horn pad assembly with a certified inspected part. The PDCs are shipping certified parts only, as of January 7, 2014. Assure that the part has a certification mark on the back, **or** a certification label on the box. A mark directly on the part will be either a "G", or two perpendicular lines that may resemble a "T". A certification label on the box will be green in color, with the letter "Q". See photos below.

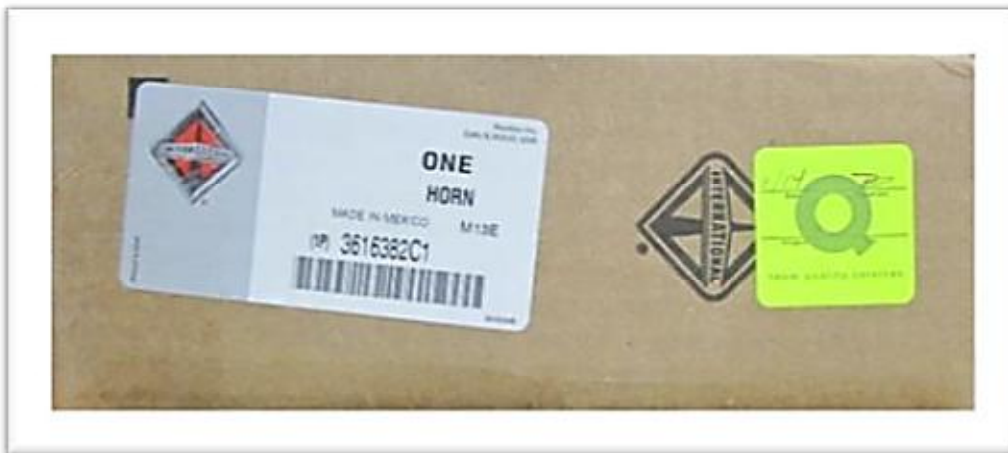
Boxed horn pad, Certification label on box
