Countries:	CANADA, COLOMBIA, UNITED STATES, PUERTO RICO	Document ID:	IK0700058
Availability:	ISIS, FleetSIS	Revision:	2
Major System:	EXHAUST	Created:	4/25/2013
Current Language:	English	Last Modified:	10/21/2014
Other Languages:	NONE	Author:	Steve Kueller
Viewed:	3123

Title: Exhaust Leak Troubleshooting for 2010 Emission MF IBB Engines

Applies To: 2010 and later HD models

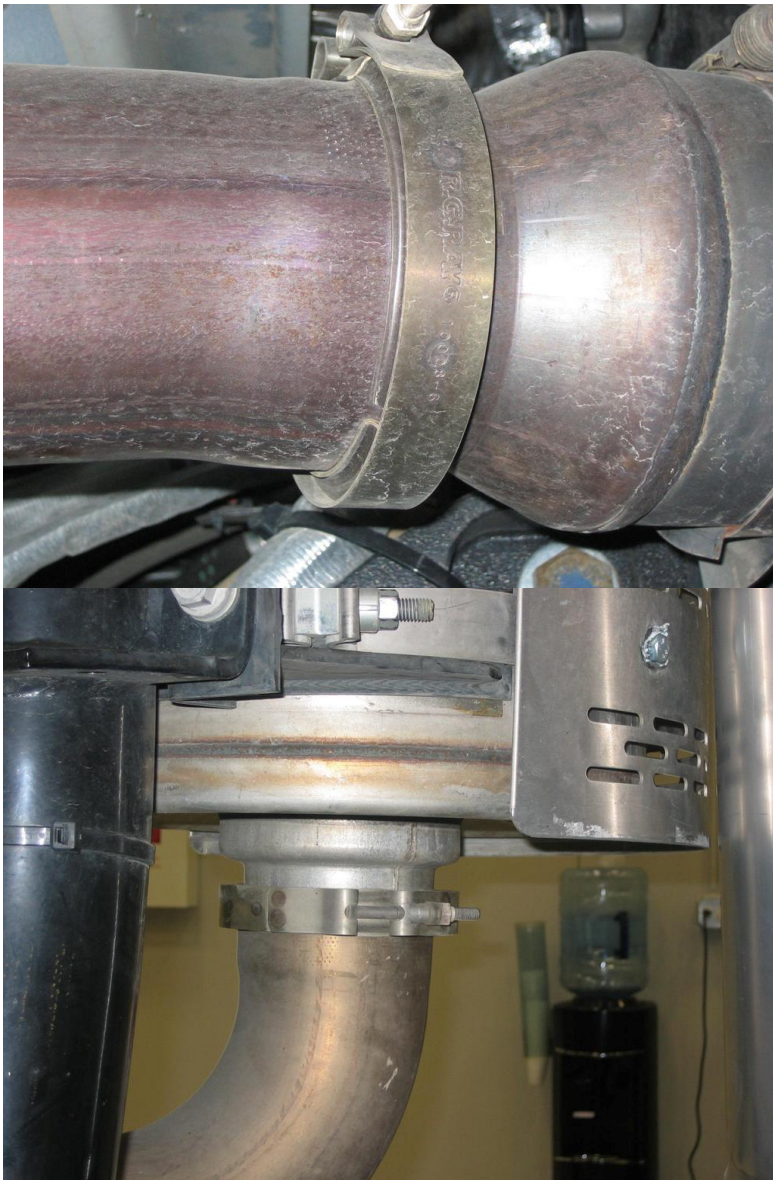
Marmon Style Clamps

Visually Inspect all pipe joints carefully for loose or missing clamps and signs of exhaust soot present. Note that 2010 pipes use a Marmon style V band clamp design @ the joint between the intermediate pipe to the turbo pipe joint if so equipped rather than the prior Torca slot slip joint design. This design also uses a gasket to seal the joint in most cases

- **If leak is found at Marmon Joints**
 - Remove clamp
 - Inspect joint mounting flanges for damage. Replace any damaged part as necessary
 - Inspect clamp for damage. Replace as required
 - Install new gasket as required
 - Connect mating flanges and install clamp over Marmon joint.
 - Verify that bellows/flexible section of pipe is relaxed and aligned. If not loosen rear clamp at intermediate pipe or inlet to the aftertreatment assembly and adjust the pipe so that the flex section is as straight as possible.
 - Secure Clamps

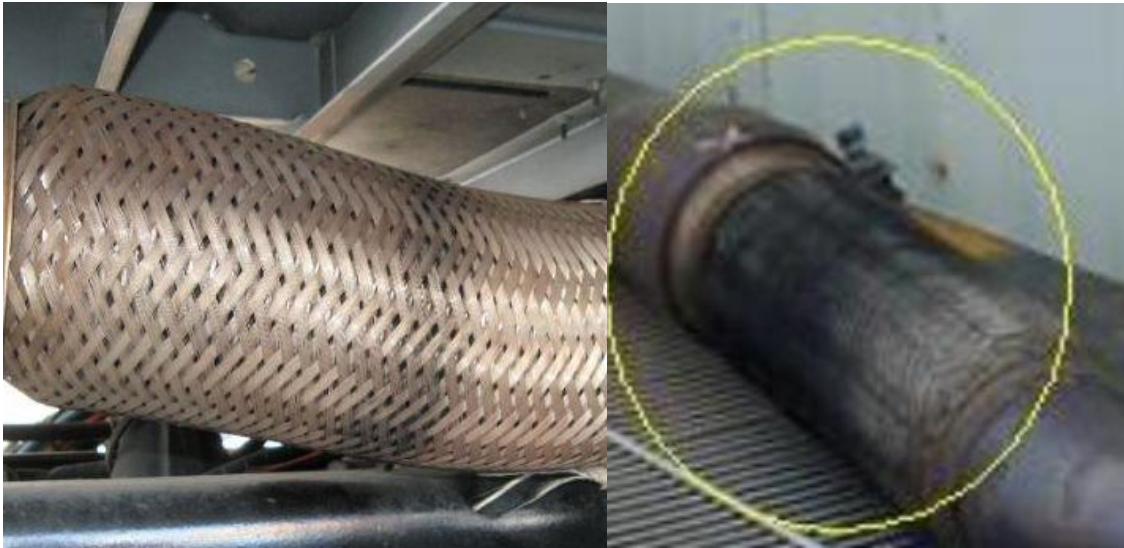
- Visually Inspect all pipes for damage or visible cracks.
- Inspect to verify that the PDOC clamp is in place. If broken or missing it is very important to install the V-Band clamp listed in parts section.
- Carefully Inspect flexible section (bellows) for signs of soot as the bellows can crack internally and allow exhaust gases to escape.
 - If there is a soot ring in the center of the bellows suspect that the bellows is cracked
 - If heavy soot is present in center section of bellows suspect that the bellows is cracked
 - If soot is only in weld area at either end of bellows suspect a pin hole or poor weld

Soot on Bellows section

If leaks are found on the turbo pipe at the flex section, weld areas or cracked the pipe will need to be replaced.

- Install replacement pipe and gaskets as needed secure the Marmon clamps over the joints
- Verify the flex section is relaxed and the pipe is aligned
- Secure the clamps

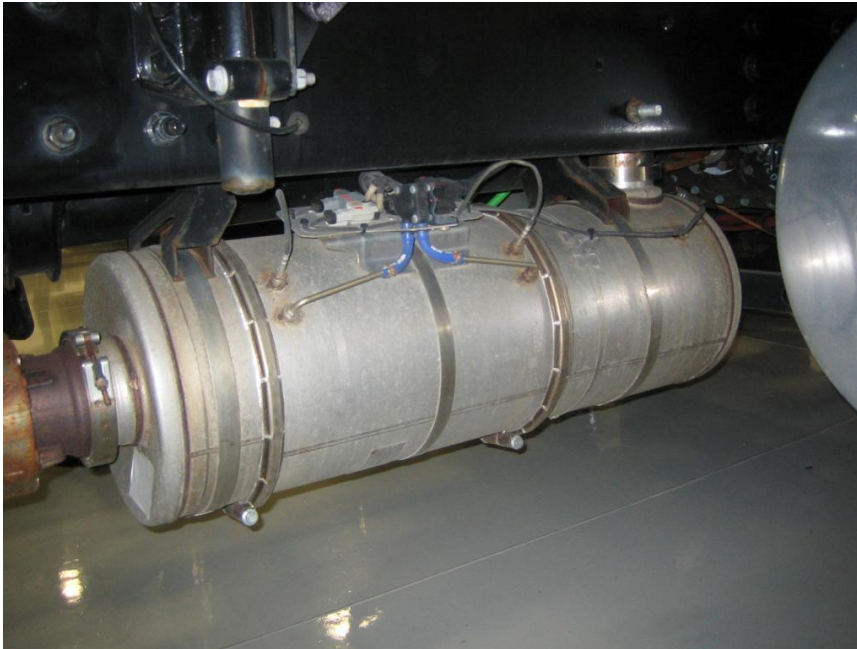
- Visually inspect the aftertreatment assembly for loose clamps, cracks or signs of leaks. There is a drain on the outlet can of horizontal systems a small leak is normal at this position.

Horizontal assembly inspect clamps for leaks

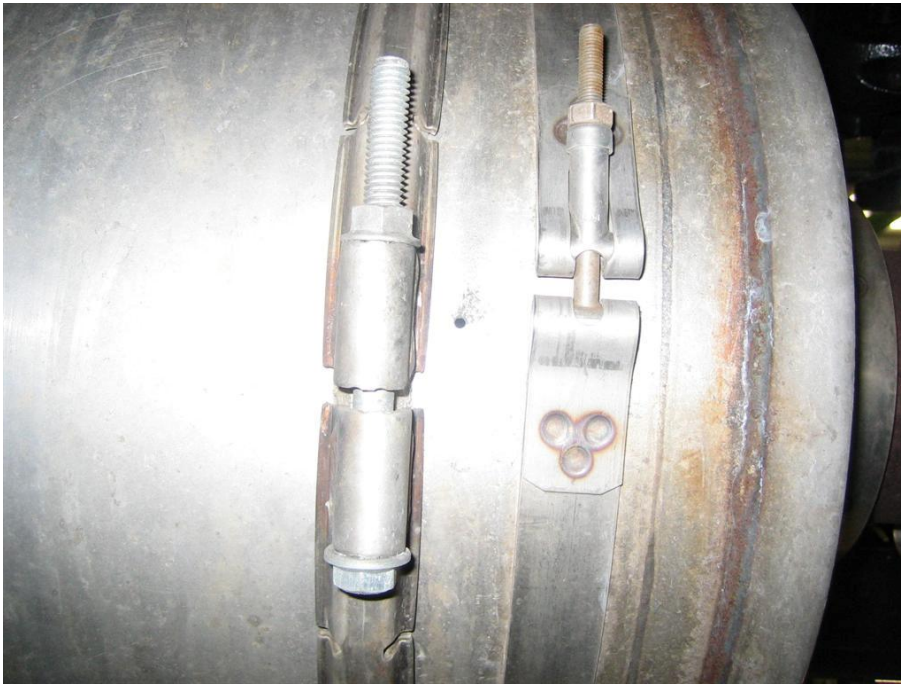
Drain Hole located on outlet between clamps should point down.

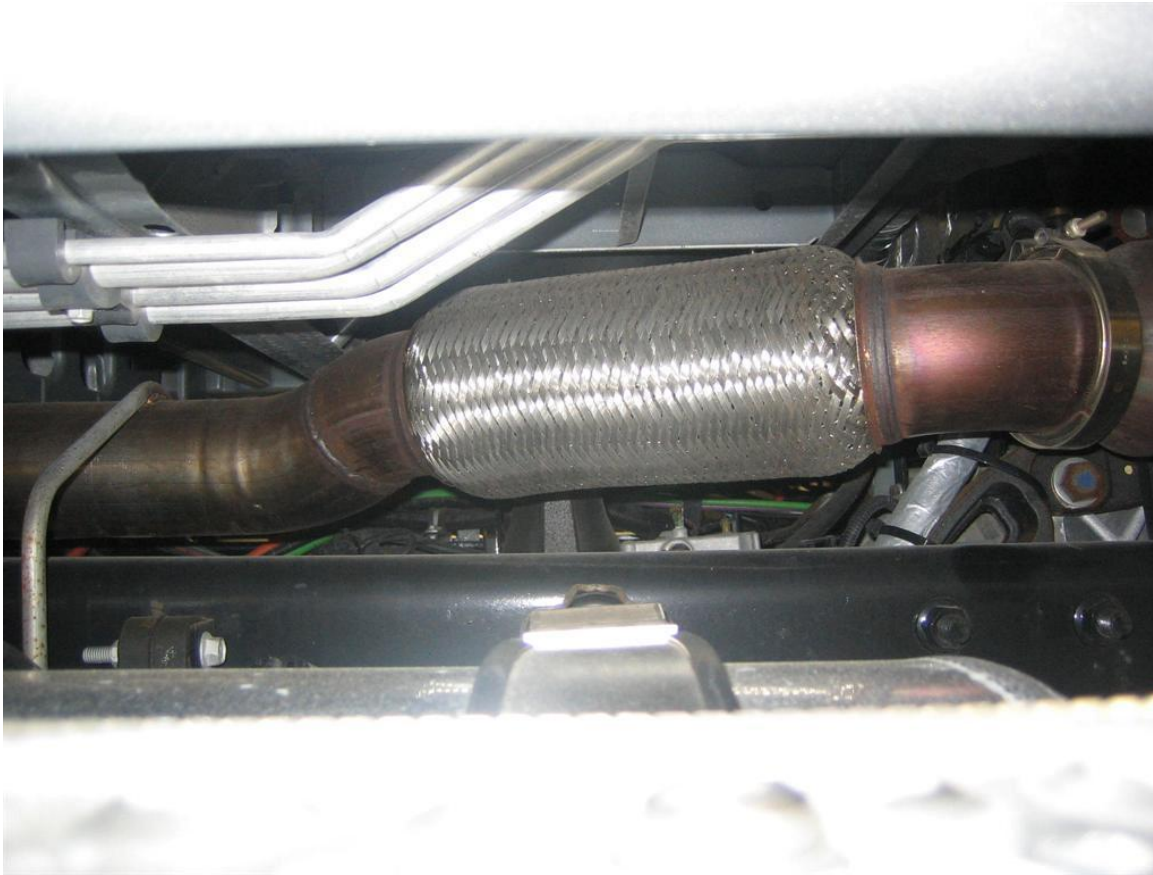
Flex pipe installed relaxed positioning:
