**Countries:** CANADA, UNITED STATES **Document ID:** IK0800485  
**Availability:** ISIS, FleetSIS **Revision:** 2  
**Major System:** ELECTRICAL SYSTEM **Created:** 3/20/2014  
**Current Language:** English **Last Modified:** 10/31/2014  
**Other Languages:** NONE **Author:** Chris Moody  
**Viewed:** 479

**Title:** Cluster Software Update Instructions

**Applies To:** CE Bus, DuraStar, TerraStar, WorkStar, TranStar, ProStar, LoneStar, 9900i, PayStar

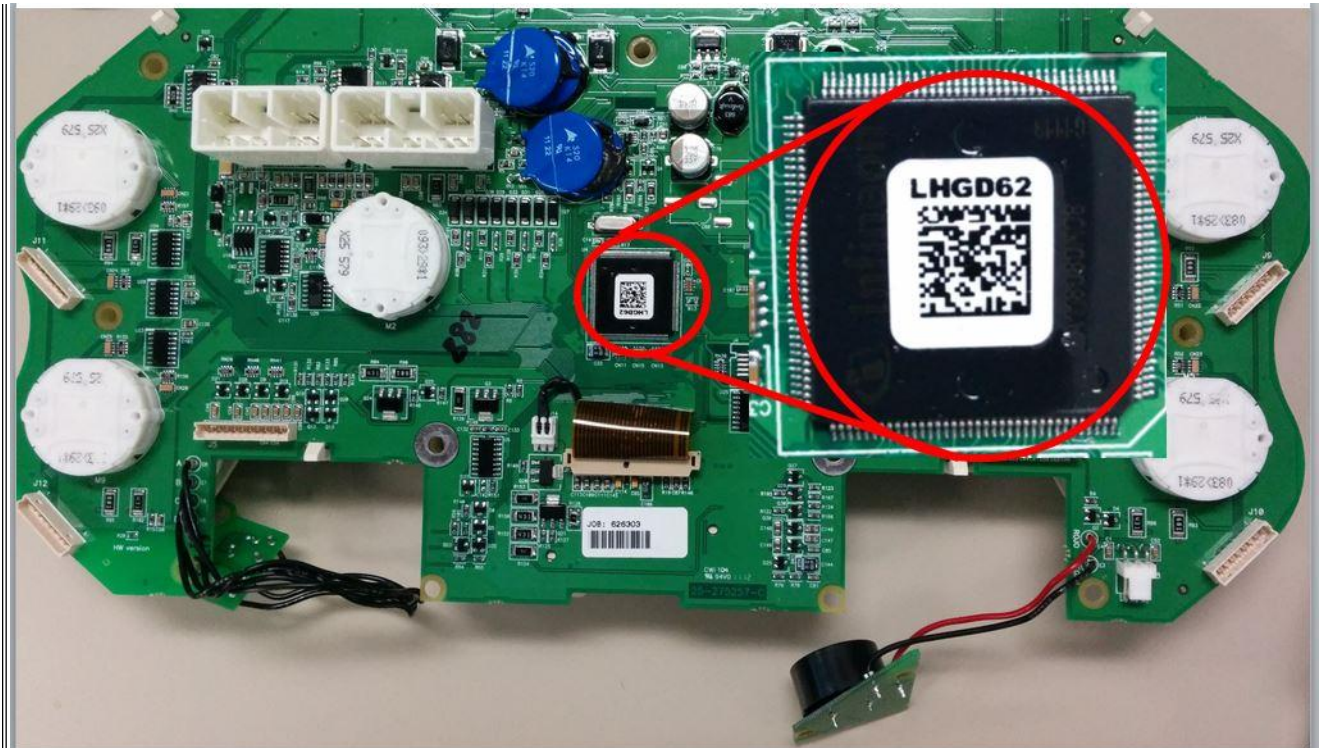
**Figure 1**

Common Cluster Software Version Identification Located on Back of circuit board. In this example, the software version is 6.2

- Common Cluster
- The latest software for common cluster is currently 7.1

If it is determined the cluster needs to be updated, follow the procedure below for the applicable cluster you have.

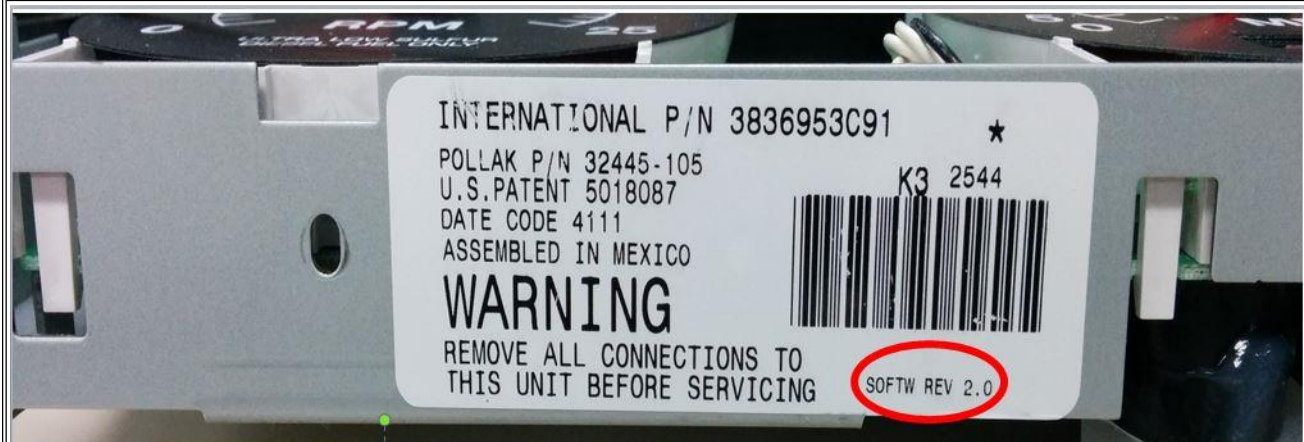
Figure 2

HDDL2 Cluster Software version. In this example, the version is 2.0

- HDDL2 Cluster
- Currently, the latest HDDL2 cluster software is 3.5
