**Document ID:** IK1201113  
**Revision:** 8  
**Created:** 4/3/2014  
**Last Modified:** 10/2/2014  
**Author:** Aaron Wenthold

**Title: 2010 MaxxForce 11 & 13 and 2013 N13 HT EGR Core Removal/Installation**

**Applies To: 2010 MaxxForce11/13, 2013 N13, All Truck Models**

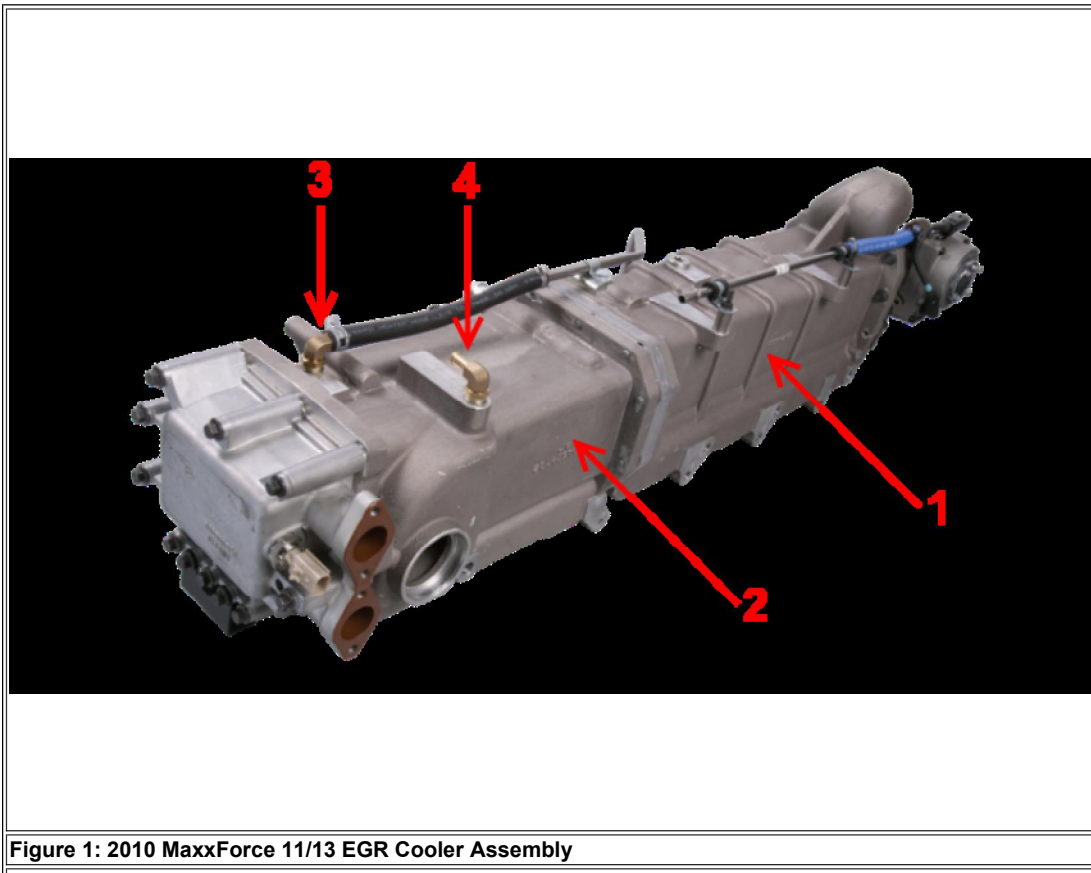
Figure 1: 2010 MaxxForce 11/13 EGR Cooler Assembly

- Item 1: High Temp (HT) Cooler
- Item 2: Low Temp (LT) Cooler
- Item 3: LT Cooler Pressure Test Port (dearation fitting)
- Item 4: HT Cooler Pressure Test Port (dearation fitting)

\*Visual inspection should never be used for diagnosing a bad cooler. The cooler (especially when constantly operated cold--read, moving the truck around the lot) will cause condensation build-up, and when mixed with soot/exhaust constituents, can be easily confused with coolant. ALWAYS pressure test the cooler.\*

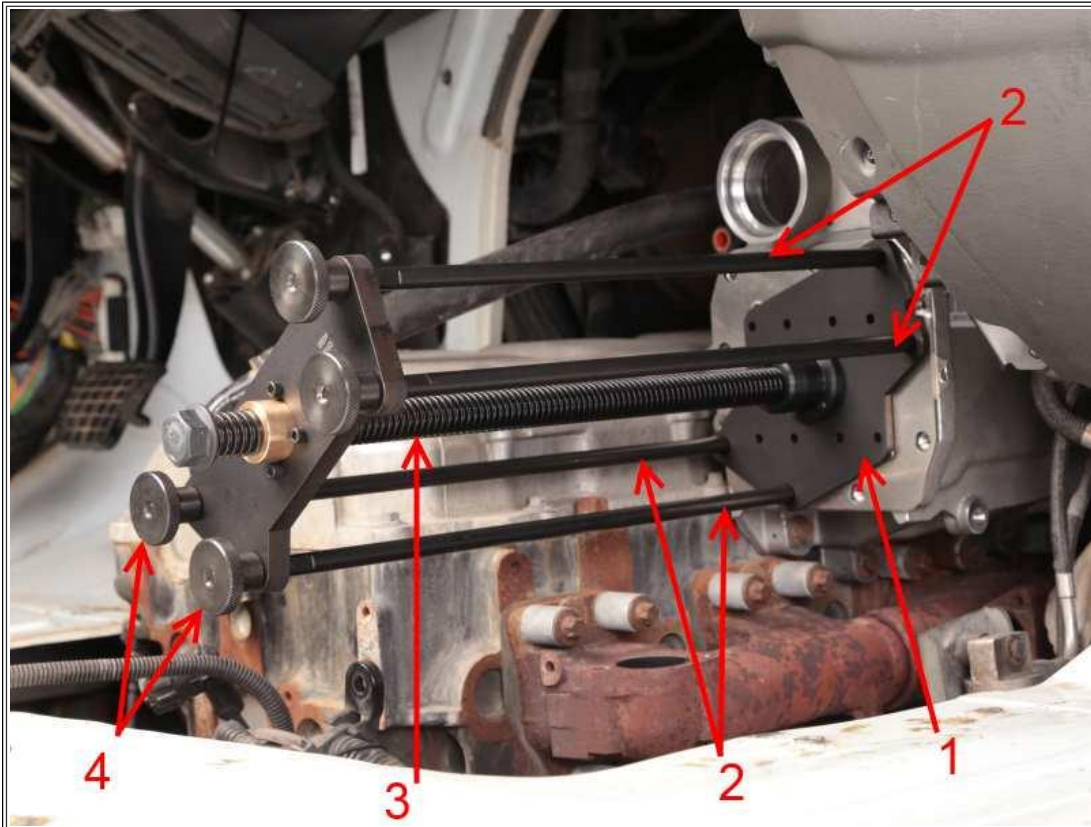
**Figure 2: HT Core Removal Tool**

- Item 1: Removal plate
- Item 2: Support rods
- Item 3: Forcing screw
- Item 4: Thumb screws

It is critical that the rods get torqued to the housing. There is a bevel between the threads and the shaft, designed specifically to drive the cooler header onto the shaft. **There is a distinct difference between bottoming out on the header plate, and bottoming out in the housing (hard stop).** Failure to do so will lead to the header being caught on the rod and breaking/bending the rod. There have been instances of the housing being damaged to the point of replacement, as well.

a. Screw in the support rods in the two upper right, and lower, bottom left corner, holes (**Figure 2**, Item 2). **Tighten using a 9mm open-end wrench.**

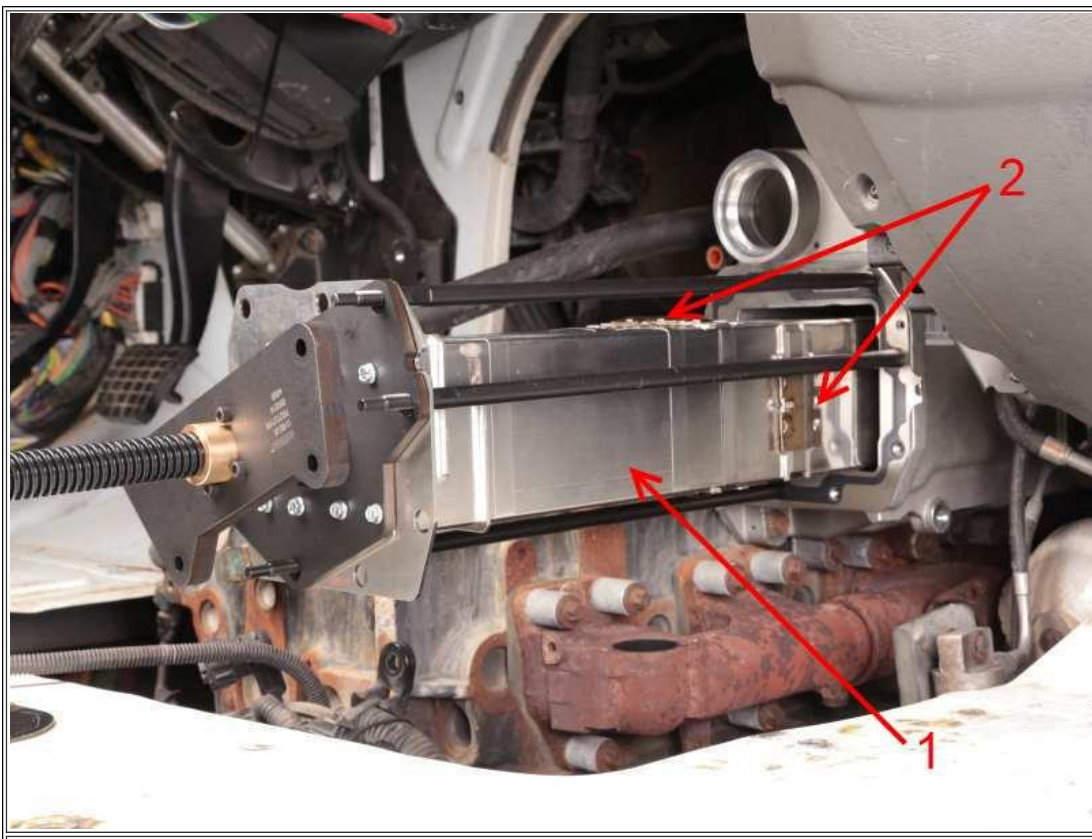
**Figure 4: High Temp Core and Spring Clips**

- Item 1: HT Cooler Core
- Item 2: Spring Clips

-There are two pairs of spring clips supporting the core in the housing. Therefore, the core will need to be pulled about 16 inches before it will be free to remove.

5. Back out the bolt to extract the core from the housing (**counter-clockwise**).

-**NEVER use an impact on the tool.** The tool was not designed to handle the stresses because core and/or housing damage will result from the uncontrolled force. Always use a ratchet.

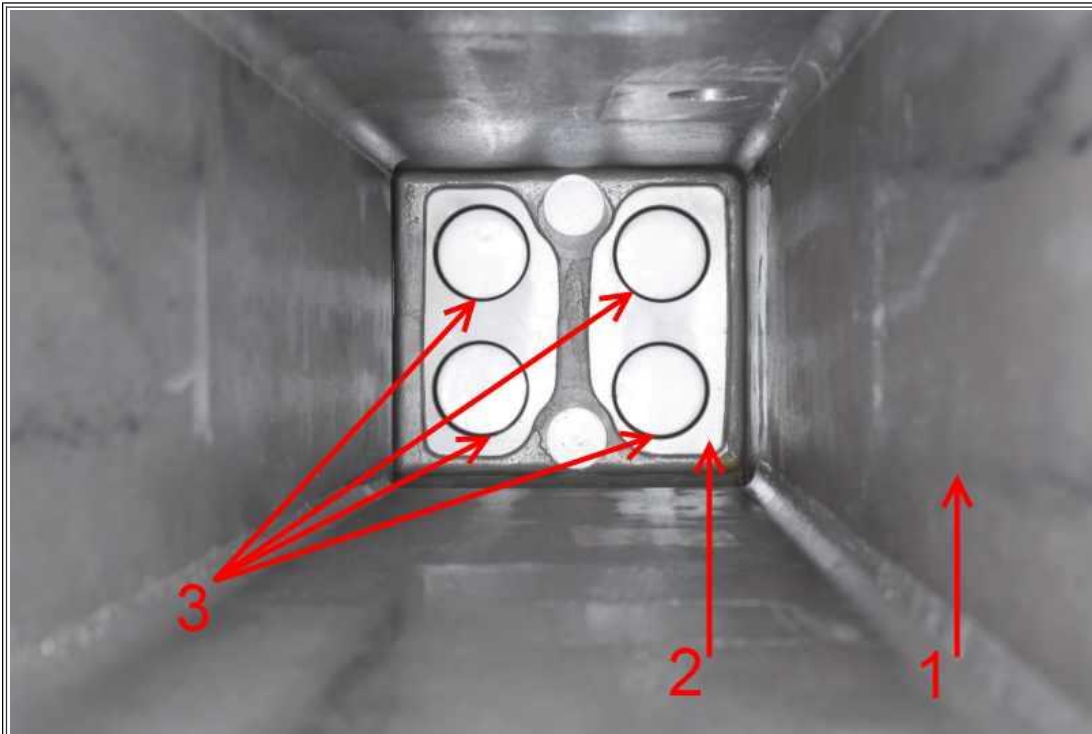
**Figure 5: HT Diffuser O-Rings**

- Item 1: HT Housing
- Item 2: Manifold (Joint) Plate
- Item 3: O-Rings

10. Use a pick to remove the four o-rings in the center of the cooler and discard. *The o-rings must be replaced every time the core is replaced. Non-compliance will result in premature failure of the core.*

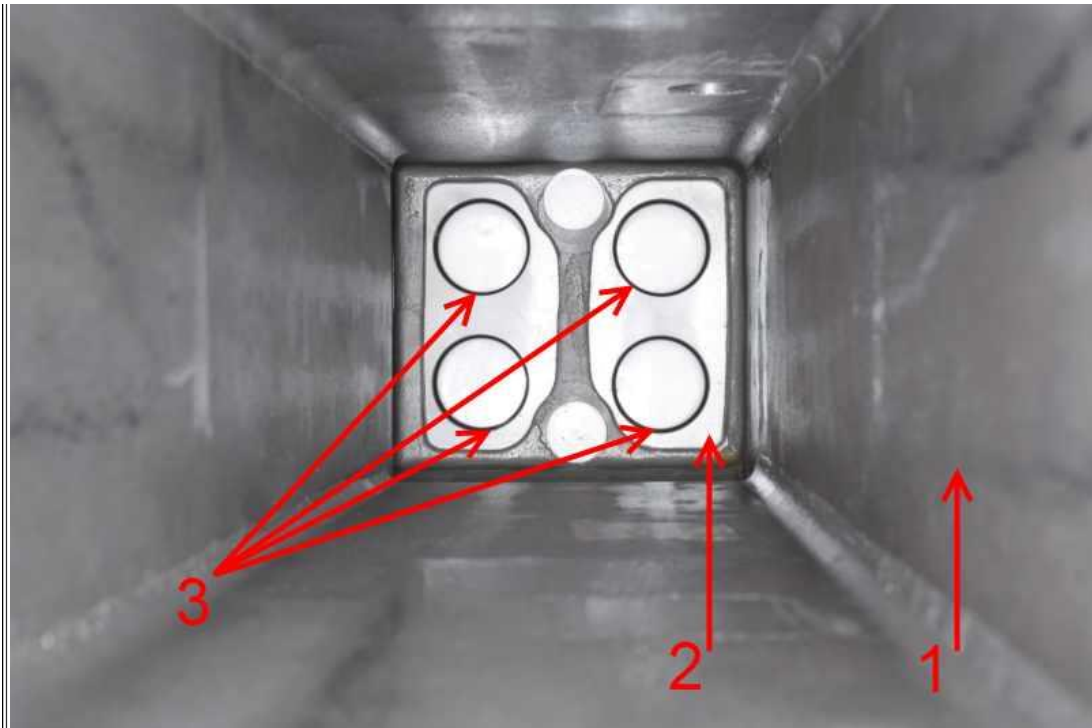
Figure 6: HT Diffuser O-Rings

- Item 1: HT Housing
- Item 2: Manifold (joint) Plate
- Item 3: O-Rings

Make sure there is no debris in the o-ring grooves prior to installing the o-rings (they don't need to be spotless, just no soot chunks that will push the o-ring out of round). In development, this was the only instance of damaged o-rings (core outlet manifold cut off a section of the o-ring), outside of not actually seating them.

1. Install the four o-rings from the HT kit (Figure 6, Item 3) and ensure they are seated properly.

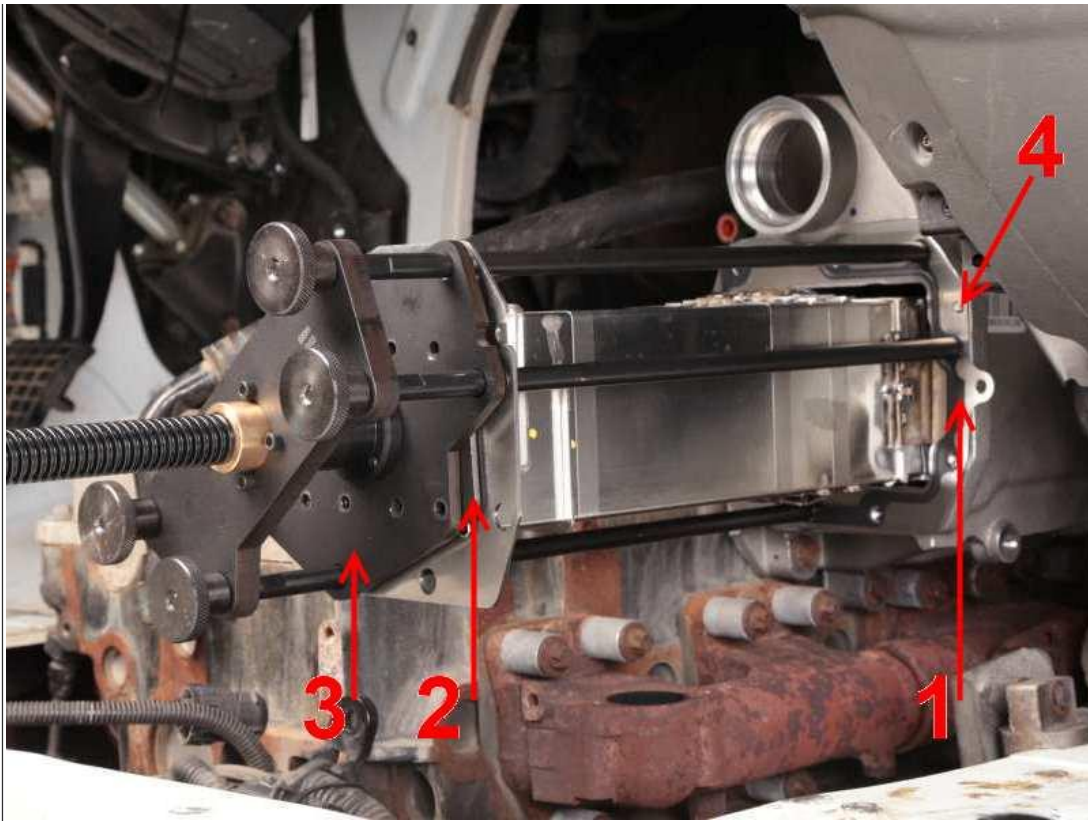
**Figure 8: HT Core Installation**

- Item 1: Core to Housing Gasket
- Item 2: Installation Plate
- Item 3: Removal Plate
- Item 4: Dowel Pin

**DO NOT OVER TIGHTEN.** Stop when the plate merely touches the gasket/housing. The core should take up to 10 lb-ft of bolt torque to slide in. **Damage to the tubes will occur if the torque exceeds 15 lb-ft (equates to 1000 lb force).**  
**NEVER USE AN IMPACT.** Failure to do so will lead to damage to the tool, core and housing.

2. Apply generous amounts of P-80 to the four o-rings.
3. Install the two dowel pins into the housing. Use a hammer to tap them in, if necessary.
4. Install the core to housing gasket (**Figure 8**, Item 1).
5. Screw in the four rods from the tool kit (tighten using a 9mm open-end wrench).

6. Apply liberal amounts of P-80 to the outlet manifold and spring clips of the HT core.
7. Slide the HT Core into the housing.
8. Attach the insertion plate to the tool and slide it over the rods.
9. Screw the thumbscrews onto the rods.
10. Use a torque wrench to tighten the bolt, which will drive the core into the housing. Stop when the core header touches the gasket.
