Document ID: IK1201201  
 Revision: 0  
 Created: 8/27/2014  
 Last Modified: 10/10/2014  
 Author: Andrew Miles

Title: 783 EOP Connector Interference

This document will guide the user through providing a corrective action to prevent the Engine Oil Pressure (EOP) harness contacting the A/C lines on 13L equipped LoneStar® and WorkStar® models.

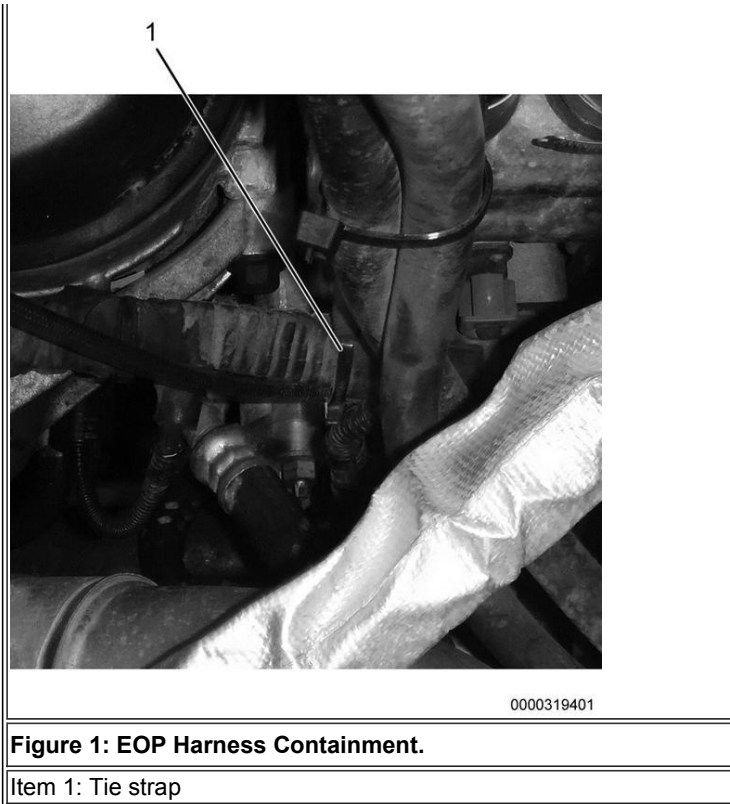
**Figure 1: EOP Harness Containment.**

Certain models (through mid 2011) could experience an issue of the Engine Oil Pressure (EOP) harness from contacting or rubbing on the A/C lines.

Item 1: Tie strap

1. Bring vehicle into shop and park on flat surface.
2. Shift transmission to Park or Neutral, set parking brake, and install wheel chocks.
3. Unlatch and open hood.
4. Using tie strap (Figure 1, Item 1), secure the EOP harness to the engine harness.
5. Close and latch hood.
6. Remove wheel chocks.
