**Title:** DTC 191-16 TOSS/VSS Service Information

**Applies To:** N13 OBD

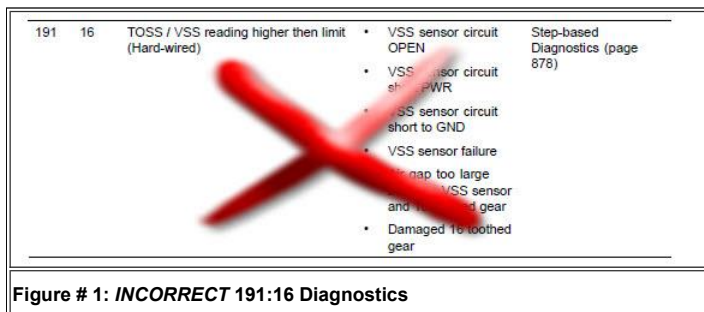
The diagnostics for fault code 191:16 have previously been to inspect the wiring, sensor and tone ring of the VSS. These diagnostics from the manual are *INCORRECT* and should not be followed when 191:16 is present (manual will be updated). This document explains how the 191:16 fault works and also covers setup of the vehicle over speed indicator.

**Figure # 1: INCORRECT 191:16 Diagnostics**

This fault is not related to the vehicle speed sensor, wiring or tone ring, but a reaction to the "Vehicle Over Speed Indicator" programmable parameter(77542). If the customer has requested to turn on vehicle over speed notices to driver then the following parameters need to be programmed accordingly:

Once these parameters have been programmed accordingly and a the unit reaches a vehicle over speed the 191:16 fault will be logged in the ECM. Since the engine warning lamp(EWL) will be illuminated when the vehicle over speed occurs a fault must be stored in the ECM due to OBD requirements. The 191:16 fault is simply a result of a over speed being reached and should not be diagnosed as a hardware issue.
