**Document ID:** IK1200099  
**Revision:** 4  
**Created:** 5/21/2007  
**Last Modified:** 2/11/2014  
**Author:** Ryan Hendrickson

**Title: Maxxforce 10 DT Code 1113, 1135, 1134 or 1112 ECM / IDM Power (Clean Power Fuses Blowing) or APS codes**

**Applies To: Maxxforce 10 DT**

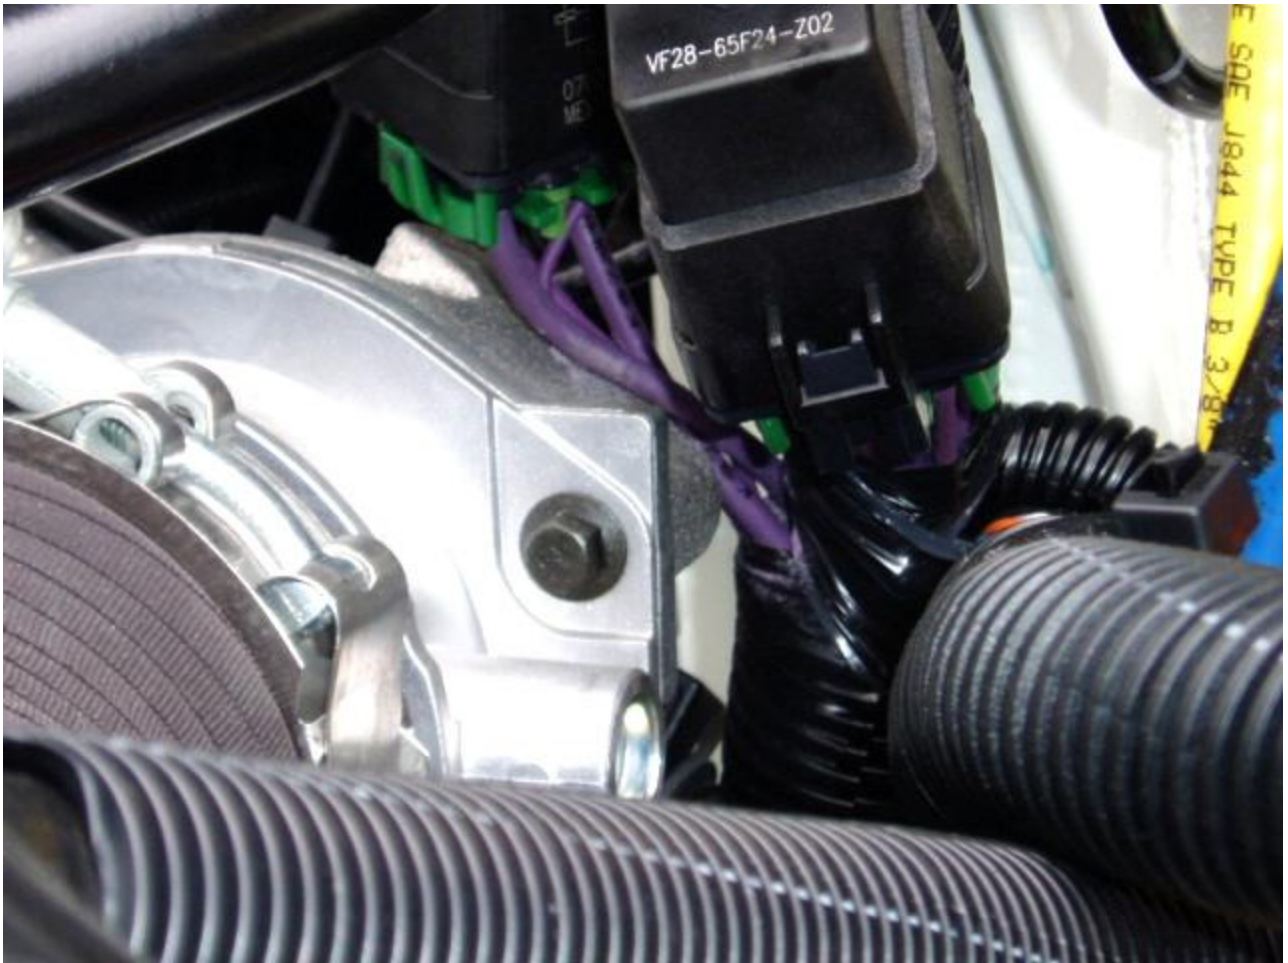
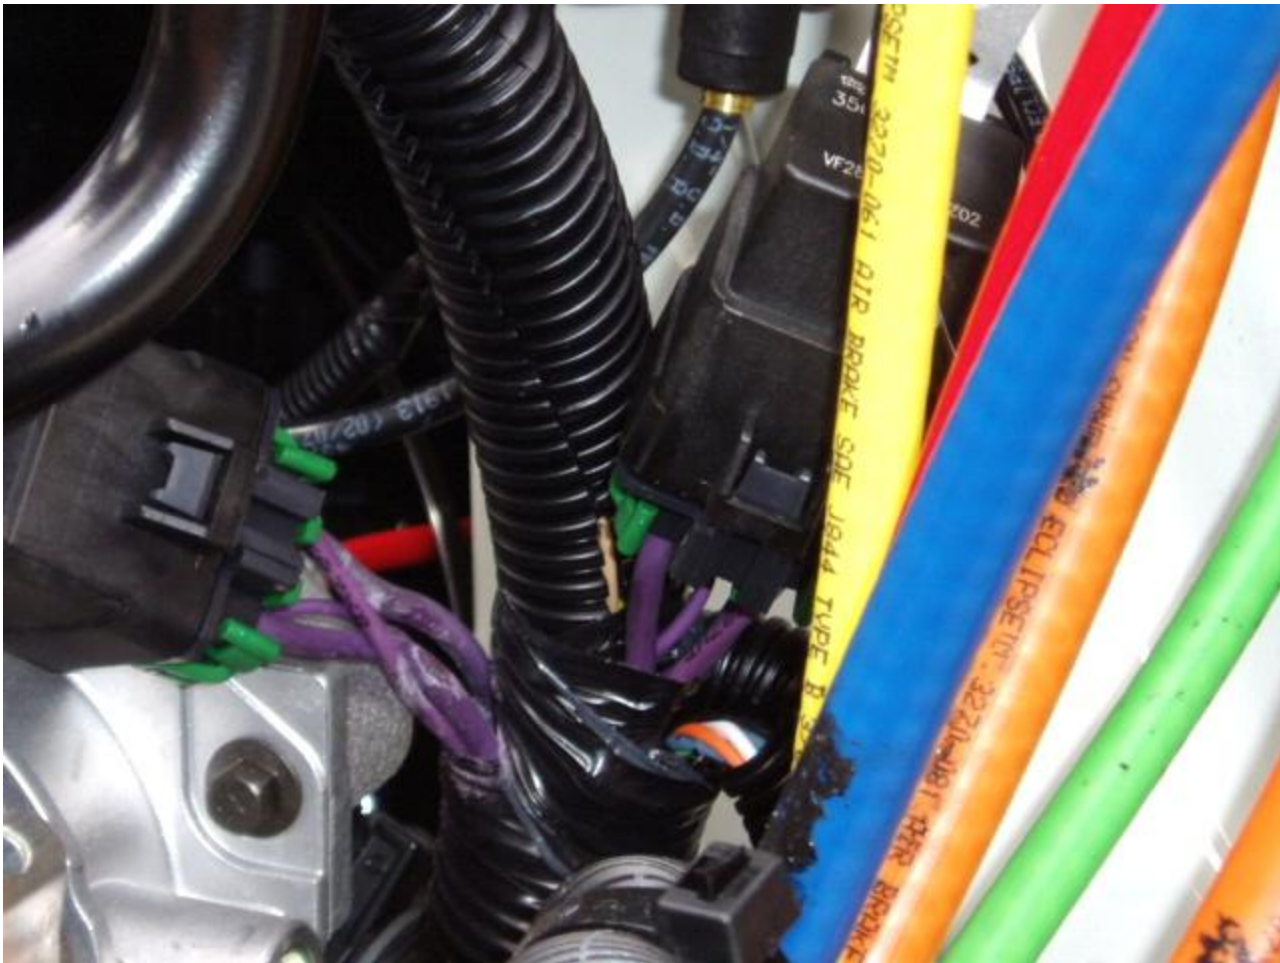
If you find the ECM or IDM clean power fuses in the battery box blown, check the ECM and IDM power relays and the wiring to them. ECM and Actuator power relays are zip tied to engine harness on left side of engine. The wires could possibly rub against the ITV and cause a short. See pictures below.

- If the IDM loses power, it will crank, but not start and you'll get a DTC 1113
- IF the ECM loses power, the engine will start, but you won't have any throttle.
