| <b>Countries:</b> | CANADA, UNITED STATES, MEXICO, PUERTO RICO | <b>Document ID:</b> | IK1200126 |

**Title: Valve train damage repair procedure on 2004 - 2009 I6 Engines**

**Applies To:** International DT 466, HT 466, DT 570, HT 570 diesel engines (2004 - 2006 MY) serial number range: 2000001 through 2999999.

**International® MaxxForce® DT, 9, and 10 diesel engines (2007 - 2009 MY) serial number range: 3000001 through 3299999.**

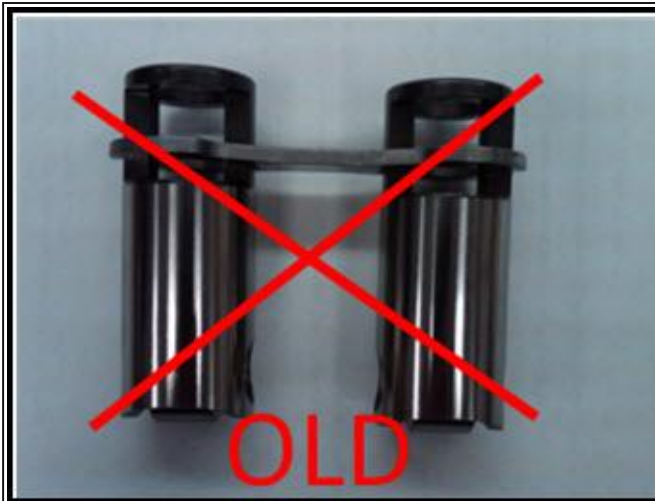
In some occasions the cam follower retainer (aka bracket or dog bone) is found broken. This procedure reinforces the original single retainer setup by adding an additional retainer per cam follower pair.

**Figure 1: Original single retainer**

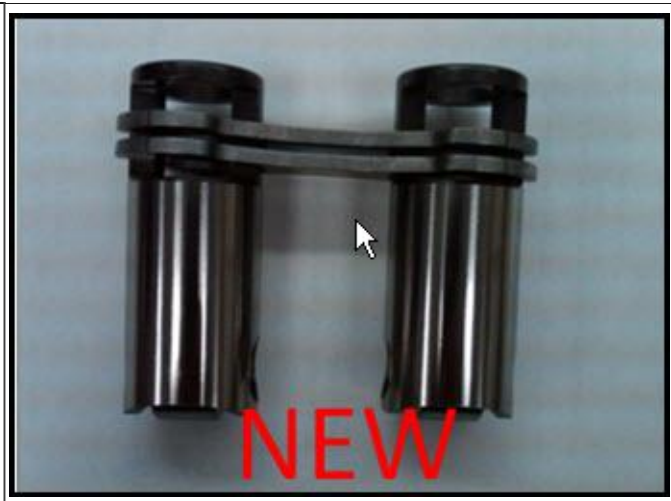
**Figure 2: Two retainers per pair of followers.**

- CamShaft
- All Cam Followers (12)
- Two cam follower retainers per pair of cam followers (12) as shown in *Figure 2*.

**IMPORTANT:** Install 12 retainers in place of the original 6 . Order 12 of the same part numbers

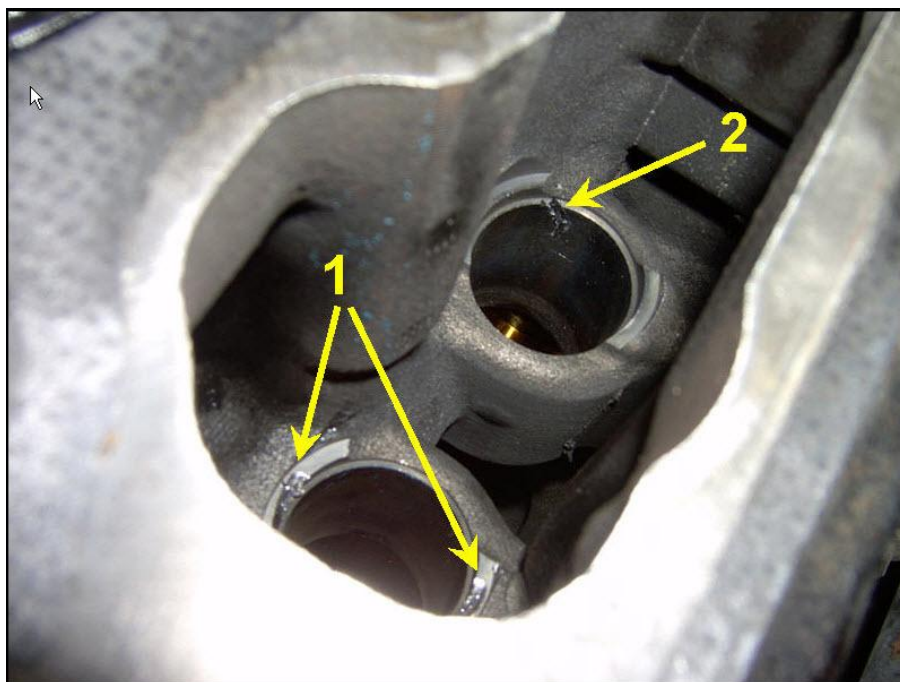
**Q.** I see damage at the top side of the lifter bore. Do I need to replace the block? (*Figure 3, Item 1*)

**A.** No, block replacement is not necessary. The lifter retainer does not come to contact with the block. It floats between the two lifters. The surface at the top of the lifter bore is machined during the manufacturing process and plays no role in lifter or retainer operation, and no role in engine operation.

**Q.** The lifter bushing is nicked. Can I replace the bushing or should I replace the block? (*Figure 3, Item 2*)

**Figure 3: Knicks and burrs at top and inside lifter bore.**

**A.** The bushing is not serviceable and a block replacement is not necessary. A knick or burr to the lifter bushing may be cleaned up by hand with very fine emery cloth. Wash all surfaces very well from abrasive residue and lubricate bore and lifter with engine oil. Install lifter inside bore and move by hand to ensure it doesn't stick or hang to ensure smooth operation.
