**Document ID:** IK1200131  
**Revision:** 4  
**Created:** 9/4/2007  
**Last Modified:** 2/12/2014  
**Author:** Robert Beckett

**Title:** Turbocharger to CAC hose coming off on MaxxForce™ 7 Engines - CAC Hose Clamp Alignment and Torque Update

**Applies To:** All Models with 2007 MaxxForce 7 (V8) Engines

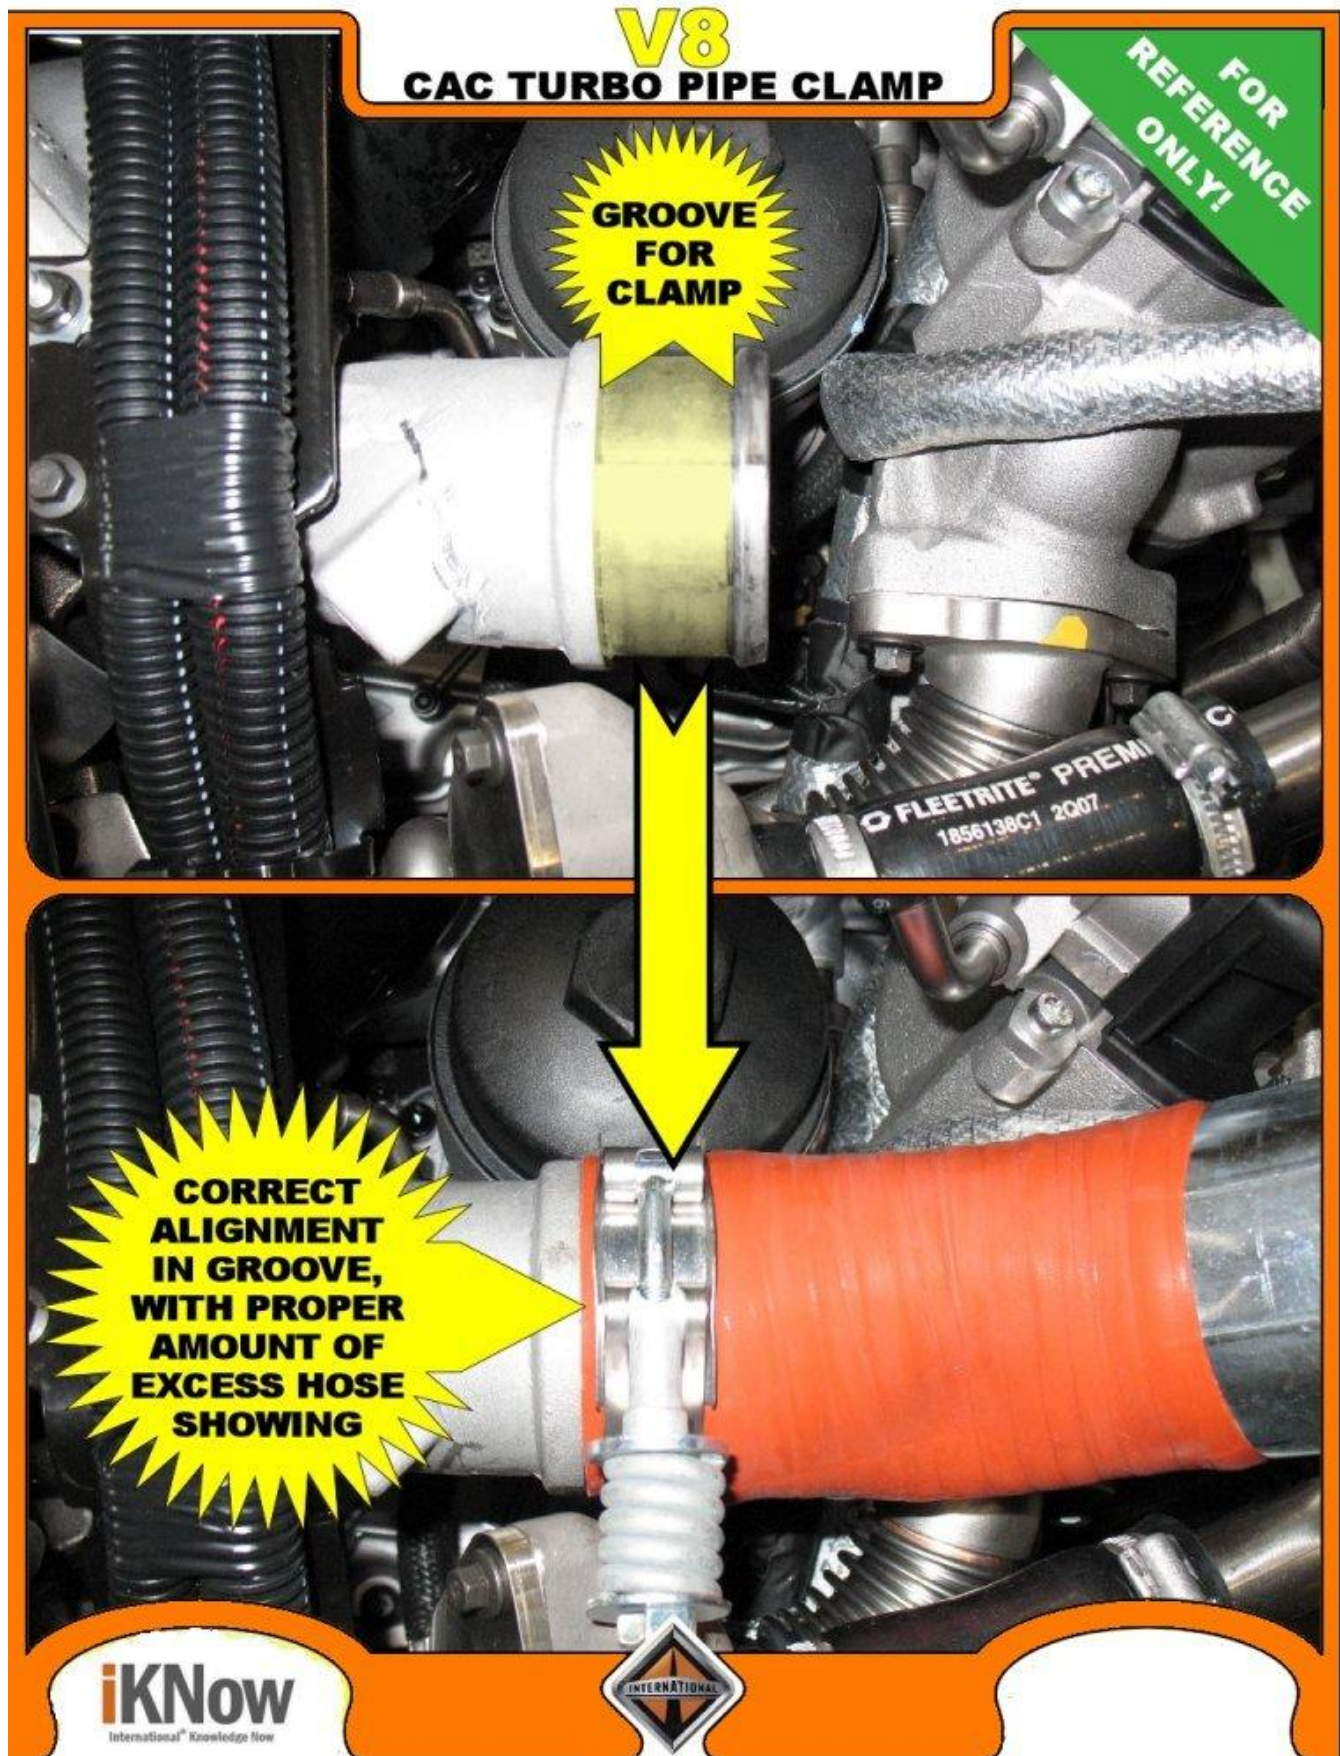
Trbocharger to CAC hose coming (blowing) off on certain MaxxForce™ 7 Engines

The clamp should be aligned in the center of the housing groove as shown in the photo below.

Updated clamp alignment and torque.

The torque for this clamp has been increased to 95 - 100 inch pounds
