Title: Updated I6 EVRT/VGT Diagnostics Check Sheet and Turbocharger Repair Procedures for engines that exhibit DTC 353 / 354

Applies To: 2004- 2006 MY EGR DT 466 and 570 with EVRT/VGT Turbos with ESN 2,000,001 - ESN 3,000,000

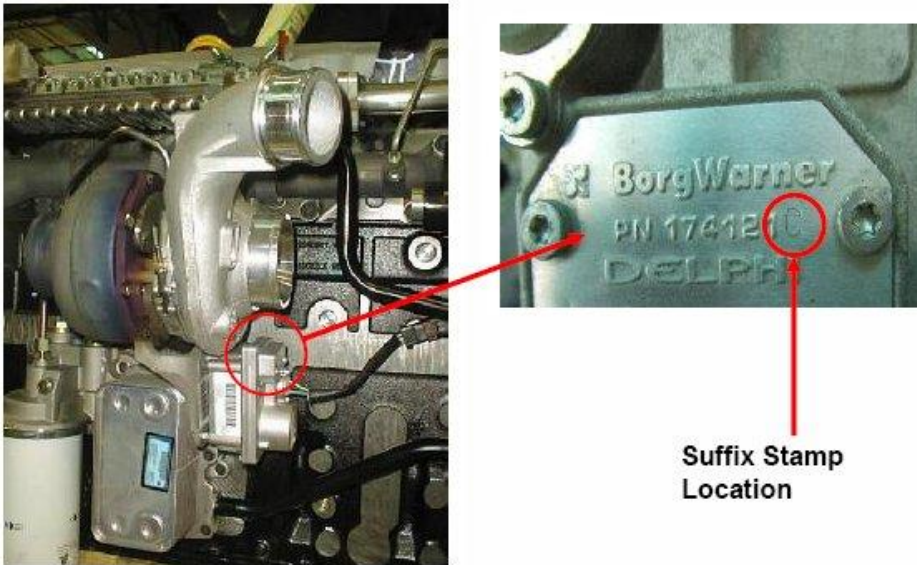
Suffix Stamp Location

2. Locate and identify the Suffix Stamp next to the Borg Warner Actuator Part Number embossed on the name plate. The Suffix Stamp will be a letter designation, but also maybe blank and not have a Suffix stamp letter.

Decision Step 4A: If it does not have Suffix stamp next to the part number, replace the actuator with Actuator Service Kit P/N 1847620C91.

Decision Step 4B: If the Suffix stamp next to the part number is A, B, C or D, replace the actuator with Actuator Service Kit P/N 1847620C91.

Decision Step 4C: If the Suffix stamp next to the part number is E, go to Step 5 Check the EBP Sensor Part Number.

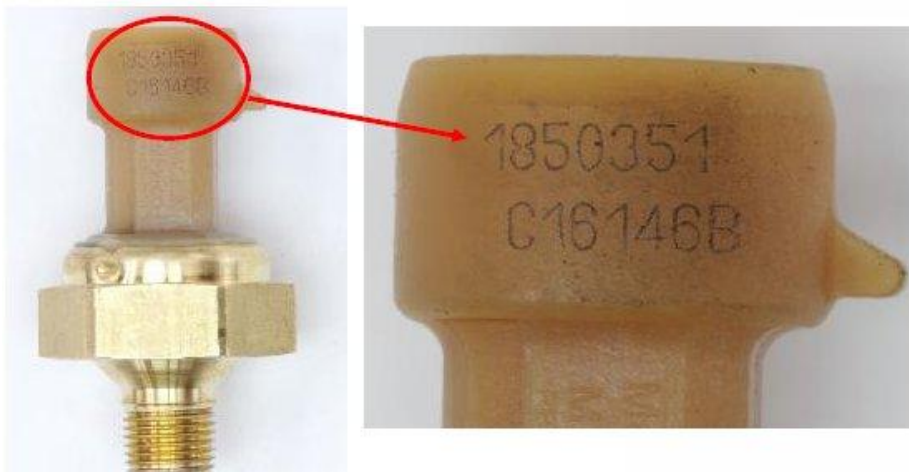
The printed part number will appear on 2 lines of the sensor body. The seven digit part number will be on the first line, and the second line will start with the part number suffix (ex. C1).

Decision Step 5A: If the EBP Sensor is not part number 1850351C1, replace the sensor.

Decision Step 5B: If the EBP Sensor is part number 1850351C1, The sensor does not need replaced unless you suspect EBP sensor is out of range. perform the EBP diagnostics steps in the Engine Diagnostic Manual [EGES 270-1 EBP Sensor](#) to validate the EBP sensor.

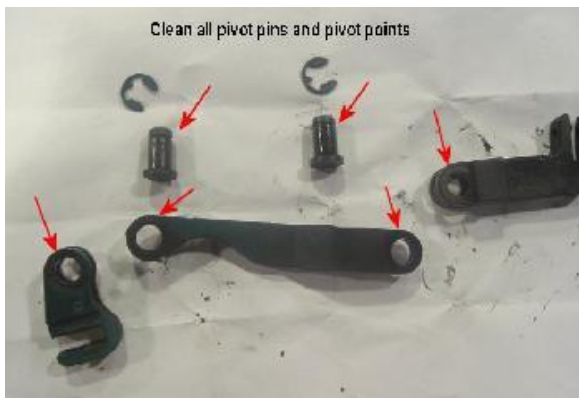
1. Remove the E clips from both of the fork lever pins and remove the pins.
2. Using emery cloth or a soft wire wheel, clean the inside of both fork levers, the ends of the intermediate linkage on both sides, and the fork lever pins

Decision Step A: If the linkages and pins are excessively worn (steps or elongated holes), replace the linkage.

Decision Step B: If the linkages and pins are not excessively worn, continue repair the linkage.

3. Apply anti-seize compound to all points of contact on the fork levers, pins, and the linkage using 1870706C1 Lubricant or commercially available equivalent.
