**Document ID:** IK1200376  
**Revision:** 2  
**Created:** 5/20/2009  
**Last Modified:** 2/11/2014  
**Author:** Randy Geweniger

**Title:** Stumble or misfire on acceleration and setting cam codes on I6 engines from 1995 to present.\*

**Applies To:** DT466 DT530 DT570

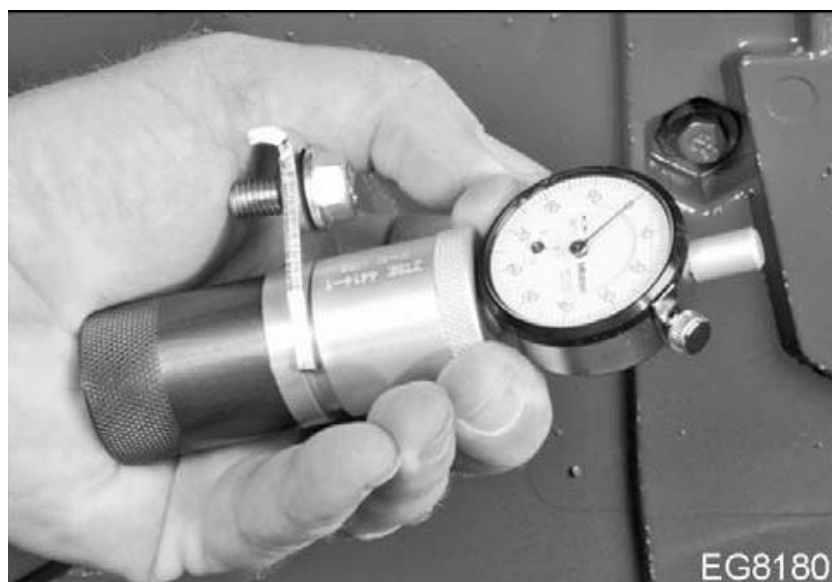
1. These cam codes can be set due to camshaft end play out of spec and may not even set a code at all but the truck is experiencing a surge, stumble, or misfire under a load during acceleration.
2. The camshaft end play will need to be checked, to do this you will need tool ZTSE4414 on pre EGR engines.

The front cover will have to be removed and the cam gear will have to be replaced.

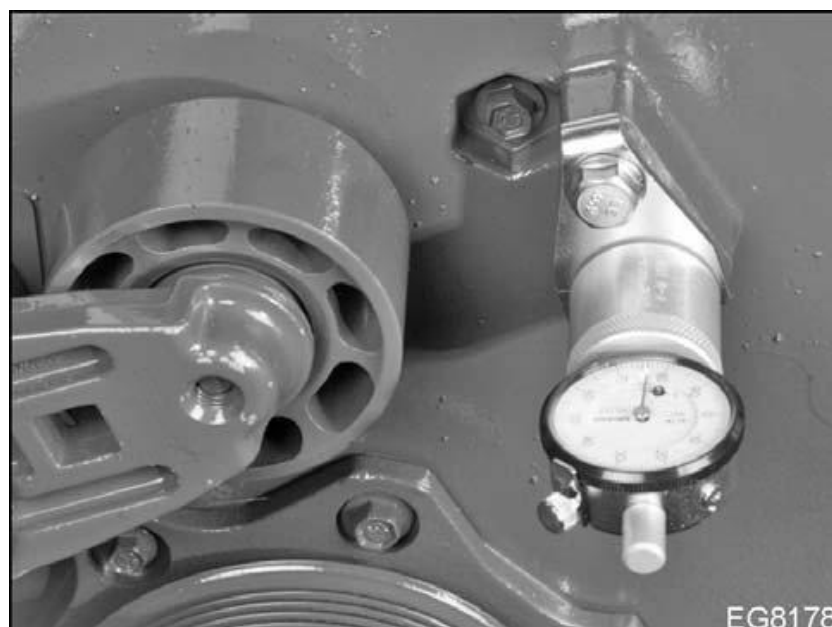
3. Remove the cam sensor and install the camshaft end play tool. Once the tool is installed rotate clockwise by hand 14 times and stop to zero out the tool. Next rotate the engine by hand 14 times counter clockwise and record the reading. The end play should be 0.005-0.013in, if it is higher than this the cam gear has walked off the camshaft.
