Title: Engine Borg Warner Turbocharger Flange Kit

Applies To: 2004- 2006 DT 466 and 570 Engines, Borg Warner Turbochargers

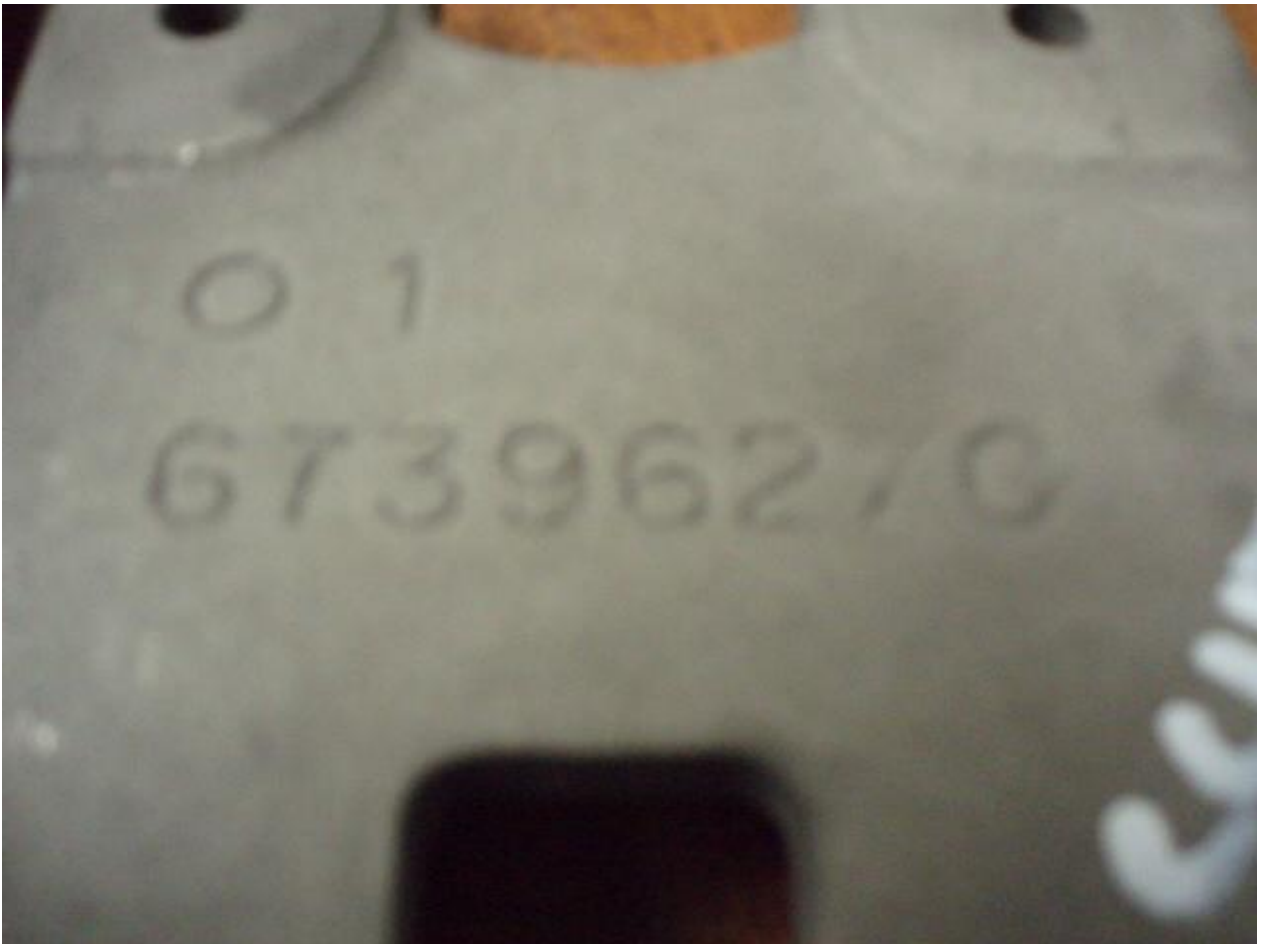
Flange with casting number that can use the service flange kit.

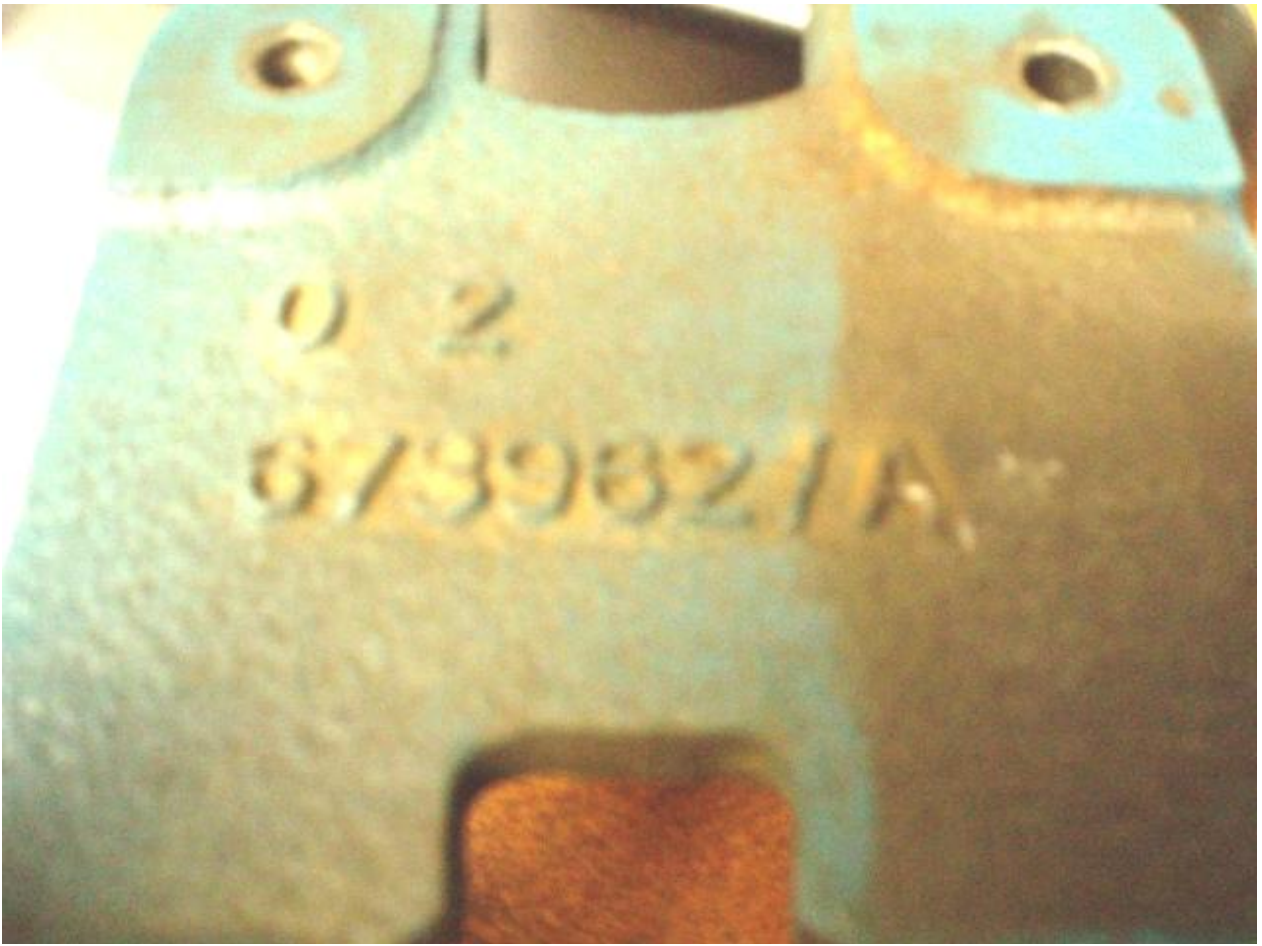
Flange with casting number that cannot use the service flange kit.

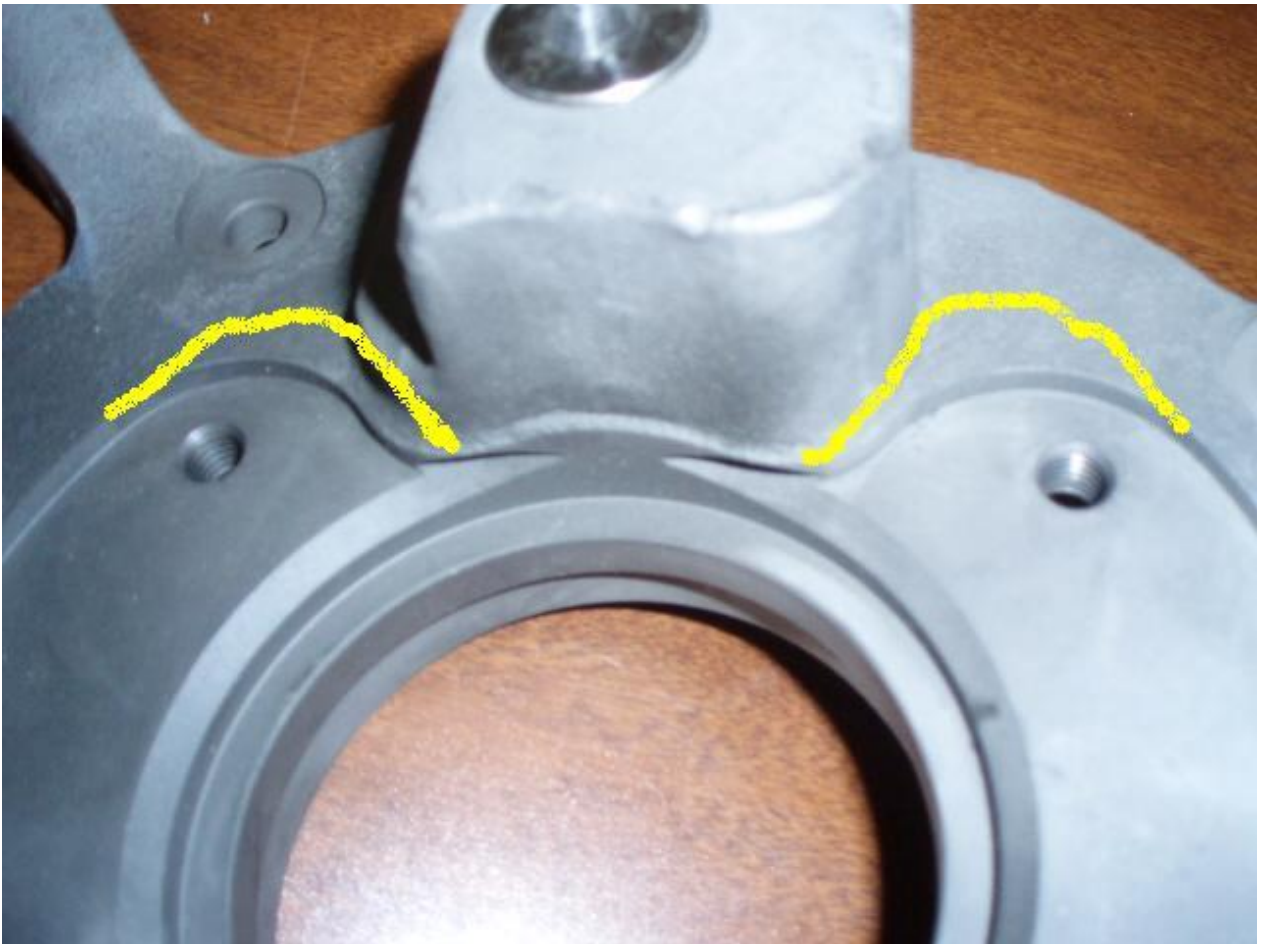
Flange above can use flange service kit. (Areas in yellow highlight difference between the two)

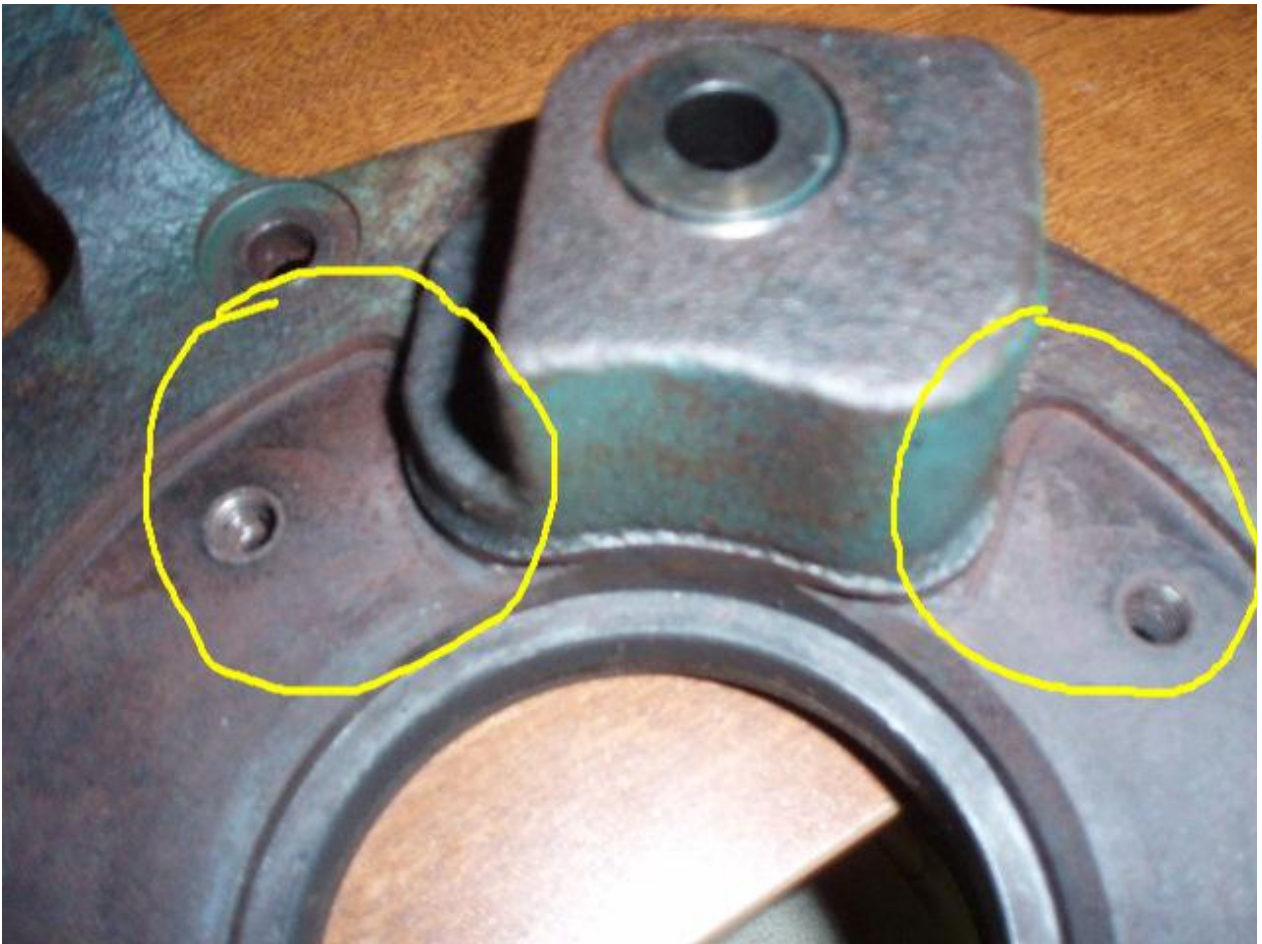
Old style flange above cannot use flange service kit. (Areas in yellow highlight difference between the two)
