**Title: Maxxforce 11 and 13 experiencing an air leak at the EGR control valve.**

**Applies To: Maxxforce 11 and 13**

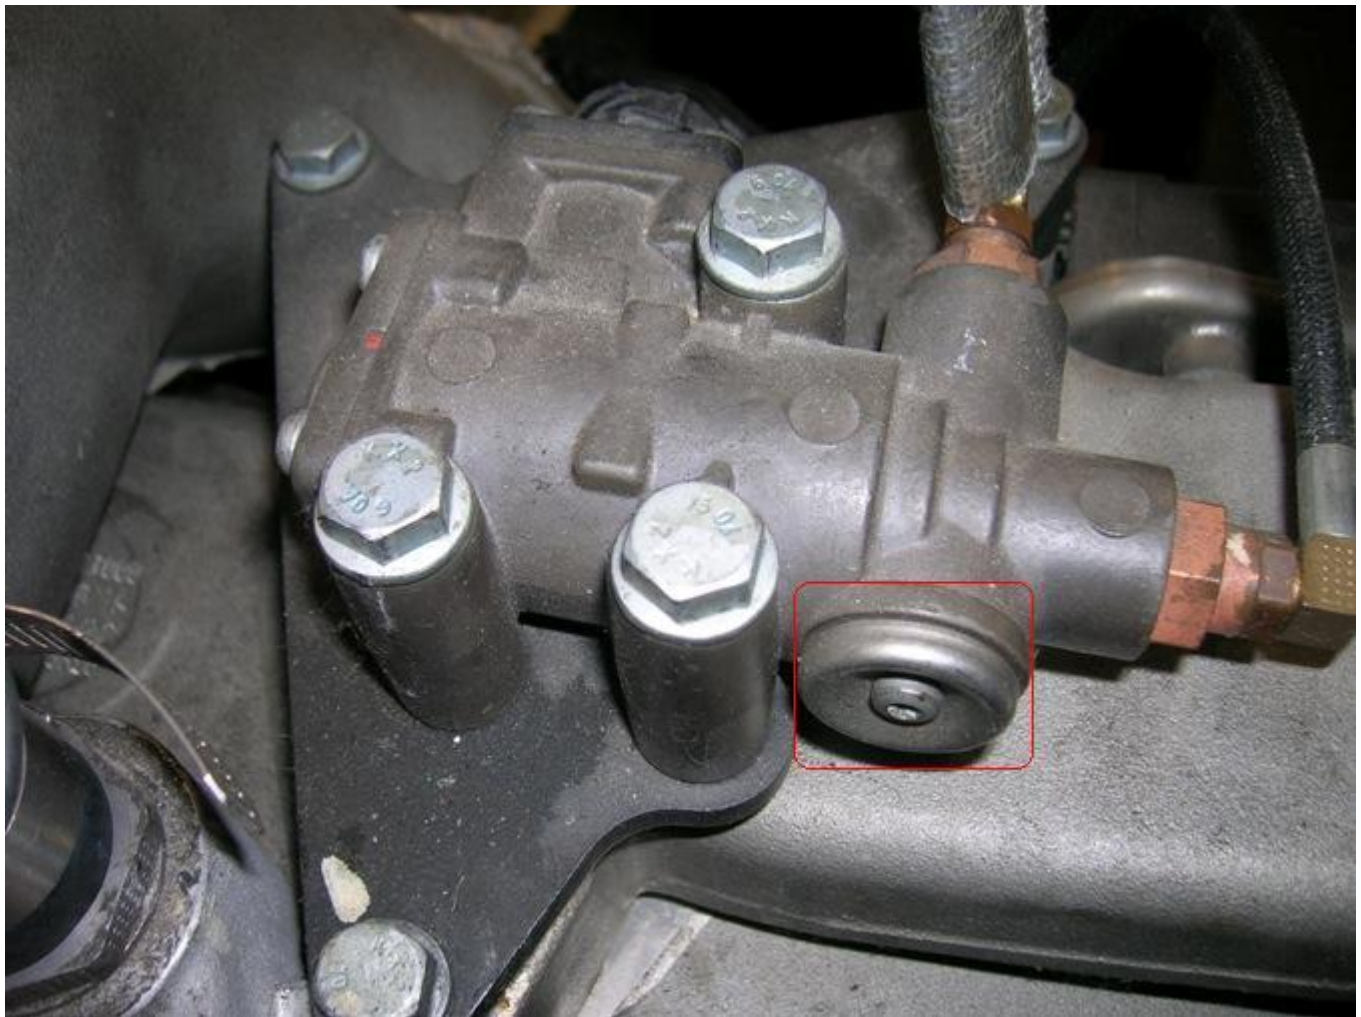
1. Inspect the EGR control valve assembly for an air leak at the exhaust port (see figure 1).
2. Inspect the air hoses going to the air dryer (see figure 2, purple hose is the Engine Air supply).
3. The Engine air supply hose should be installed on the Aux port 2 (see figure 3)
4. If it is installed on Aux port 1 it can create an air leak in the cab air ride system.

(Figure 1, EGR control valve exhaust port)

Remove the plug in Aux 2 and install the engine supply hose (purple hose) into Aux 2. Install the removed plug into the Aux 1 port, this will ensure the engine air system will have its own dedicated air supply.
