**Document ID:** IK1200478  
**Revision:** 7  
**Created:** 3/23/2010  
**Last Modified:** 2/12/2014  
**Author:** Robert Beckett

**Title:** On vehicle DOC Cleaning MaxxForce® 7 Engines**Applies To:** 2007 - 2009 MaxxForce® 7,

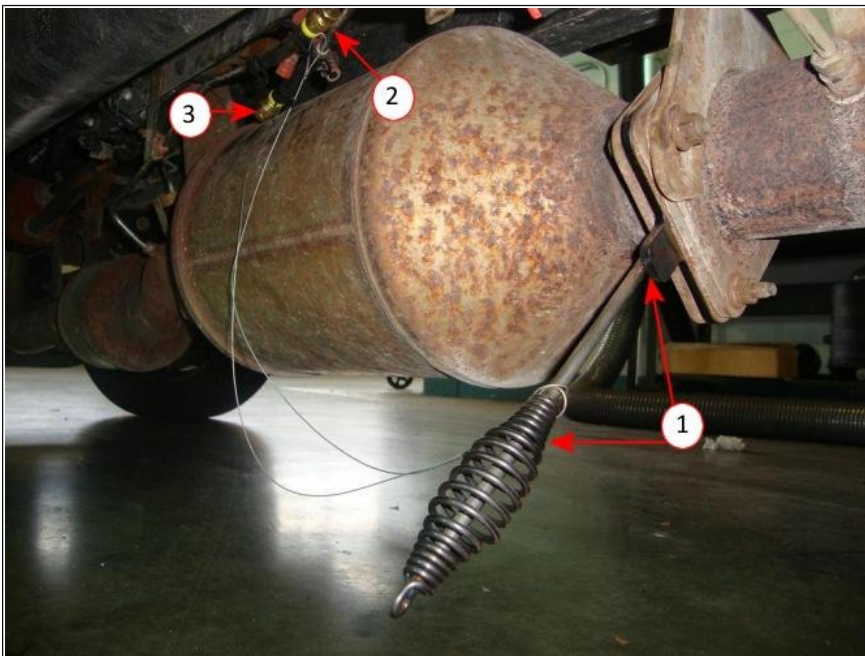
Photo 1 - Restrictor Installed - Horizontal Exhaust

- 1. Restrictor Tool
- 2. EGDH Hose Plug
- 3. EGDH Hose Plug

2. Insert Restrictor plate torque bolts to 40 lbf-ft. (School Bus and horizontal tailpipe only) See Photo 1

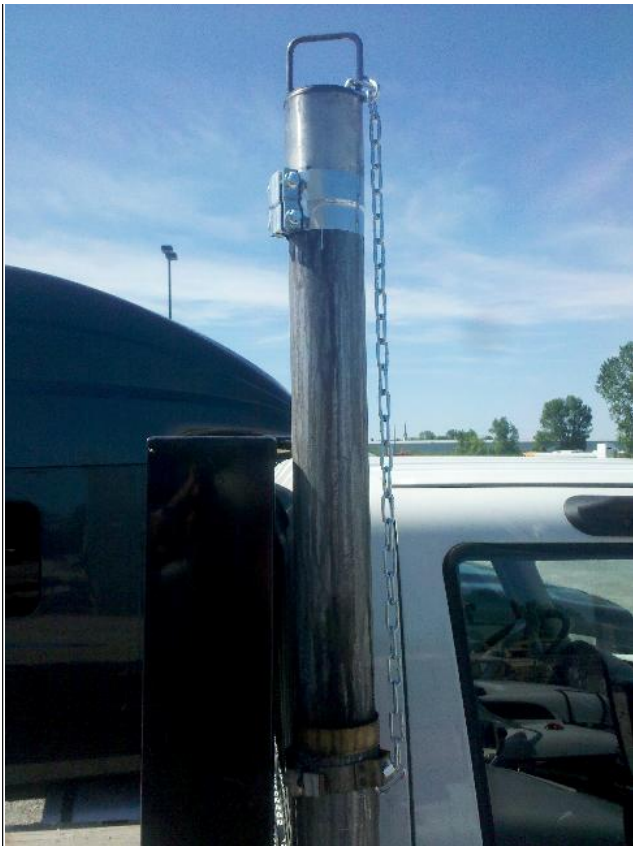
Photo 2 - Vertical Exhaust Restrictor- **Chain must be taut and securely attached at the bottom**

3. For Vertical Exhaust install Restrictor Cap as shown in Photo 2 - Tighten clamps bolts to 60 ft. lbs.

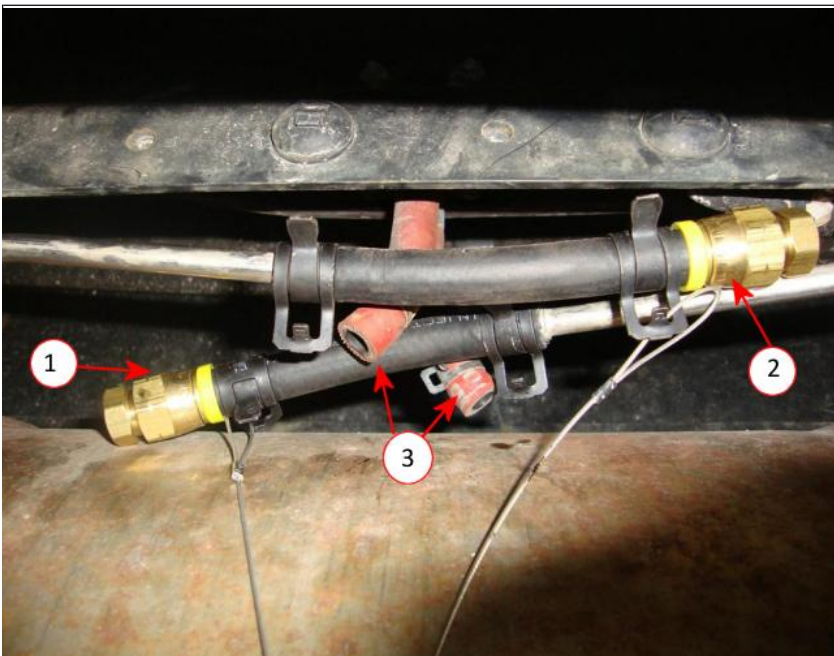
Photo 3 - EGDP Plugs and Hoses Installed on Steel EGDP Tubes  
EGDP Plug  
EGDP Plug  
Original hoses to EGDP Sensor disconnected

4. Disconnect both the EGDP tubes from the rubber hose at the EGDP Sensor
5. Install the 2 EGDP Plugs and hoses supplied with tool kit. See Photo 3
