**Document ID:** IK1200494  
**Revision:** 2  
**Created:** 5/3/2010  
**Last Modified:** 2/11/2014  
**Author:** Randy Geweniger

**Title:** Repair procedure for oil leak on at the crankcase centrifugal breather assembly MaxxForce® DT,9 and 10 engines.

**Applies To:** MaxxForce® DT,9 and 10

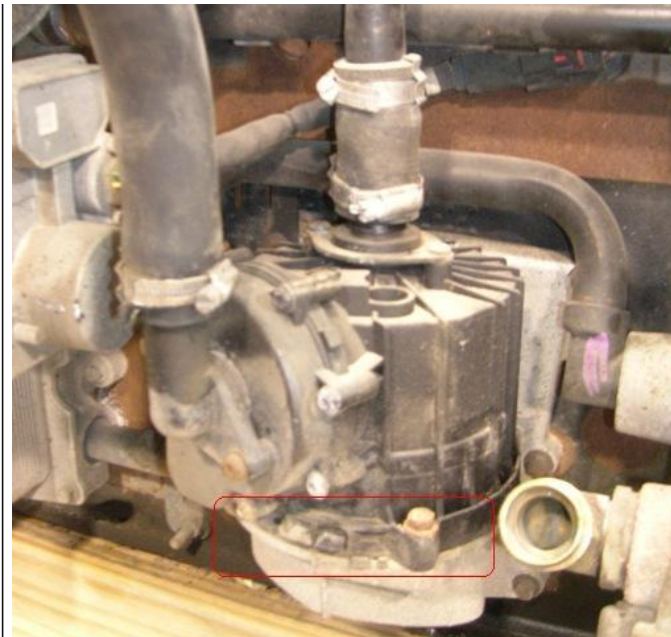
Oil leaks found on MaxxForce® DT,9 and 10 engines at the crankcase centrifugal breather assembly between the upper and lower units.

Figure 1, Oil leak in this area on the crankcase breather assembly.

Replacement of the complete breather assembly for an oil leak between the upper and lower units (Figure 1) is not a warrantable repair. Installation of this seal will correct the oil leak for the Haldex crankcase centrifugal breather assembly. Remove the Haldex unit per engine service manual and disassemble on a clean surface area for inspection. If all parts check out good replace the seal (Figure 2) and retest. If there are parts that are damaged beyond reuse, open a case file with Tech Services.

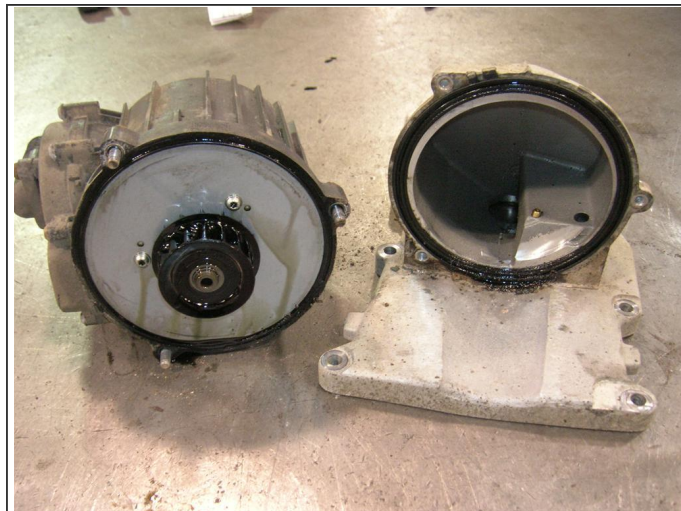
Figure 2, Upper and lower unit seal.
