**Document ID:** IK1201075  
**Revision:** 0  
**Created:** 2/11/2014  
**Last Modified:** 2/14/2014  
**Author:** Steven Bell

**Title: 2010-2013 IBB Intake Throttle Valve Causing Regen Issues**
**Applies To: 2010-2013 IBB Maxxforce 11/13/15L Engines**

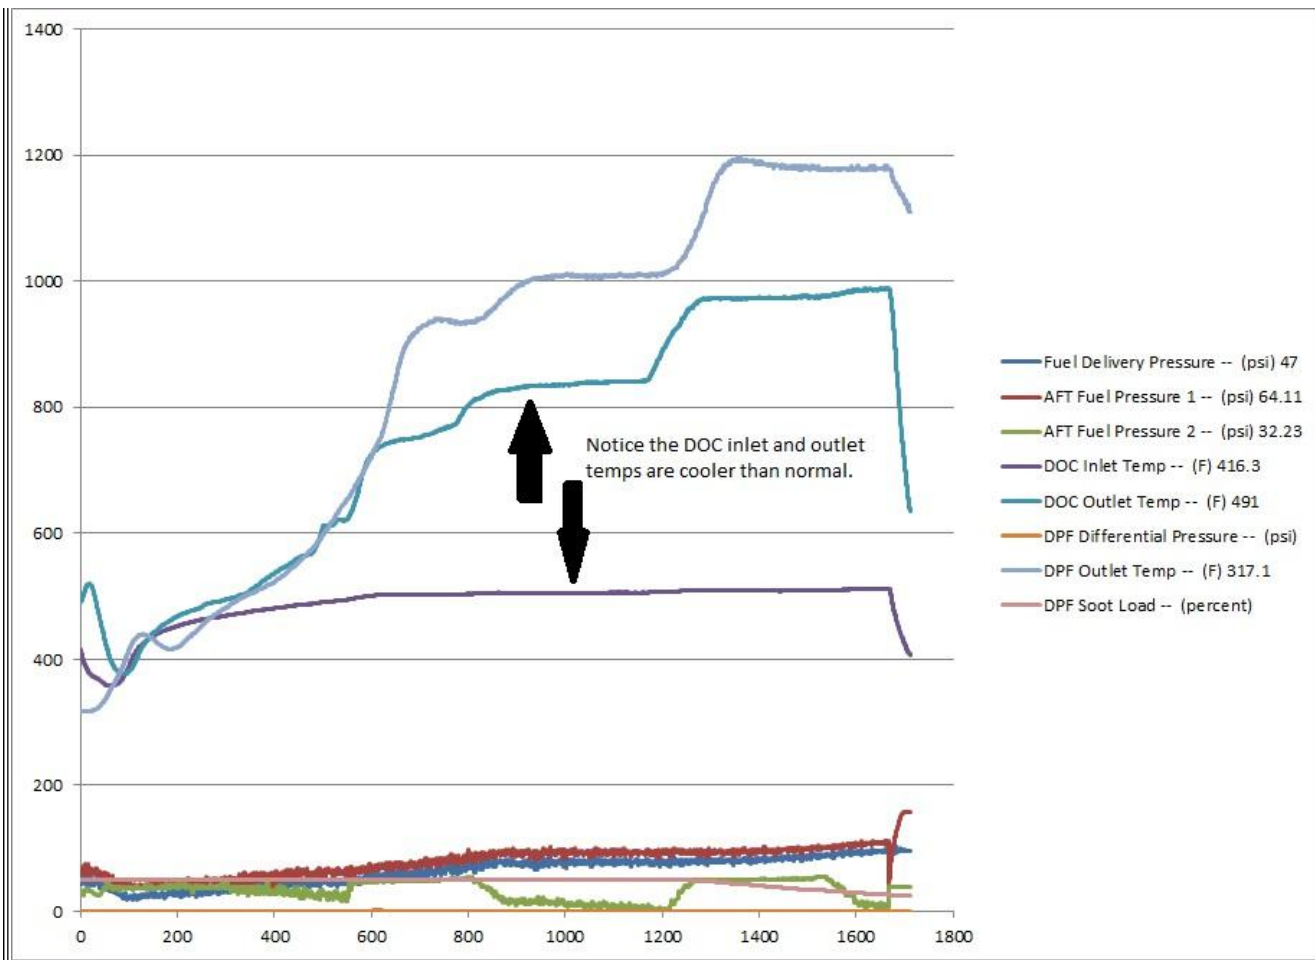
**Figure #1: OBFCT with a Bad ETV**

1. Hook up ServiceMaxx and run an OBFCT
2. Review the OBFCT and compare to the graph below in Figure #1. As stated in items 1 and 2 of Figure #1 look for a slow to build temp and a DOC inlet temp that stays too cold. You generally should see DOC IT around 550-700 degrees as shown in Figure #2.
3. If your OBFCT looks similar to Figure #1 and all aftertreatment components are testing good then replace the ETV and retest. If it does not exhibit a similar failure then refer to the MaxxForce Aftertreatment Manual for further diagnostics of any regen concerns.

Item 1: Notice the DOC inlet and outlet temps are cooler than a normal regen should be. DOC inlet should be in the 600-700 degree F range. This is due to the ITV not working properly to produce enough heat in the exhaust system.

Item 2: Notice the length of time it takes for the temps to start rising

Replace the ITV and rerun the OBFCT to verify the repair

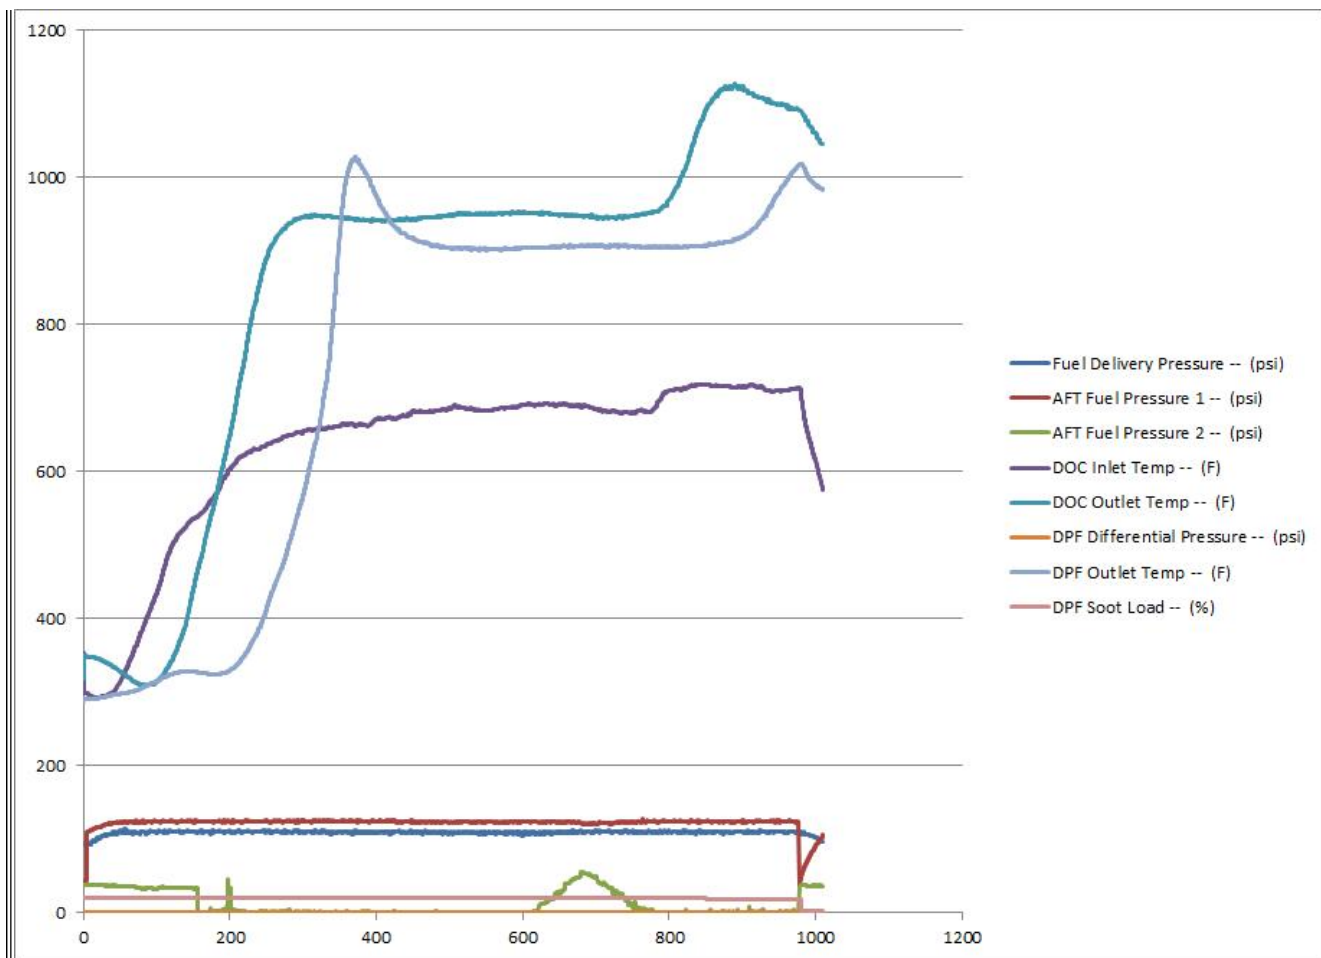
**Figure #2: Good Regen**

Item 1: Notice the temps rise much quicker than the bad regen shows

Item 2: DOC Inlet temp is in a good range
