SLIDING DOOR– INTERIOR POST FINISHING TRIMS Prevost vehicles

DESCRIPTION

On the vehicles affected by this bulletin, replace the sliding door interior post finishing trims as described in the following procedure.

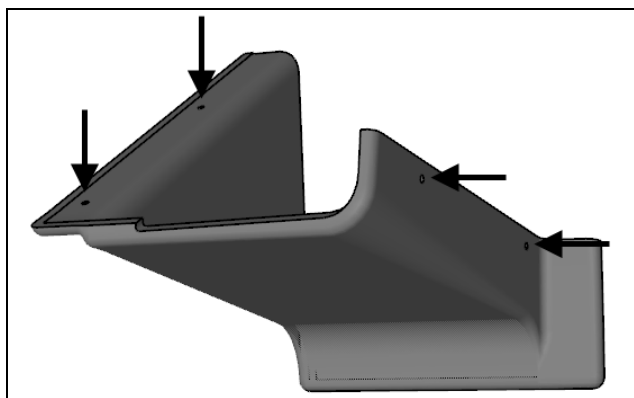
FIGURE 2: TRIM 314471, WITH 4 FASTENING POINTS

- 2) Install the new finishing trim similarly. Take note that each finishing trim has four fastening points instead of five like the previous version.

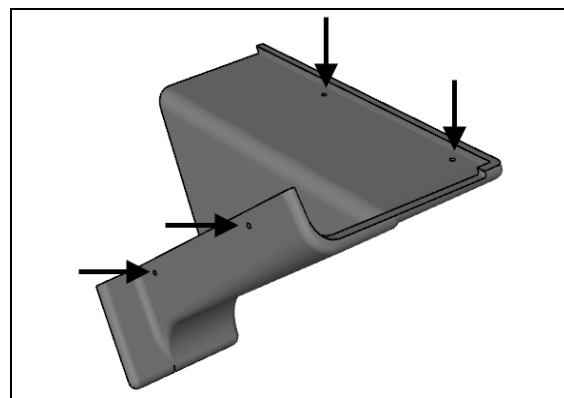
FIGURE 3 TRIM 314470, WITH 4 FASTENING POINTS
